### Material characterisation for preserving cultural heritage: Evidence of the 1595 fire at Pisa Cathedral --Manuscript Draft--

<b>Abstract:</b>	Recent restoration work on Pisa Cathedral provided the opportunity for a multidisciplinary analysis of the monument that identified interesting aspects of its history, conservation and structural safety. In particular, the study of the matroneum provided clues about the role of the structures in the well-known fire that occurred in 1595. Alteration patterns and damage forms on the stone masonry walls were analysed to better understand their relationship with this catastrophic event. The investigation of the stone specimens enabled textural and mineralogical features typical of fire damage to be identified on the surface. The evidence of fire also provided a terminus ante quem to correctly interpret and diachronically date a damage pattern consisting of cracks in the eastern arch supporting the dome. The cracks were likely to have been induced by a soil consolidation phenomenon related to the renowned leaning of the Pisa tower, centuries before the fire.

## Material characterisation for preserving cultural heritage: Evidence of the 1595

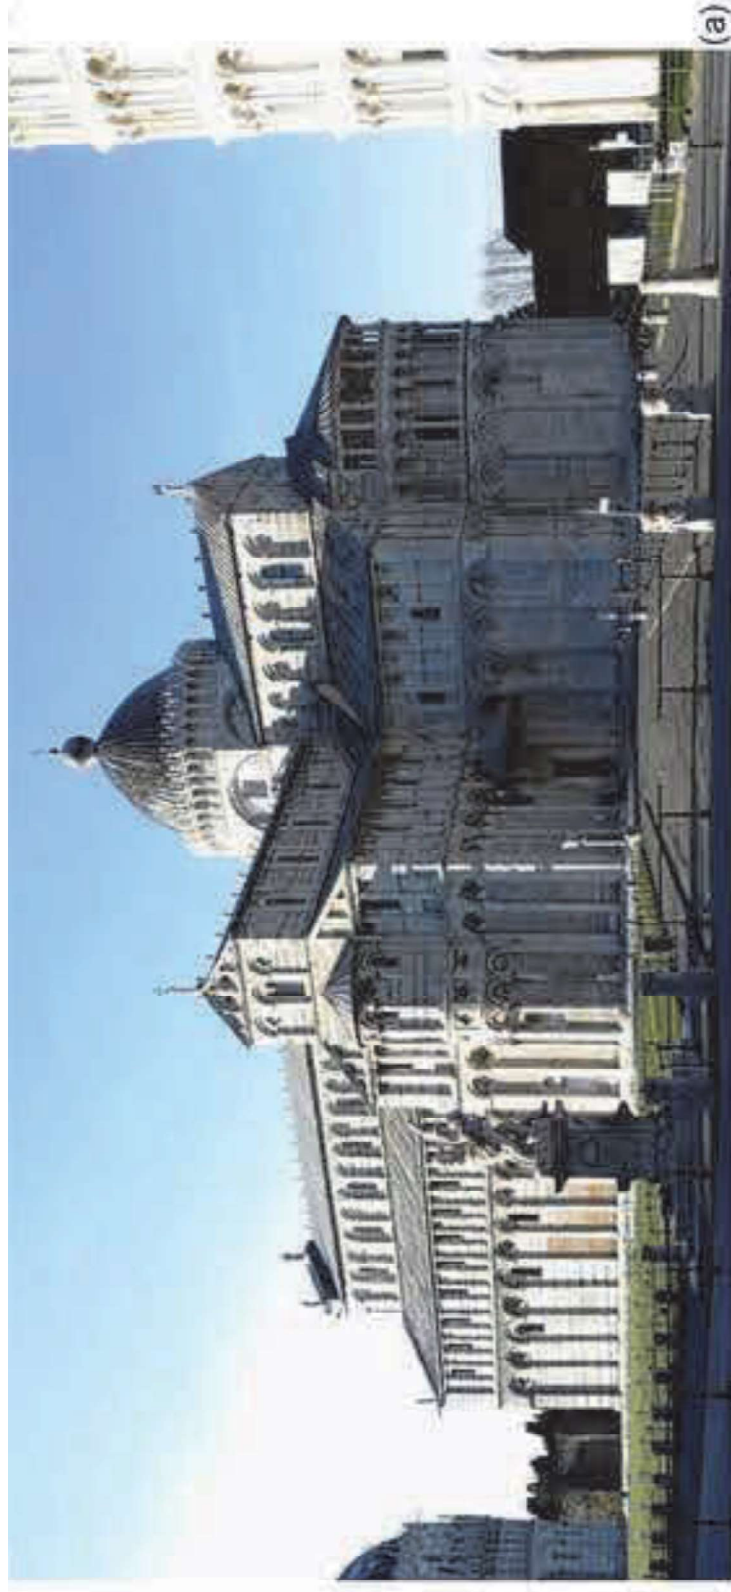
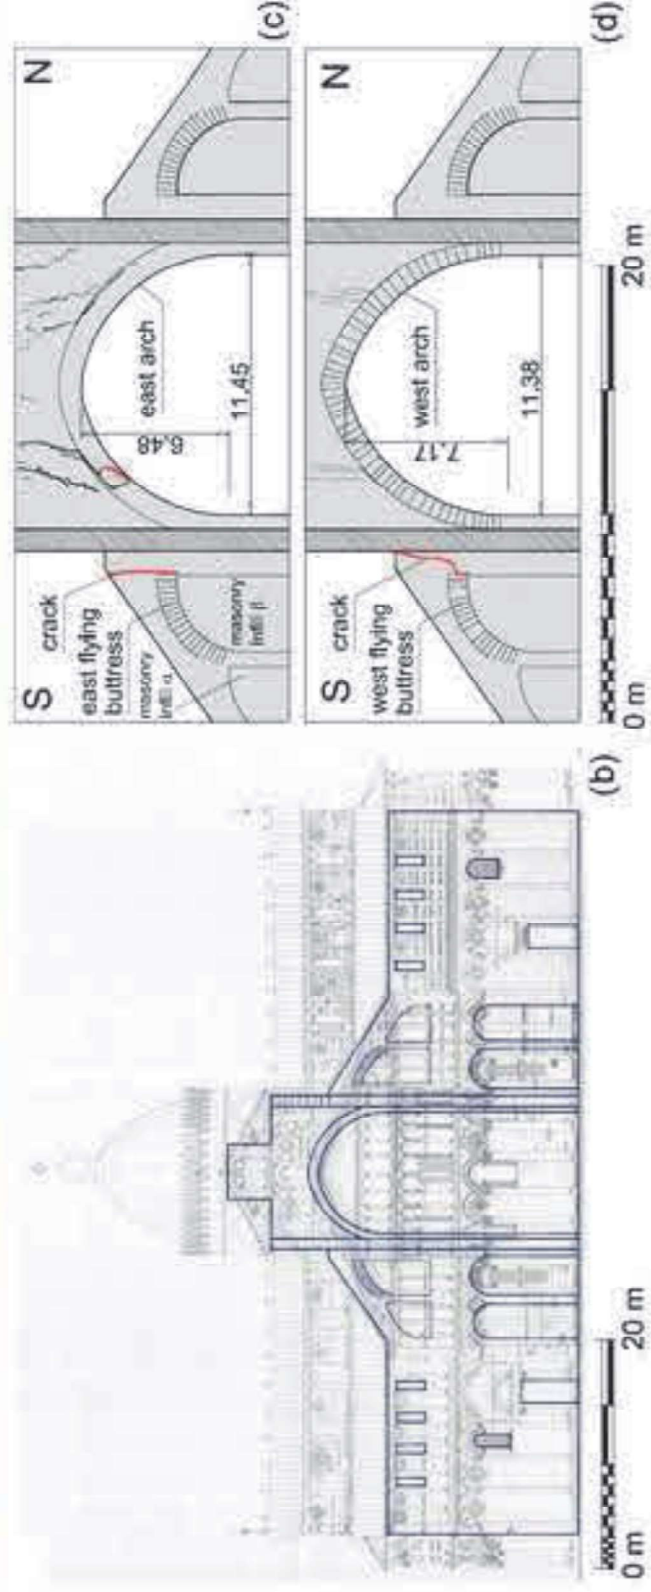
Further insights into the origin of this crack pattern are provided by the on-going archaeological study of the brick masonry infill “β” (Fig. 1.c), which probably dates back to the late Middle Ages. As the masonry infill is not damaged nor detached from the adjacent structures and is **affected** by chromatic alteration, it was likely to have been built after the formation of the cracks on the flying buttress and before the fire of 1595. The crack patterns were thus probably produced many centuries before the 1595 fire by soil consolidation and related to the renowned leaning phenomenon of Pisa Tower. The cause of this will be assessed in the on-going structural analysis.

**Figure 1.** (a) The Cathedral and the Miracle Square complex. (b) Schematic view of the rear façade (Sanpaolesi 1970); on both **north** and **south** sides, flying buttresses connect the arch to the external walls of the transepts. Details of the (c) **east** and (d) **west** arches and flying buttress affected by the crack pattern.

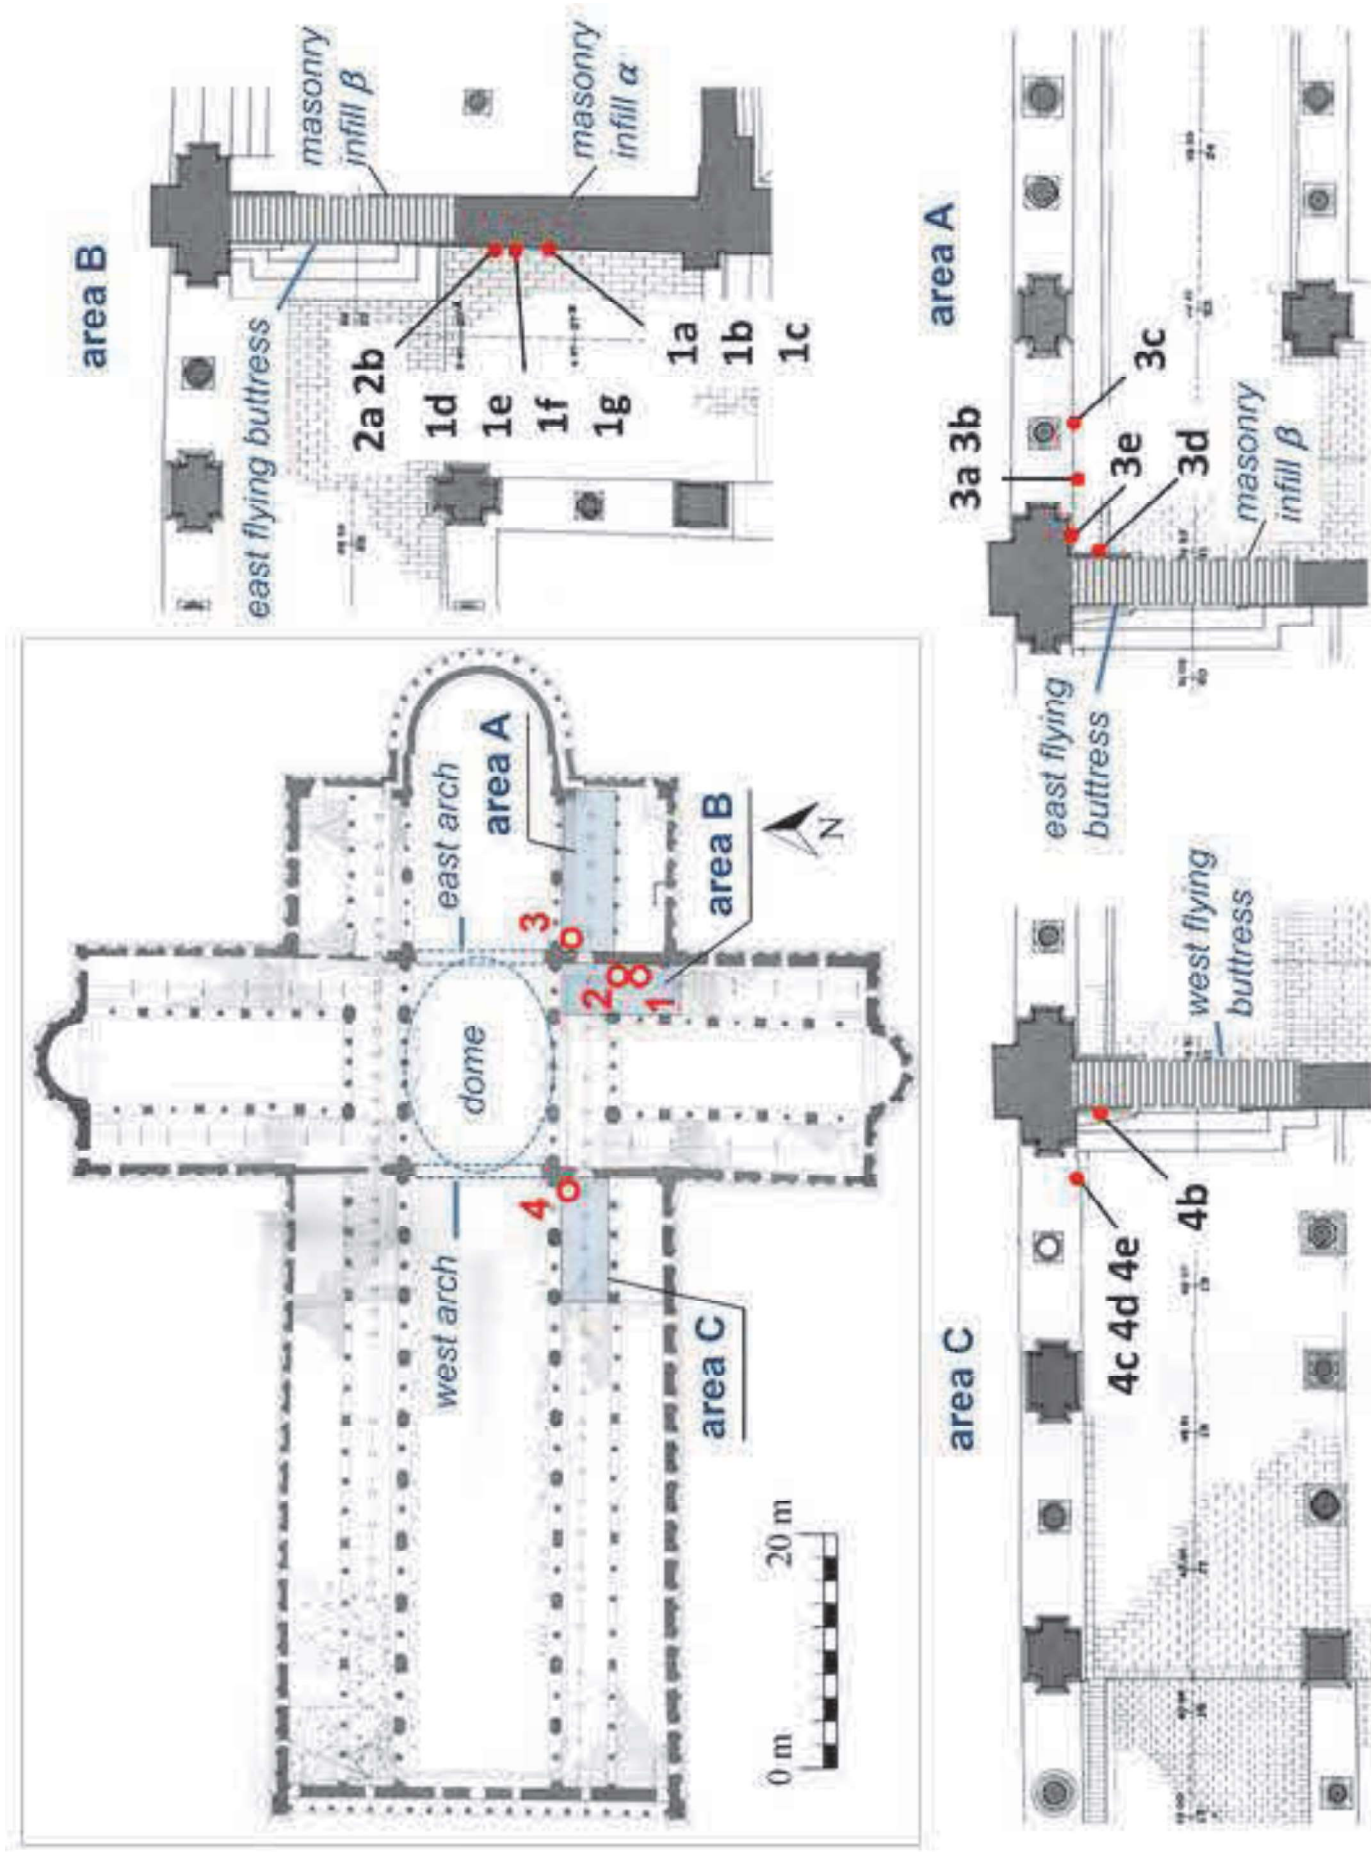
**Figure 2.** Localisation of stone specimens sampled at the Pisa Cathedral's *matroneum*. Modified from Sanpaolesi (1970).

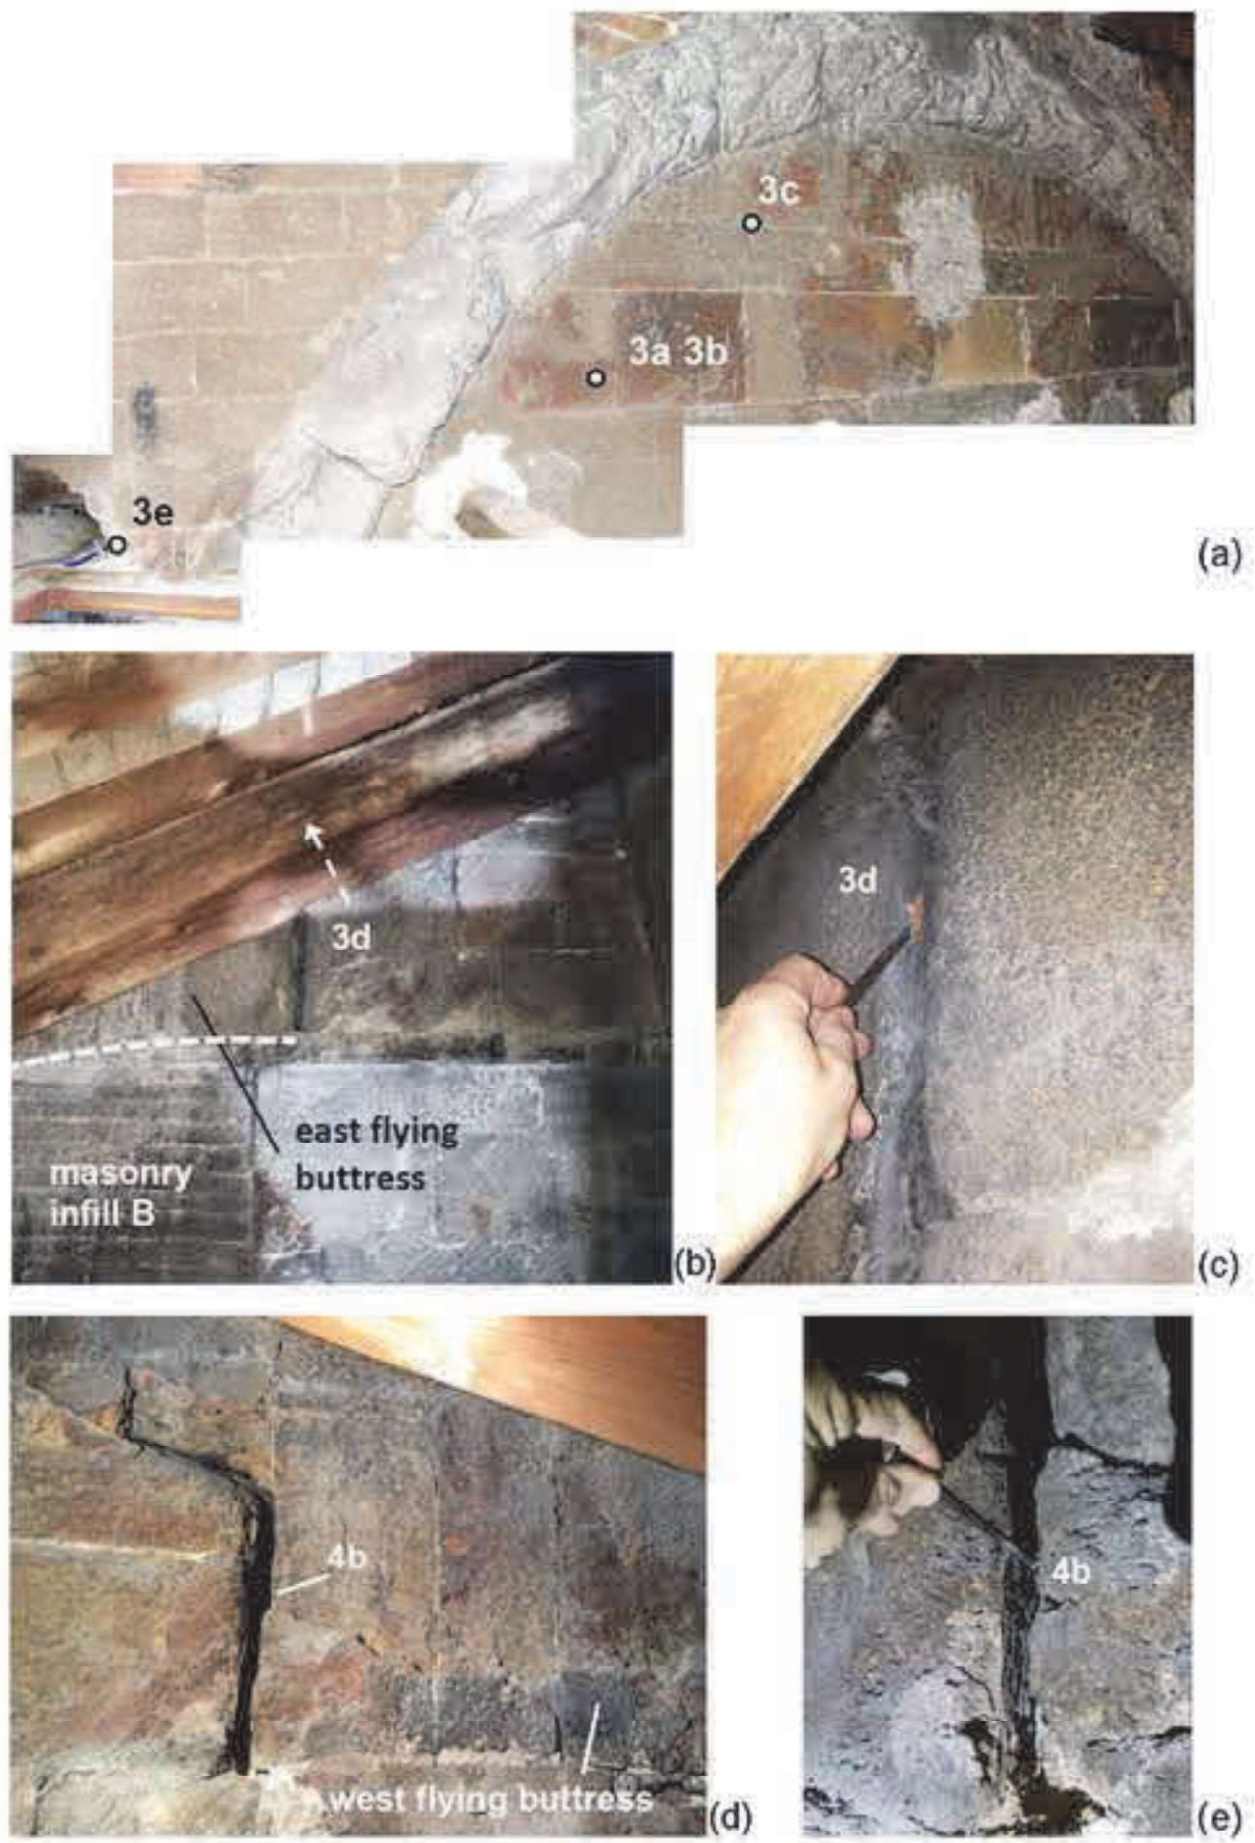
Five specimens are from area A (see Fig. 2, inset area A), four of which (labelled as 3.a, 3.b and 3.d) were taken from the internal surface of the wall facing the choir under the blind arcade (Fig.3.a) and one specimen (labelled as 3.d) was taken from the flying buttress adjacent the east arch supporting the dome, corresponding to the crack pattern (Fig.3.b-c).

**Figure 3.** (a) Internal surface of the wall facing the choir - under the blind arcade - affected by red chromatic alteration (area A). (b-c) Stone ashlar of the flying buttress adjacent the **east** arch affected by cracks and dark deposits on the stone surface (area A). (d-e) Surface of the wall facing the main nave (area C).

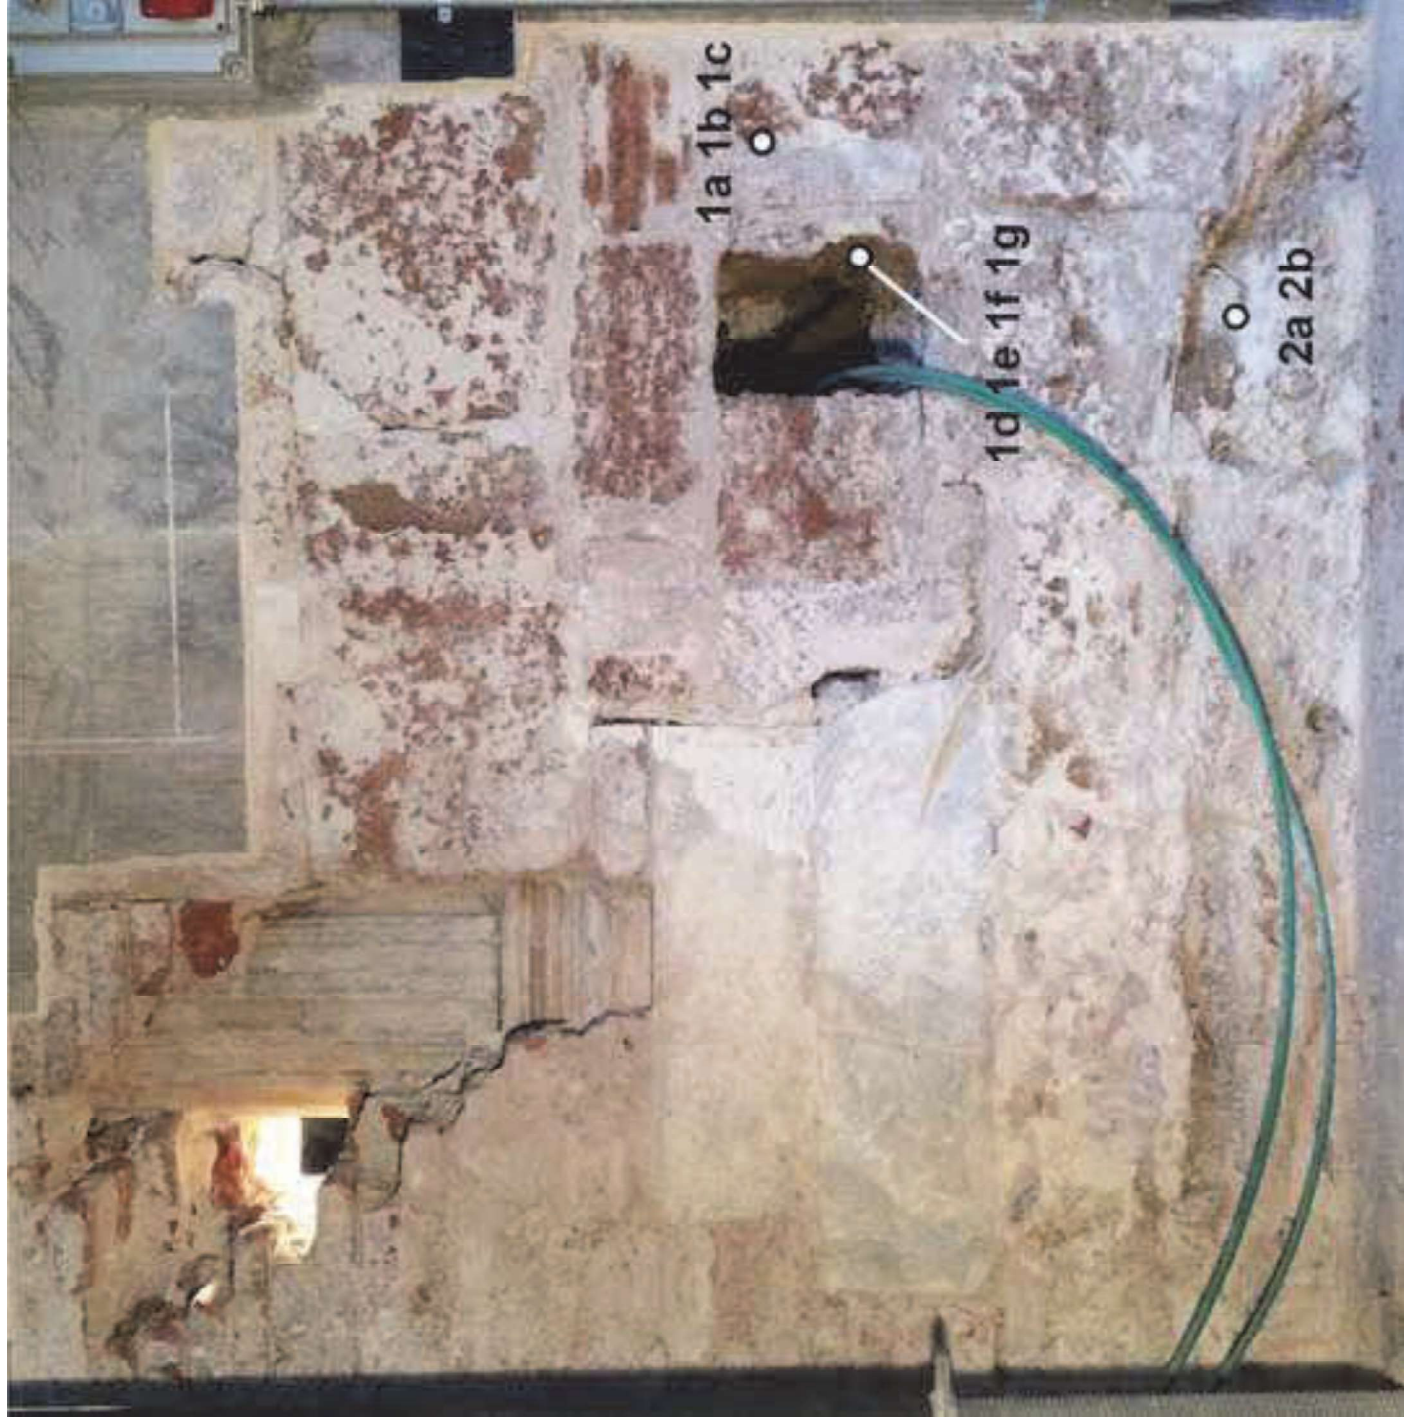
Nine specimens were sampled from area B (see Fig. 2, inset area B), in the south transept, and most were taken from the stone surface constituting the masonry infill “ $\alpha$ ”, which clearly showed chromatic alteration (labelled as 1.\*) (Fig.4). Two specimens (labelled as 2a and 2b) were taken from unaltered masonry. Finally, four specimens (labelled as #4) were taken from area C (see Fig. 2, inset area C); specimens 4c-e were from the inner surface of the wall facing the main nave, and were clearly affected by alteration, while specimen 4b is a chip of the dark deposit entering the crack pattern on the west flying buttress (see Fig. 3.e-d).

**Figure 4.** Details of the masonry infill “ $\alpha$ ”, area B.

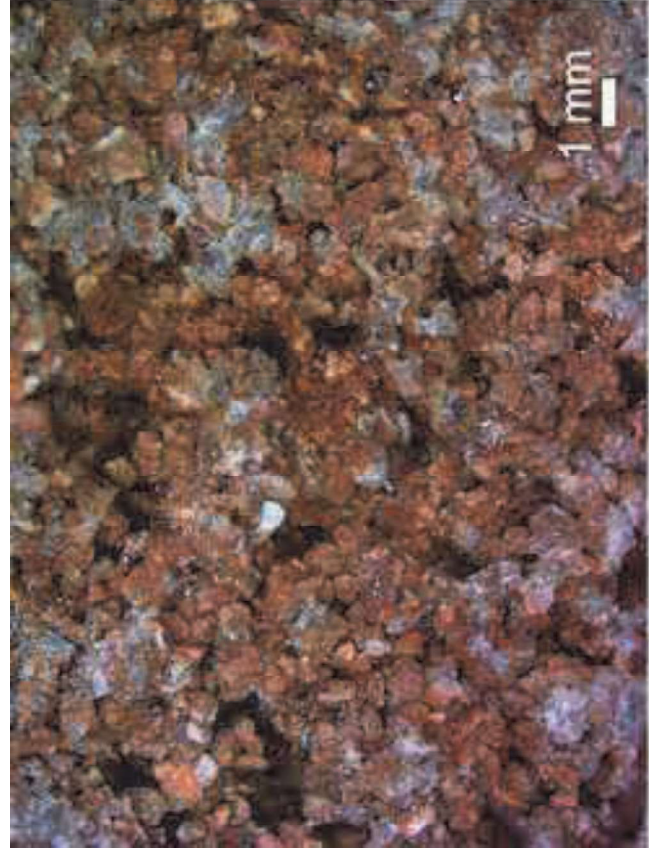
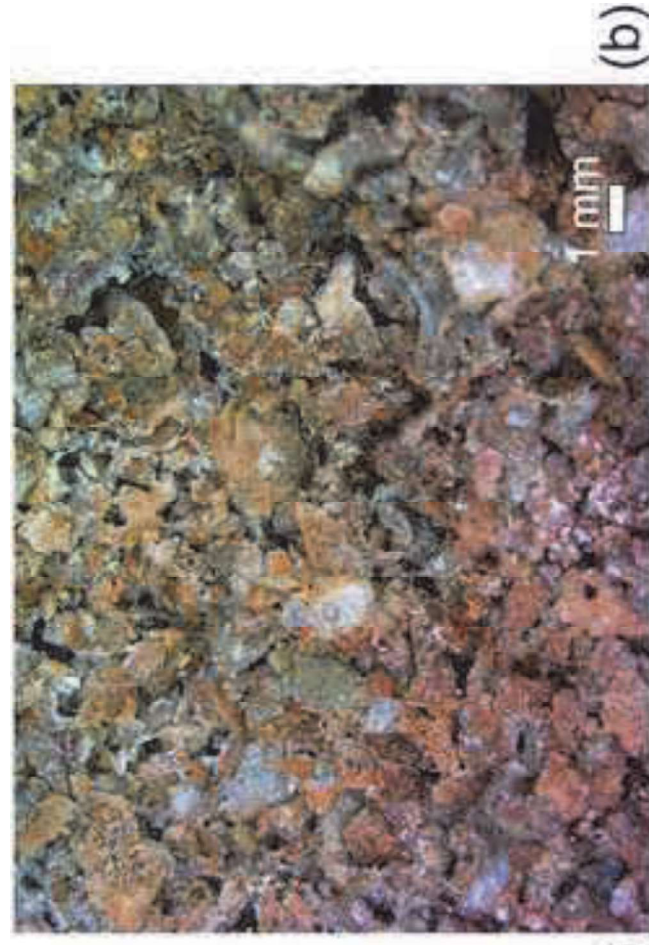
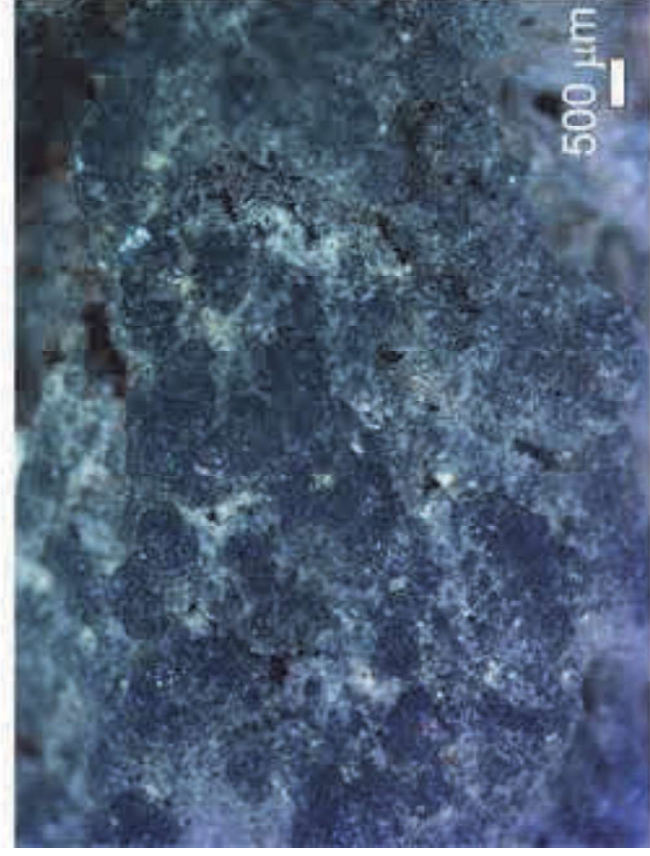
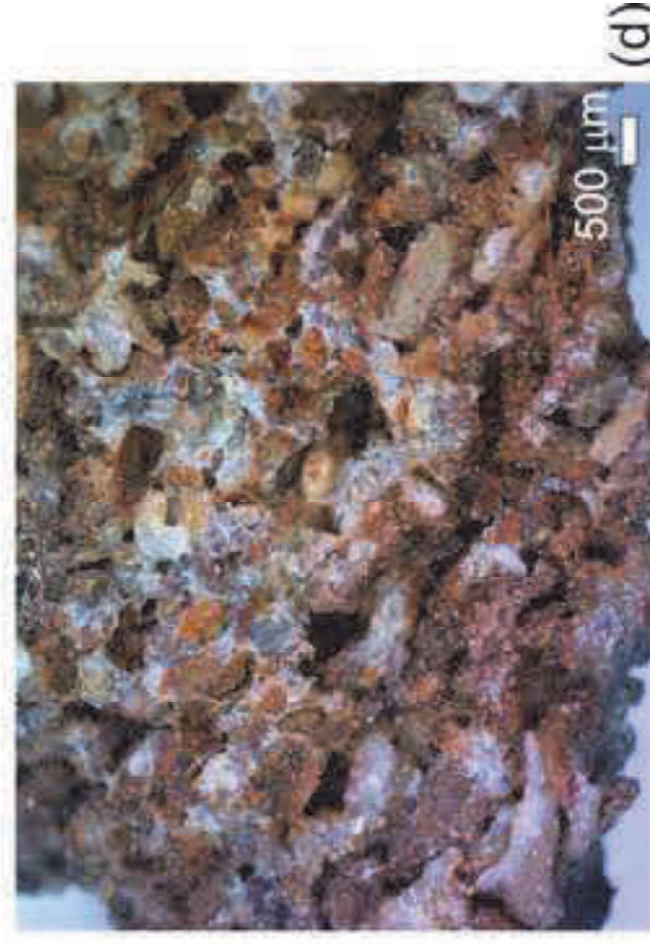
Chromatic alteration, **dark** deposits and **salt crystallization** in the open outermost porosity were the main alteration patterns observed **with the light microscope** on the stone sample surfaces. For the samples **affected** by chromatic alteration, the stone colour turns from yellow to red (*e.g.*, 1.d, 3.b, 3.c, 3.e) (Fig. 5.a) and a sharp boundary between altered and unaltered areas was observed (Fig. 5.b). The microstructure consists of elongated and angular grains and fossil fragments embedded in a calcite cement and a slight variability in the cement/grain ratio was observed among the studied samples (*e.g.*, a higher cement proportion in 3.b and 3.c). In the unaltered and yellow areas the bioclast fragments are clearly visible (*e.g.*, 2.a, 2.b) and the porosity is estimated at about 10-20% vol. In the red altered areas bioclast fragments are partially obliterated, and the porosity increases to 20-30% vol. The **dark** deposit is about 1 cm in thickness (*e.g.*, in 3.c and 3.d) and appears to be homogeneously distributed on the stone surface (Fig. 5.c). Under the deposit, the stone is altered and appears red. The presence of the **dark** deposits obliterates the textural features of the stone, and also fills the outermost porosity. In all samples, the open and outermost porosity is indicated by the presence of secondary crystalline phases (*e.g.*, in 1.d, 3.c, 3.d and 3.e), especially in darkening areas (Fig. 5.d).

**Figure 5.** Macro-pictures of studied samples demonstrating the observed alteration patterns: (a) chromatic alteration (sample 1.d); (b) sharp interface between altered and unaltered areas (sample 1.d); (c) dark deposit (sample 3.c) and (d) salt crystallisation into outermost porosity (sample 3.c).
