New Frontiers of Composites Applications in Heritage Buildings: Repair of Exposed Masonry of St. Nicola Church in Pisa

Pietro Croce

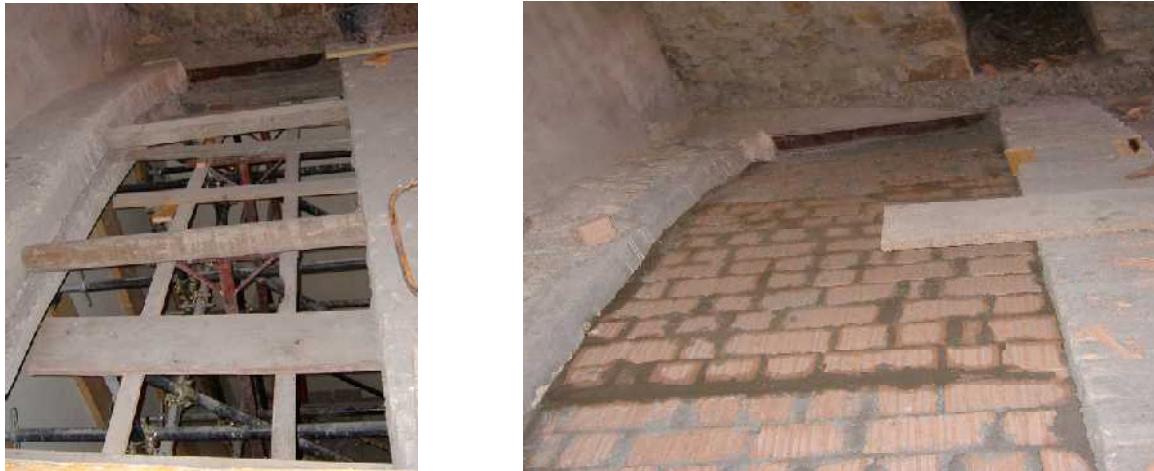
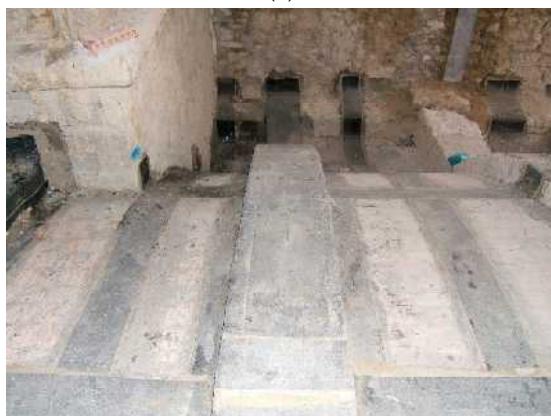
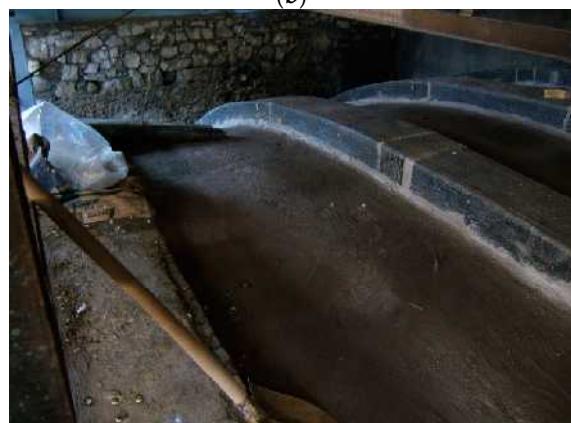
Figure 5. Composite strengthening of a partly collapsed ribbed barrel vault: (a) detail of the collapsed part; (b) reconstruction of the collapsed part; (c) detail of composite reinforcement; (d) detail of the completed intervention.

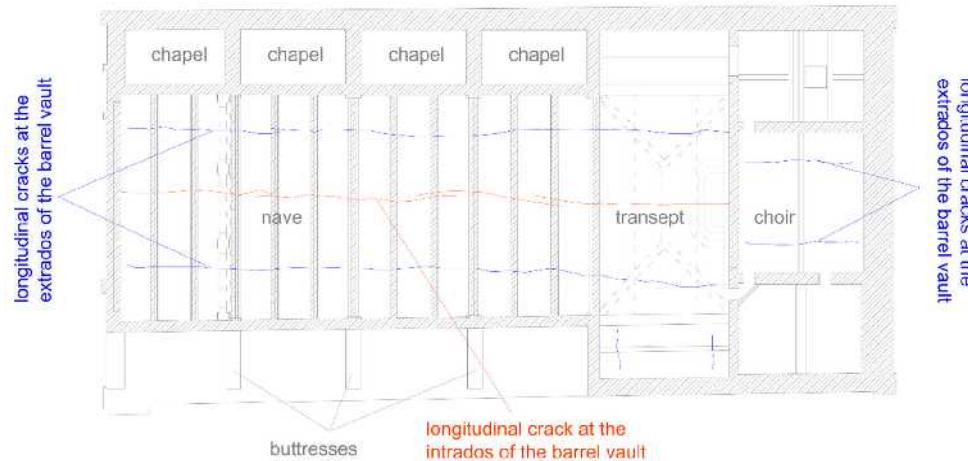
A first crack pattern, summarized in Figure 14, affected the longitudinal barrel vault of the nave and its stiffening arches. This crack pattern denoted the exemplary and classical vault mechanism, characterized by three longitudinal Pol Abraham's hinged cracks [79,80]: A central one at the intrados of the crown (Figure 15a) and two lateral ones, nearly symmetric, at the extrados of the vault haunches (Figure 15b).

Figure 14. Crack pattern of the longitudinal barrel vault of the nave.

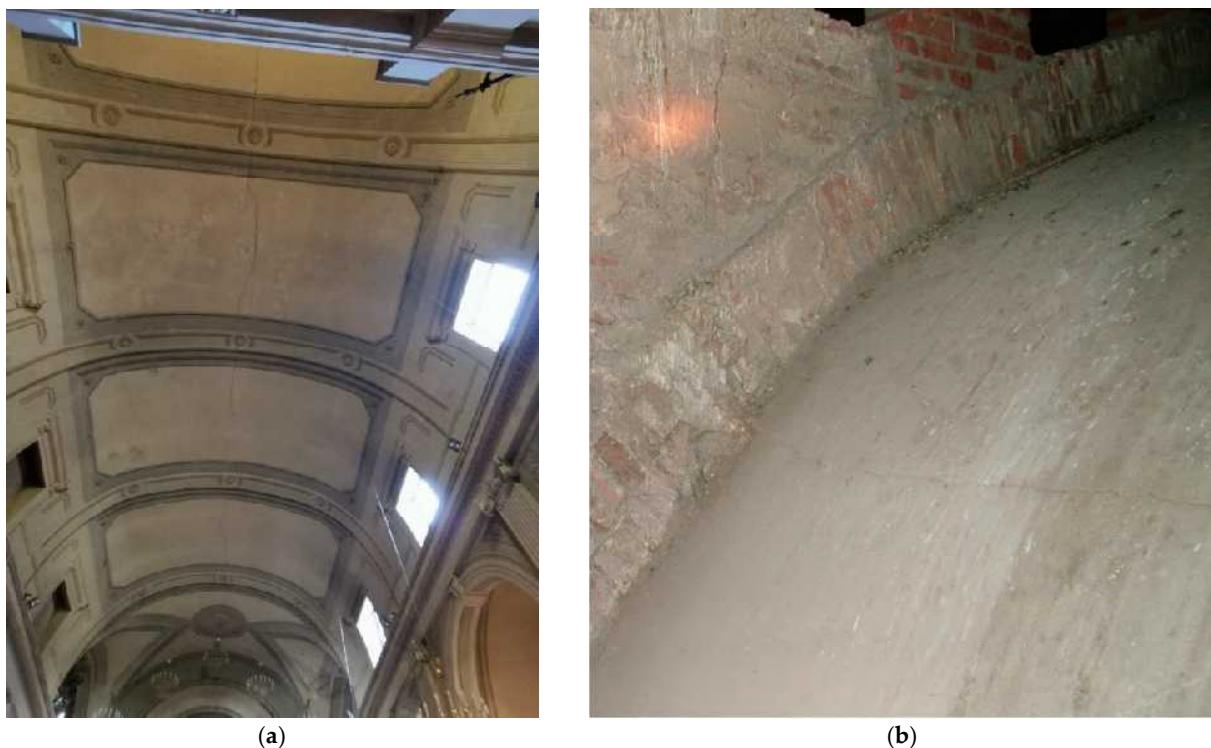
Figure 15. Longitudinal hinged cracks of the barrel vault of the nave: (a) longitudinal crack at the intrados; (b) longitudinal crack at the extrados of the barrel vault haunches.

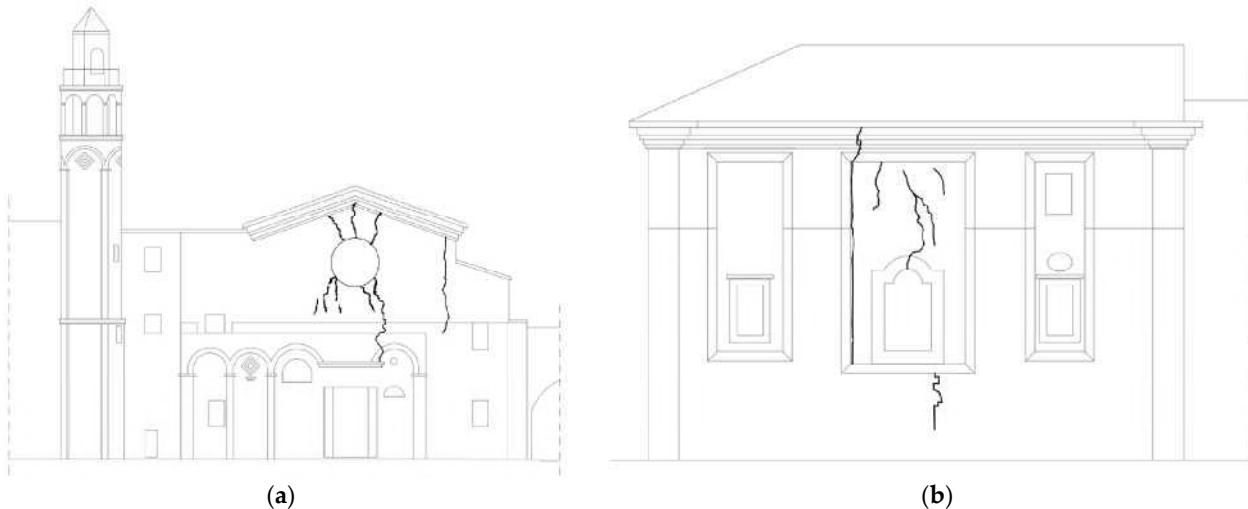
A second, clearly visible, family of vertical cracks, summarized in the diagrams of Figure 16a,b, was detected on the main façade (Figure 17) and on the rear façade (Figure 18). A common feature of these cracks, mainly concentrated near the rose windows on the main façade, and in the neighborhood of the second window on the rear façade, was the width increasing with the height.

Figure 16. Graphic representation of the crack pattern on the façades: (a) main façade; (b) rear façade.

The crack patterns just described are both coherent with a unique failure mechanism: the relative horizontal displacement of the vault abutments, caused by the horizontal thrust, and by the resulting out-of-plane rotation of the longitudinal walls, barely restrained by the main façade, and by the rear façade. The origins of this failure mechanism seem quite remote; in fact, several stone stripes have been detected on the main façade straddling the cracks (see Figure 17b). The presumable rationale of the insertions of these narrow stones was stitching the cracks, but, the stone stripes also having cracked, the results were clearly unsatisfactory.

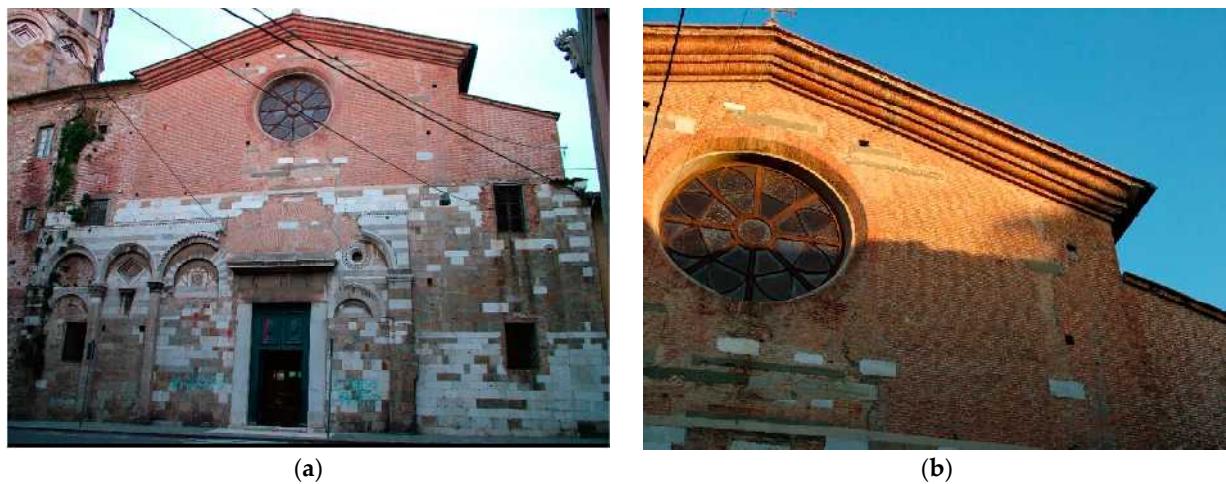
Figure 17. The crack pattern on the main façade: (a) general view; (b) detail.

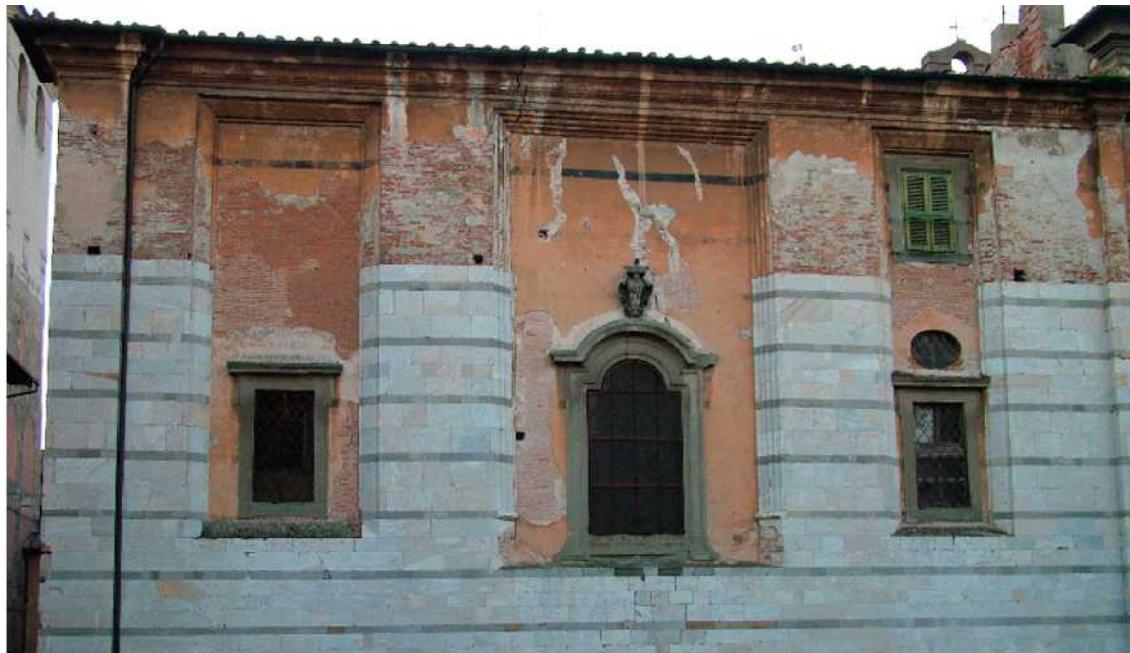
Figure 18. General view of the crack pattern on the rear façade.

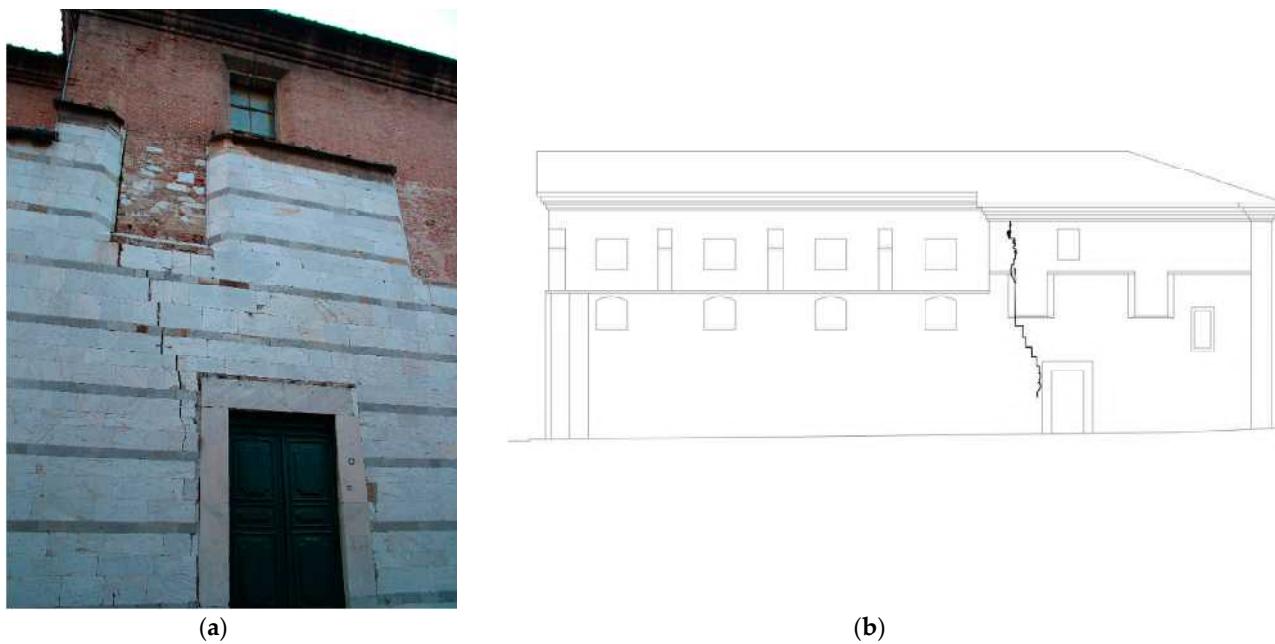
The third detected crack pattern was a significant vertical crack on the south façade, located at the connection between the nave and the transept, whose opening increased with the height (Figure 19). This crack was originated by a second failure mechanism, initiated

in fairly remote times: a settlement of the foundation of the corner between the main façade and the south façade, further emphasized by the construction, in the 19th century of the arched passage connecting the Church with the Royal Palace. Nevertheless, after a suitable analysis of the evolution of the crack over time, it was concluded that the settlement was no longer active, and that specific strengthening interventions of the foundation were unnecessary. For these reasons, the interventions were mainly concentrated on the façades.

Figure 19. The crack pattern on the south façade: (a) detail; (b) graphical representation.

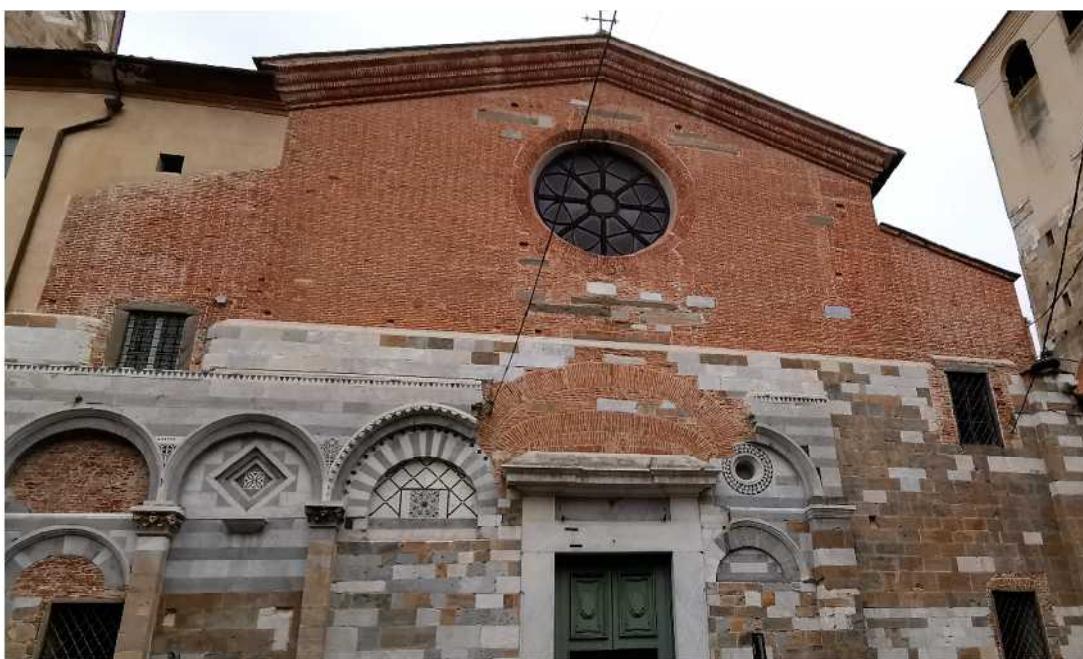
Figure 25. The actual aspect of the main façade—global view (June 2021).

Looking at the photos, it can be remarked that all the crack patterns have stabilized. In addition, till now,

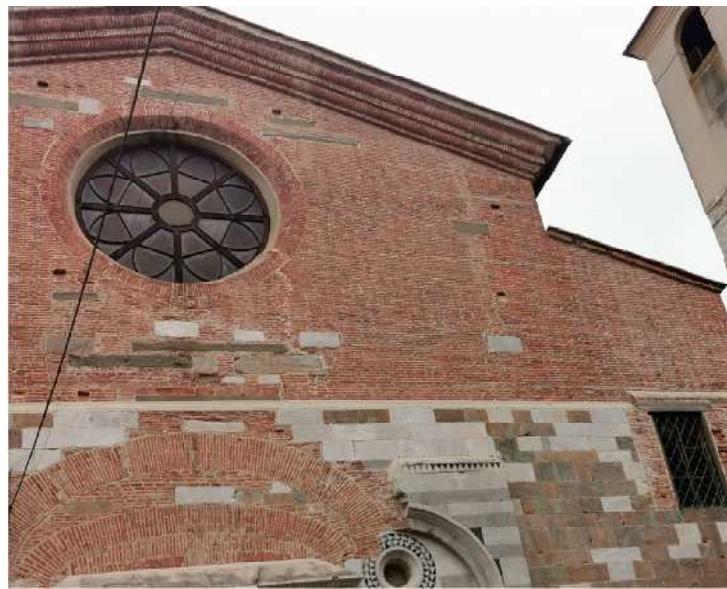
Figure 26. The actual aspect of the main façade—detail (June 2021).

- there is no evidence of the reopening of existing cracks, or of the formation of new cracks, on the exposed masonry of the main façade, as demonstrated in detail by the photo in Figure 26,
- the marble facing of the rear façade, reconstructed during the restoration works of 2005, is undamaged, while the crack pattern previously evident in the neighborhood of the central window is no longer active (Figure 27b), and, finally,
- the vertical crack of the south façade is still closed, so confirming that the differential settlement, which originated it, is nearly inactive.

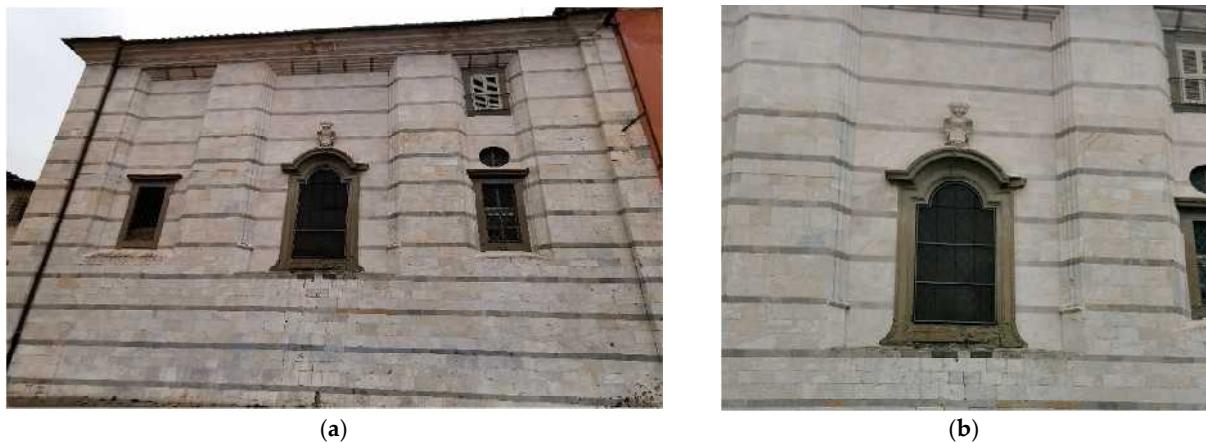
Figure 27. The actual aspect of the rear façade (June 2021): (a) global view; (b) detail.

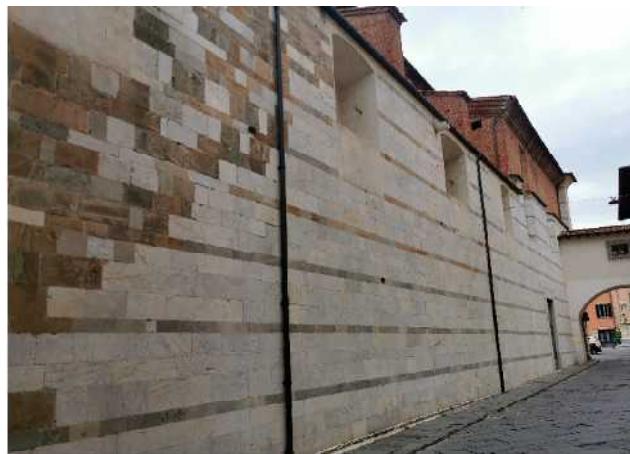
Figure 28. The actual aspect of the south façade (June 2021).
