# Damage detection, localization, and quantification for steel cables of post-tensioned bridge decks

The present work aims to provide an in-situ inspection methodology for prestressed concrete bridges with post-tensioned cables (PT bridges). The adoption of non-destructive techniques (NDT), already widely employed in other engineering fields, is proposed, providing reliable information with a relatively low impact on the existing infrastructure. For each of the specific inspection topics (i.e. cables' layout detection, defect localization and quantification, estimation of residual prestressing force) the proposed investigation procedure was calibrated through a deep experimental test campaign, including both laboratory tests – planned and performed to validate the method and check its efficiency and reliability – and applications to existing viaducts located on the Italian highways.

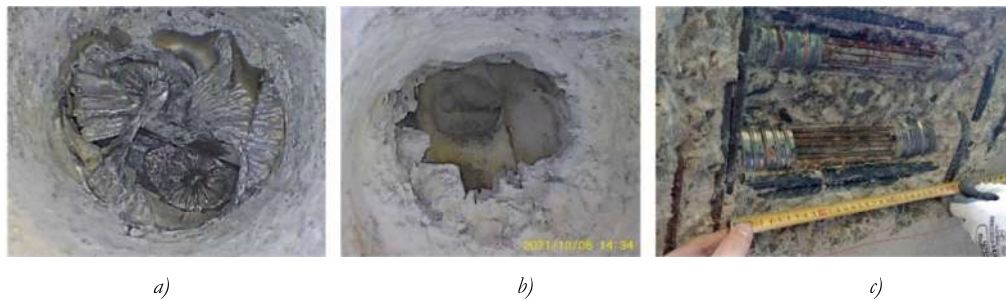
**Fig. 3.** A) Poorly executed endoscopy: the mashed duct does not allow a correct evaluation; b) well-executed endoscopy: there is no grouting inside the duct; c) exposed cable with evident corrosion phenomena.

proceed with the removal of the concrete cover (Fig. 3c).

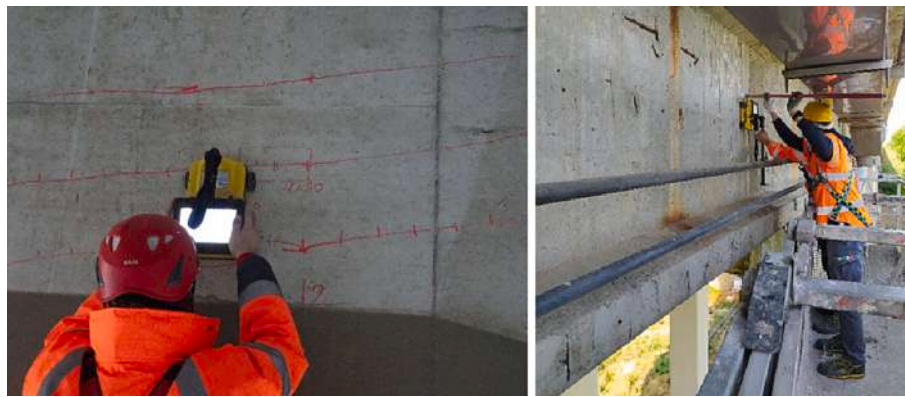
Fig. 7. GPR execution in situ.

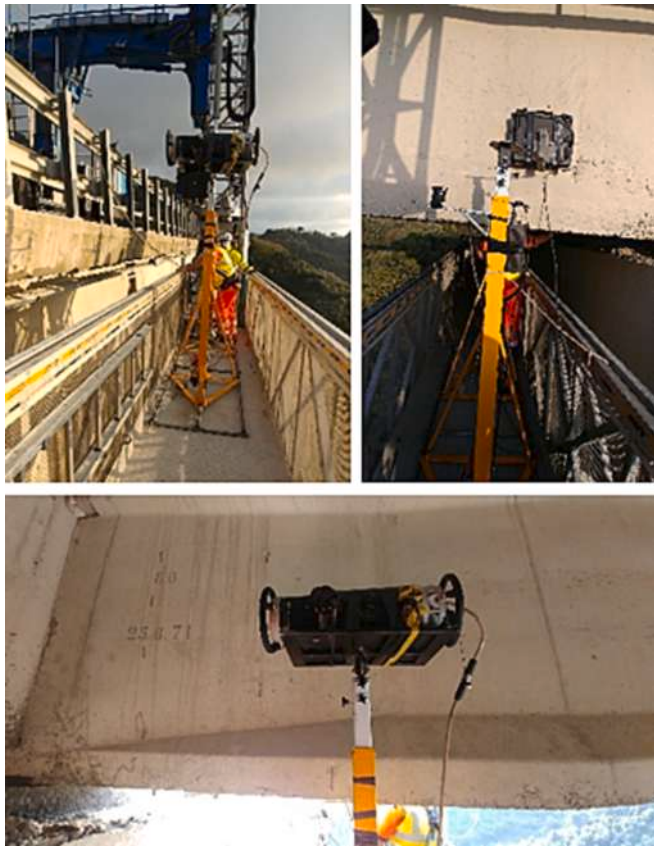
Fig. 19. Some views of the emitter and the receiving panel.
