Legal disputes and building defects: some data from Tuscany (Italy)

ABSTRACT

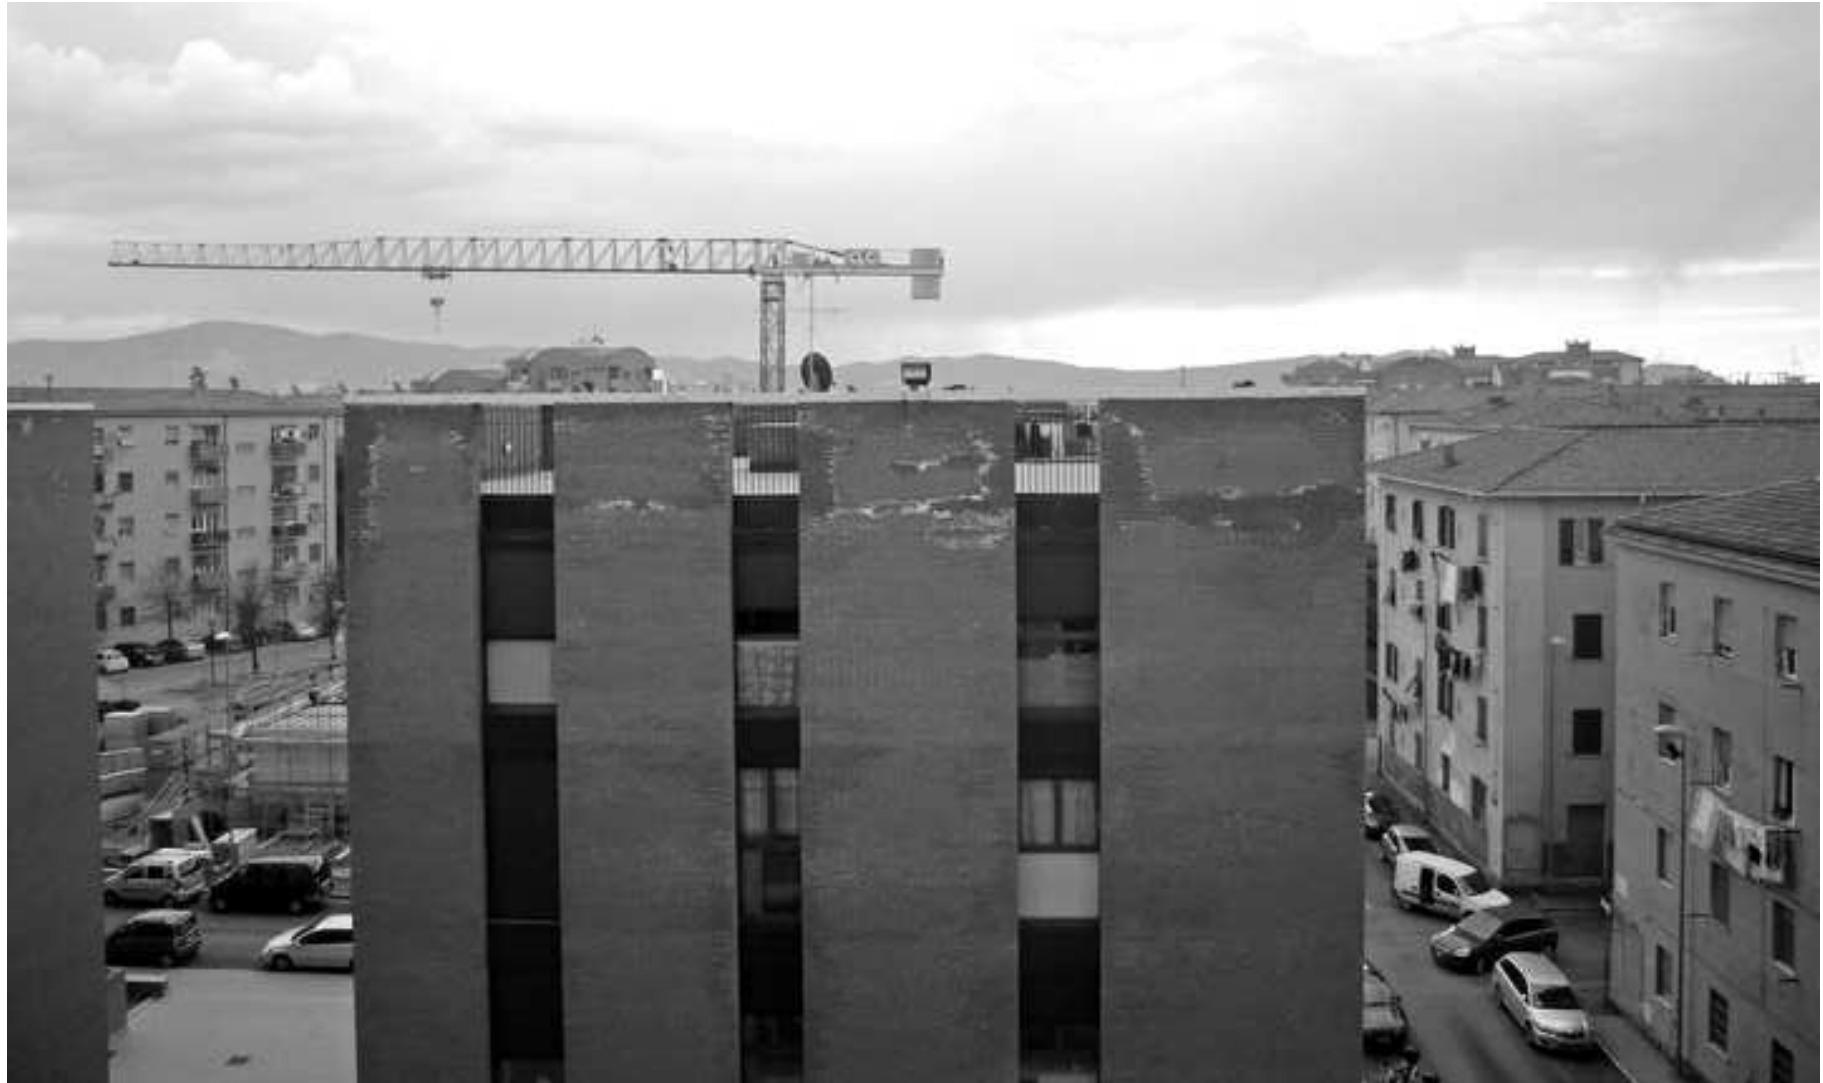
Fig. 2. Modern roof terrace (with water damage) and surrounding traditional pitched roofs (without problems)

In particular, the efficiency of the drainage system is crucial: when gutters and downspouts become clogged or fail, rainwater flowing down house walls can cause a great deal of damage, contributing to the decay of siding and the house's structure. Similarly detrimental is the absence of eaves that ensure protection of the facades against rain. Figure 1b shows a water damaged facade. Moreover, the humidity after rains evaporates, thereby subtracting heat from and increasing the thermal transmittance of the walls (Cirillo 1985 - Gucci et al, 1997). In addition, even without the penetration of rainwater, the dampness can produce condensation and mould on the upper parts of the building, (fig. 2).

Instead, the overhang of the eaves of a pitched roof determines an aerodynamic effect, like a "spoiler", which keeps the rain away from the surfaces. Modern architectural trends call for the adoption of flat roofs to enable the addition of terraces, roof gardens, etc., though such designs call for particular attention to all details regarding the removal of water, together with proper selection of materials and careful inspection of the work. Moreover, perimeter walls must be well connected to the roof to prevent water penetration. In this regard, one recurring defect cited was water penetration from a roof terrace. Figure 2 shows the moisture determined efflorescence on the top of a building after wind-driven rain. The traditional roof shapes in low-rise buildings are pitched, gable or hip type to permit the outflow of rain and sliding off of snow: in such cases ensuring perfect water tightness is unnecessary.

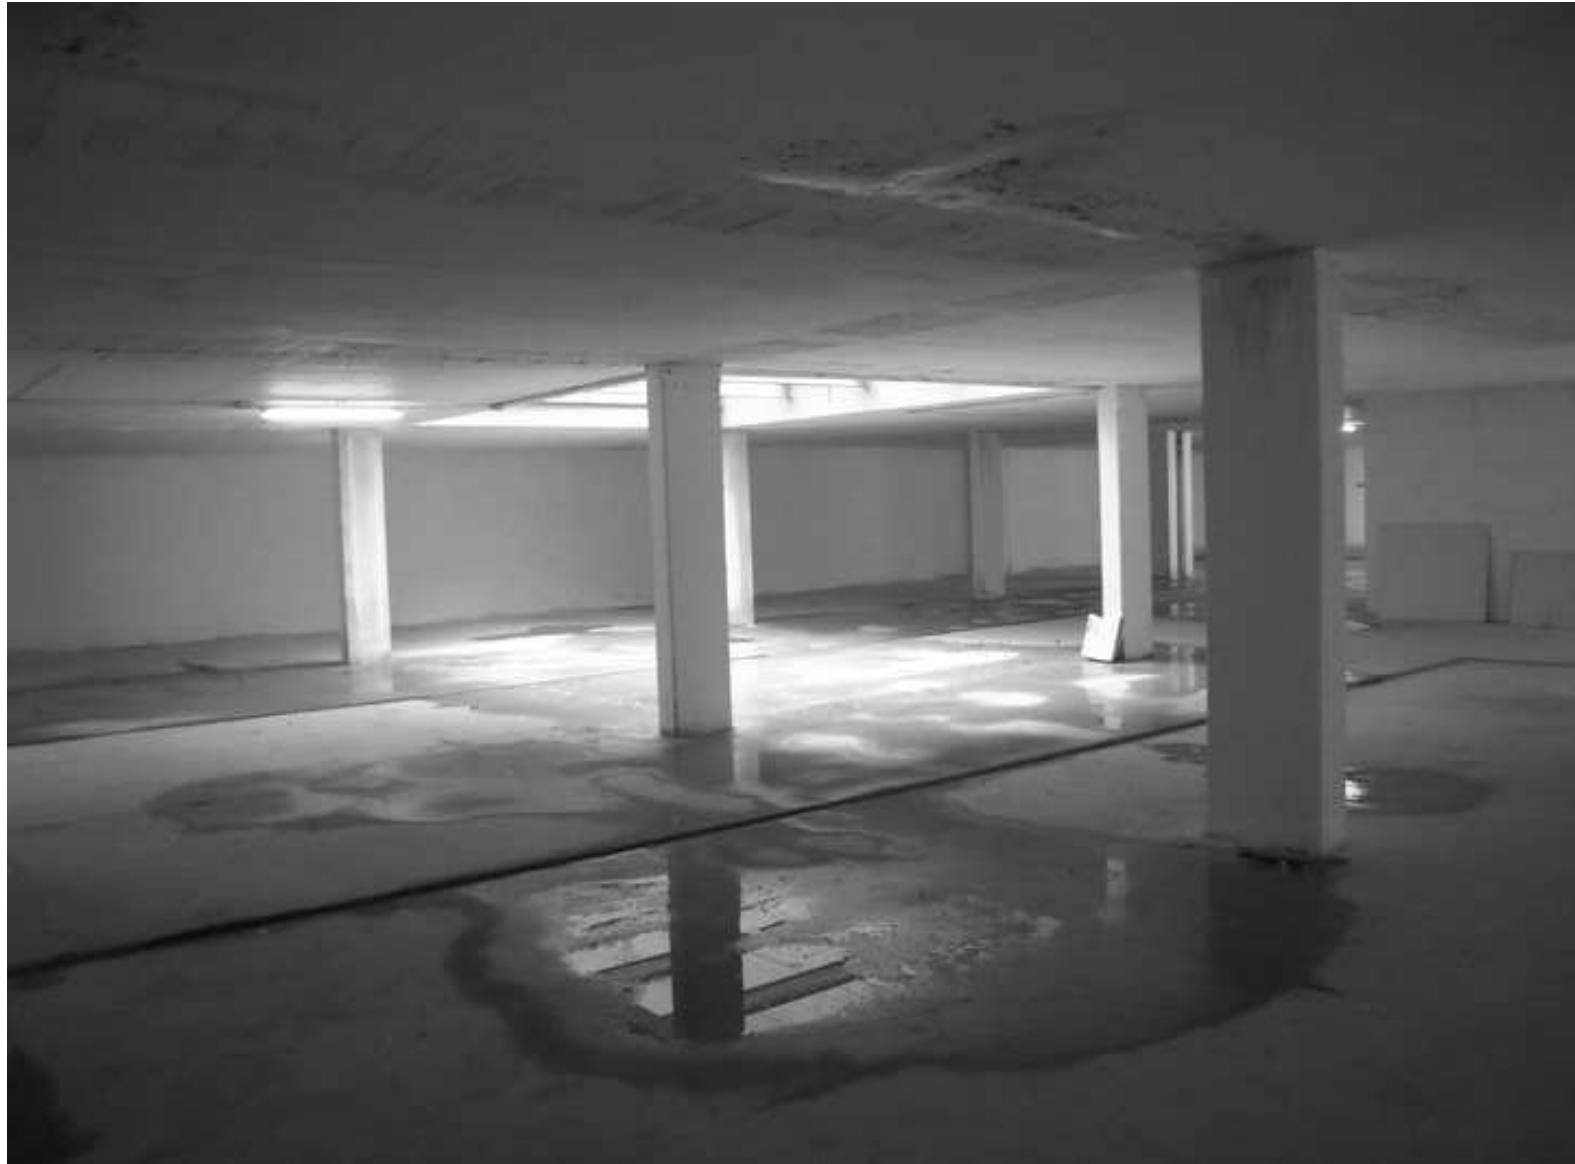
Fig.3. Improper disposal of rainwater in underground garage and efflorescence on an r.c. ceiling.

Fig.3. Improper disposal of rainwater in underground garage and efflorescences on an r.c. ceiling.

Proper design of the rainwater drainage from underground garages is crucial to avoid penetrations: in many cases defective drainage systems from unsuitable design of air ducts and/or protection from rain (fig. 3). Another frequent cause for litigation was inappropriate selection of materials to use in buildings, often in ordinary elements such as clay units, plaster or concrete. Moreover, in most cases repairing such defects requires demolition and reconstruction (fig. 4).

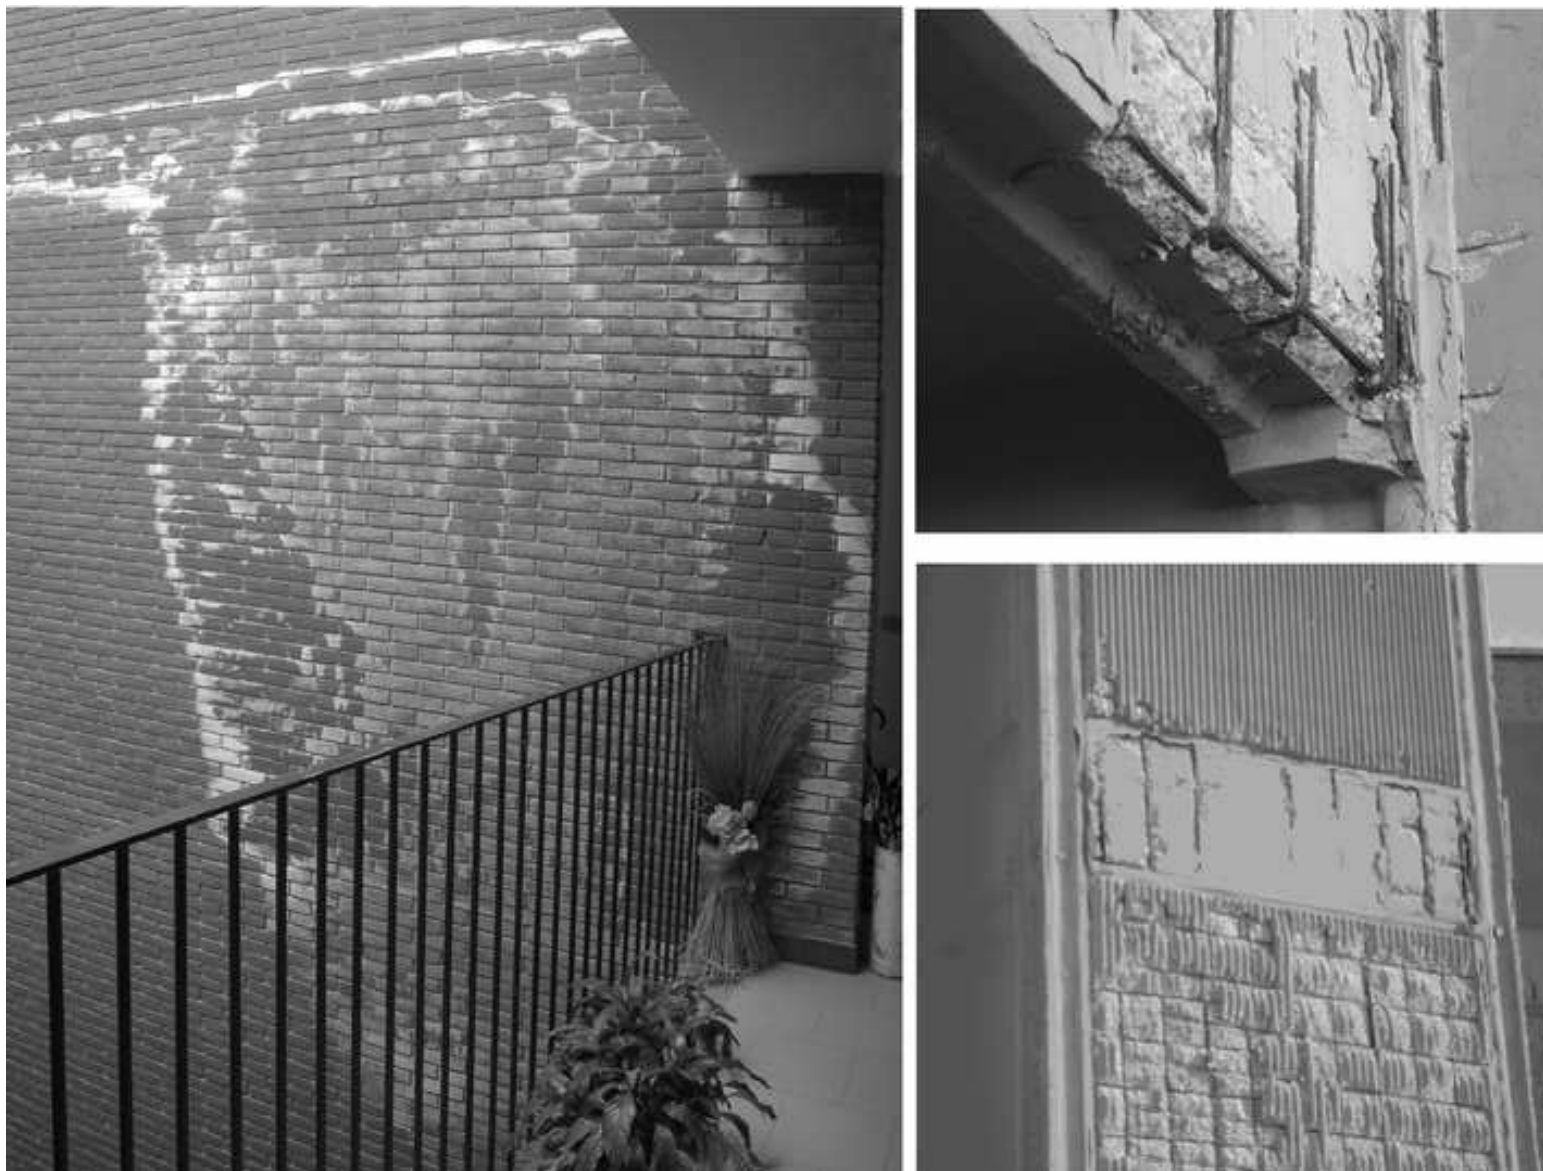
Fig.4. Erroneous selection of clay units (left), concrete (upper right) or plaster (lower right)

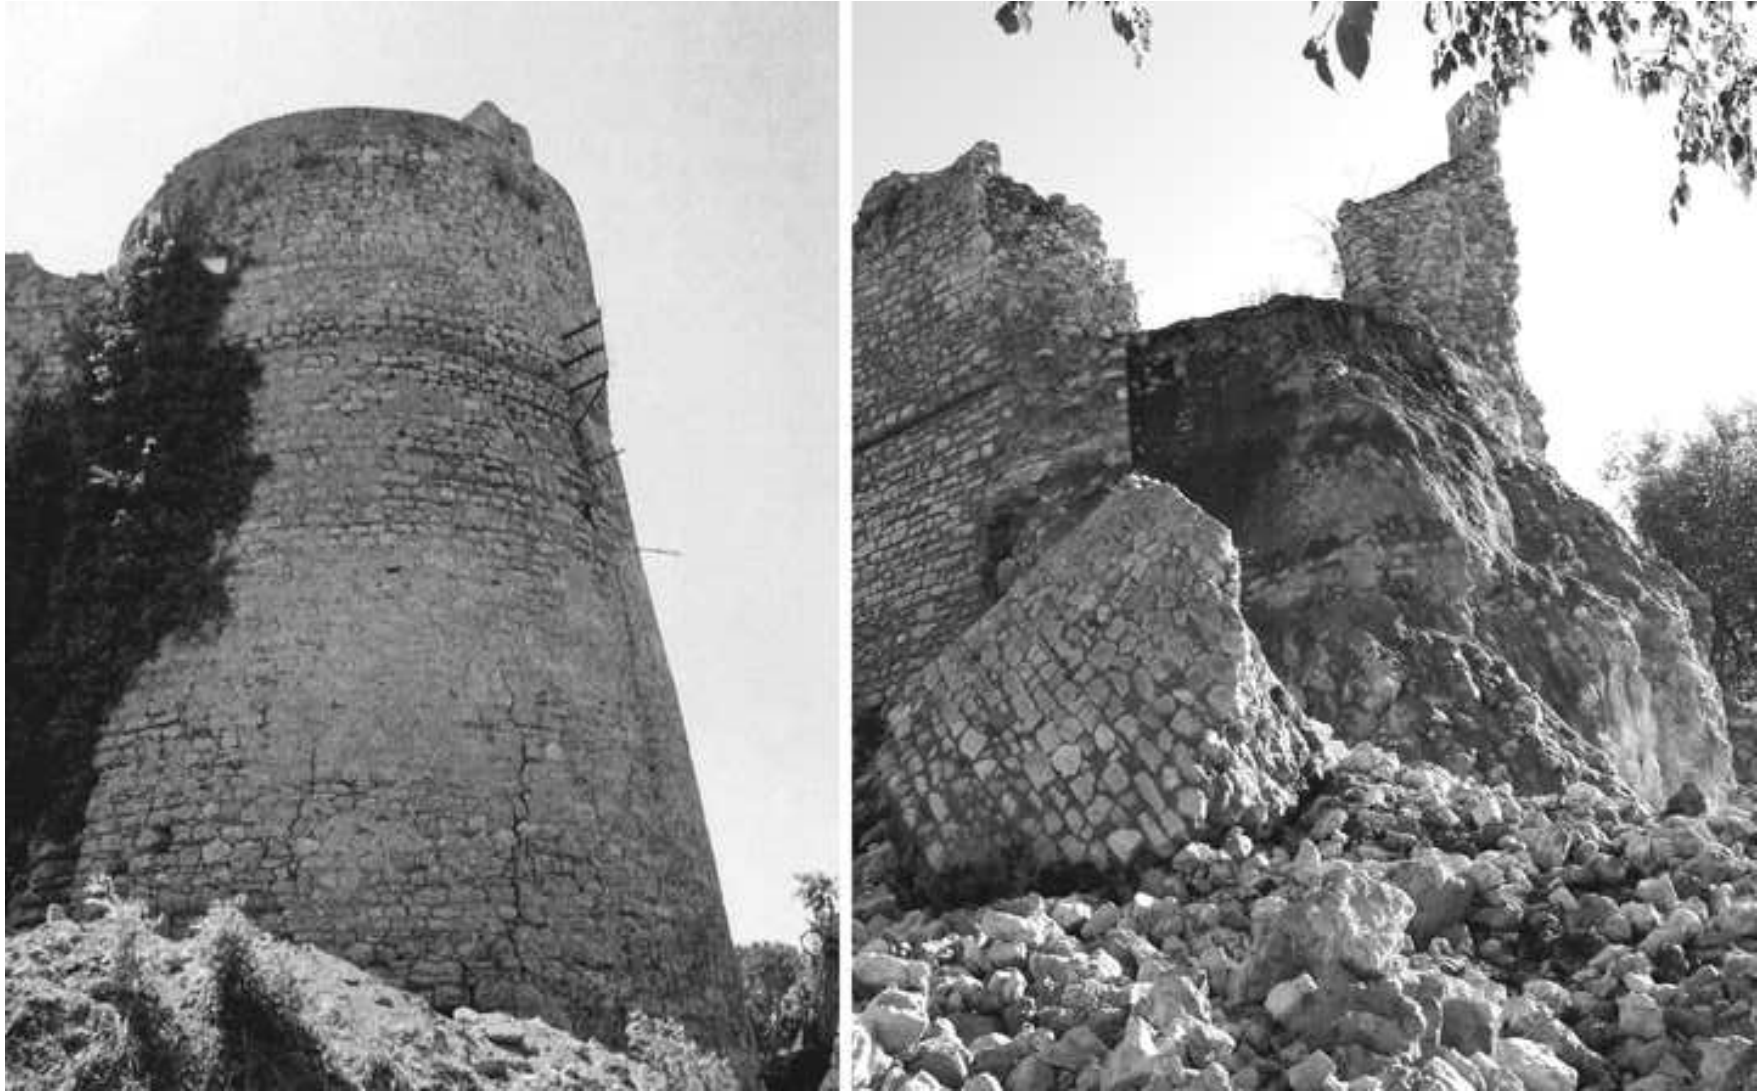
Fig.5. Unassessed structural integrity of historical tower (collapsed after heavy rain)

Finally, some collapses are linked to the lack of accurate assessment of the structural integrity of existing buildings. A common misconception, held by both private and public owners, is that historical constructions are “self-tested” by age. This often leads to underestimation of the seriousness of cracking patterns. In the case shown in figure 5 excessive rainfall determined the failure of recently restored base walls, due to the absence of scuppers.

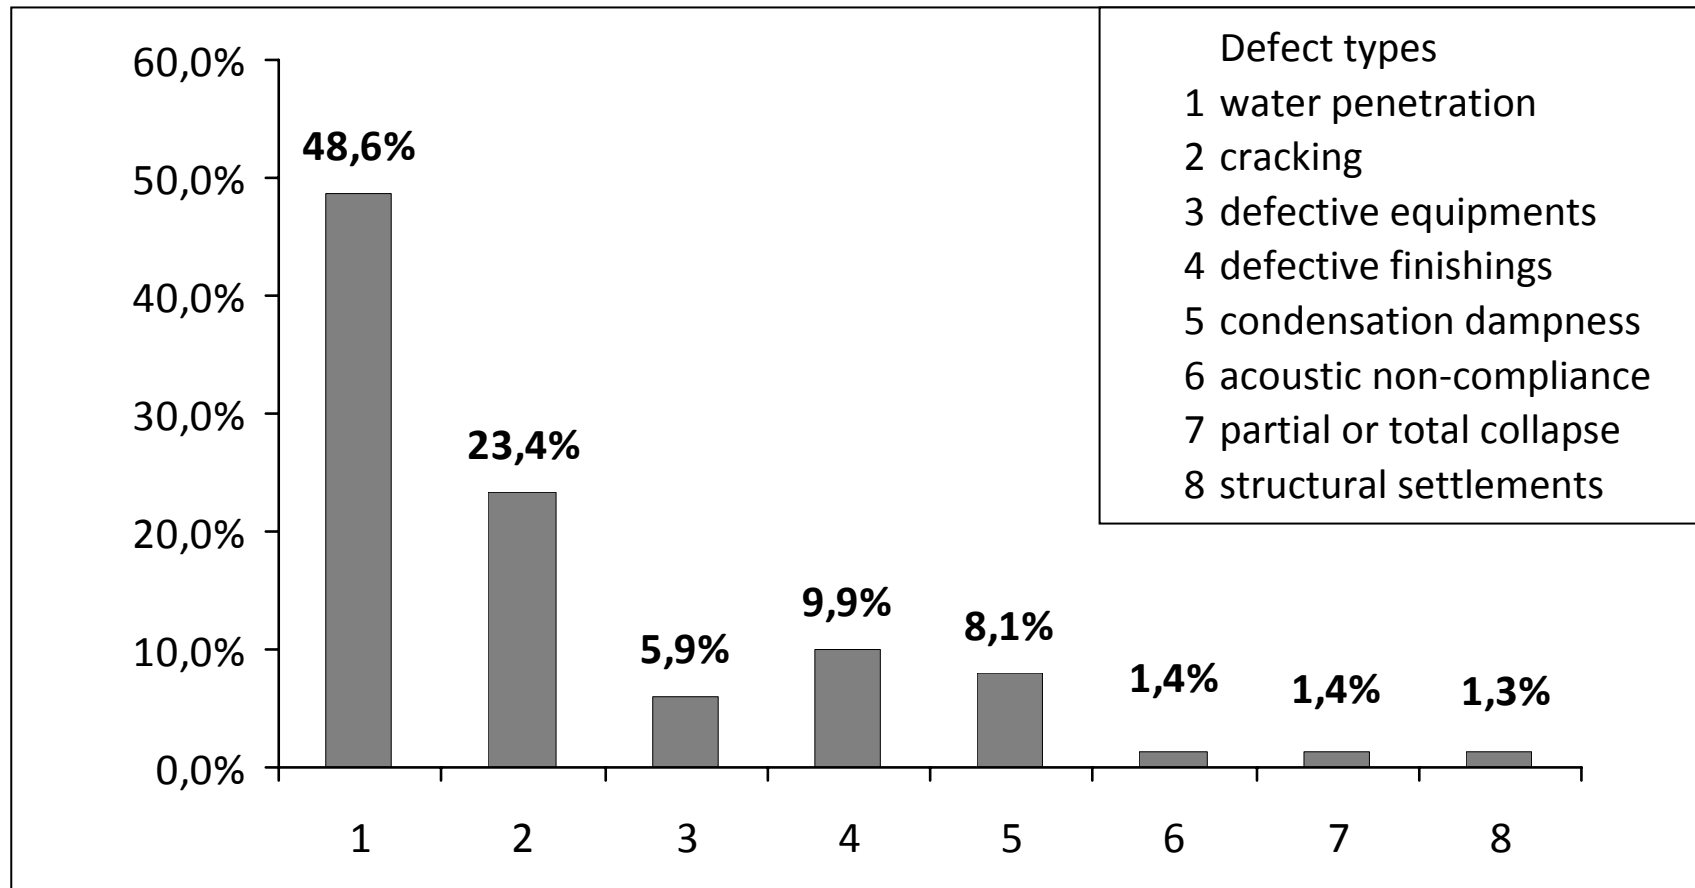
Fig. 6: Percentage distribution of construction defects reported in the district of Pisa 2000 - 2011.

Some first findings of general interest are shown in Figure 6, which reports the percentage frequency of each type of construction flaw, according to the above classification, expressed out of the total number reported (222) in all the 120 I.T.A.s examined in the province of Pisa. Clearly, the problem of water damage (48.6%) is the one most commonly affecting buildings, especially new ones, its incidence being more than twice that of the second most frequent, cracking phenomena (23.4%). Looking at the individual damage categories, it is moreover possible to subdivide the defects encountered according to their main causes and locations, as is done in the following.

As stated, one aim of the study has been to look at the evolution of building practices over the years, in particular to see how technological advances have affected the quality of construction in recent years. To this end, we compared the results obtained in the current study with those from a similar survey carried out on legal suits for damages during the 90s, also in the district of Pisa. From the results obtained it is clear that the types of defects and their percentage occurrences have remained surprisingly similar over the past twenty years, especially with regard to the categories of the most frequent problems: water damage, cracking and condensation. This can be clearly seen by comparing graphs in figures 6 and 12, which

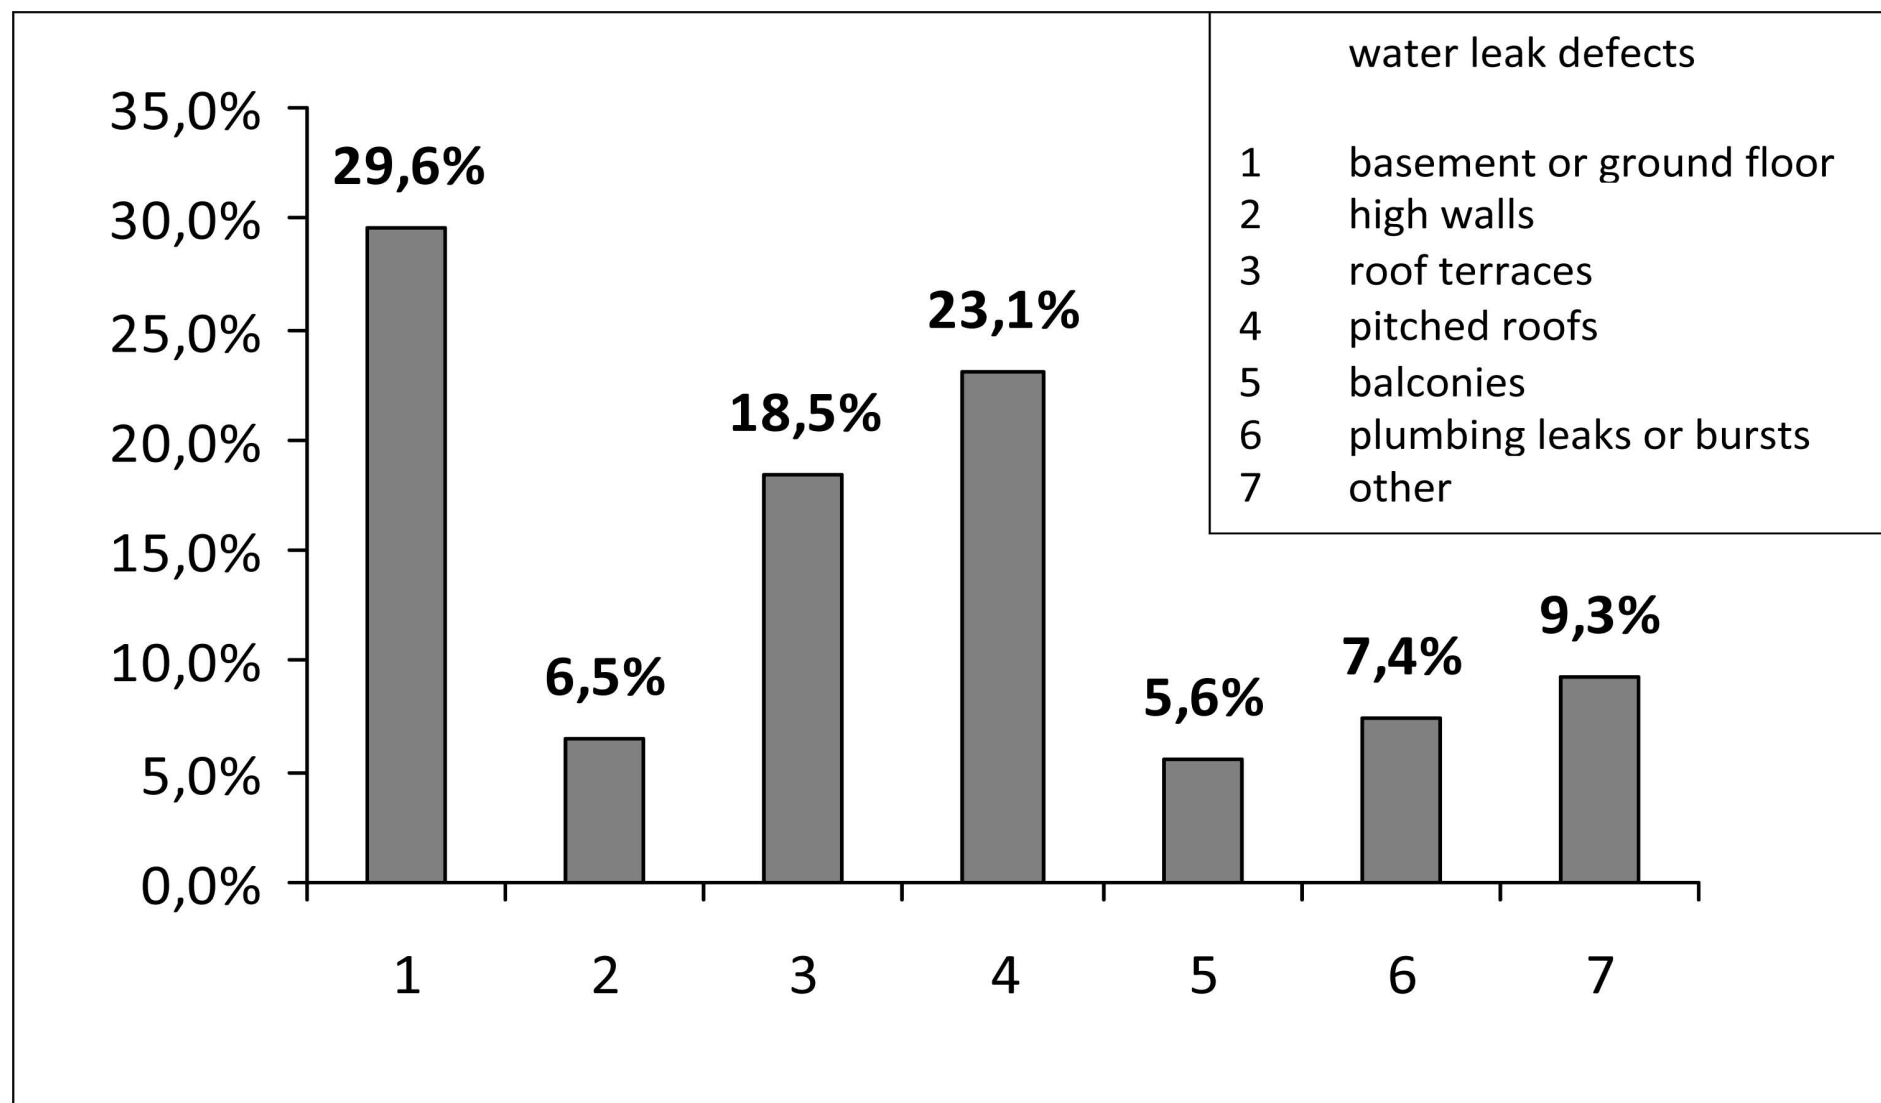
Fig. 7. Percentage distribution of water leak defects according to source.

As stated, water damage is the most often cited for both new and old buildings and, not surprisingly, often leads to other problems of various types. Figure 7 shows the frequency distribution of the source concerned.

Leakage from flat and pitched roofs, taken together, is clearly the most common source of water damage (18.5% for plane and 23.1% for pitched). It has also been noticed that in newer buildings, seepage arises mainly from the ground due to capillary action (39.5%), while in older buildings leaks are most often linked to imperfections in the roofing (50% overall, including 27% for pitched roofs and 23% for flat, as compared to 26.8% for capillary action). The problem of capillary water rise can be attributed to insufficient insulation, which is often due to improper design or construction. Figure 8 shows the percentage distribution of the major causes of water infiltration in the basement and ground floor.

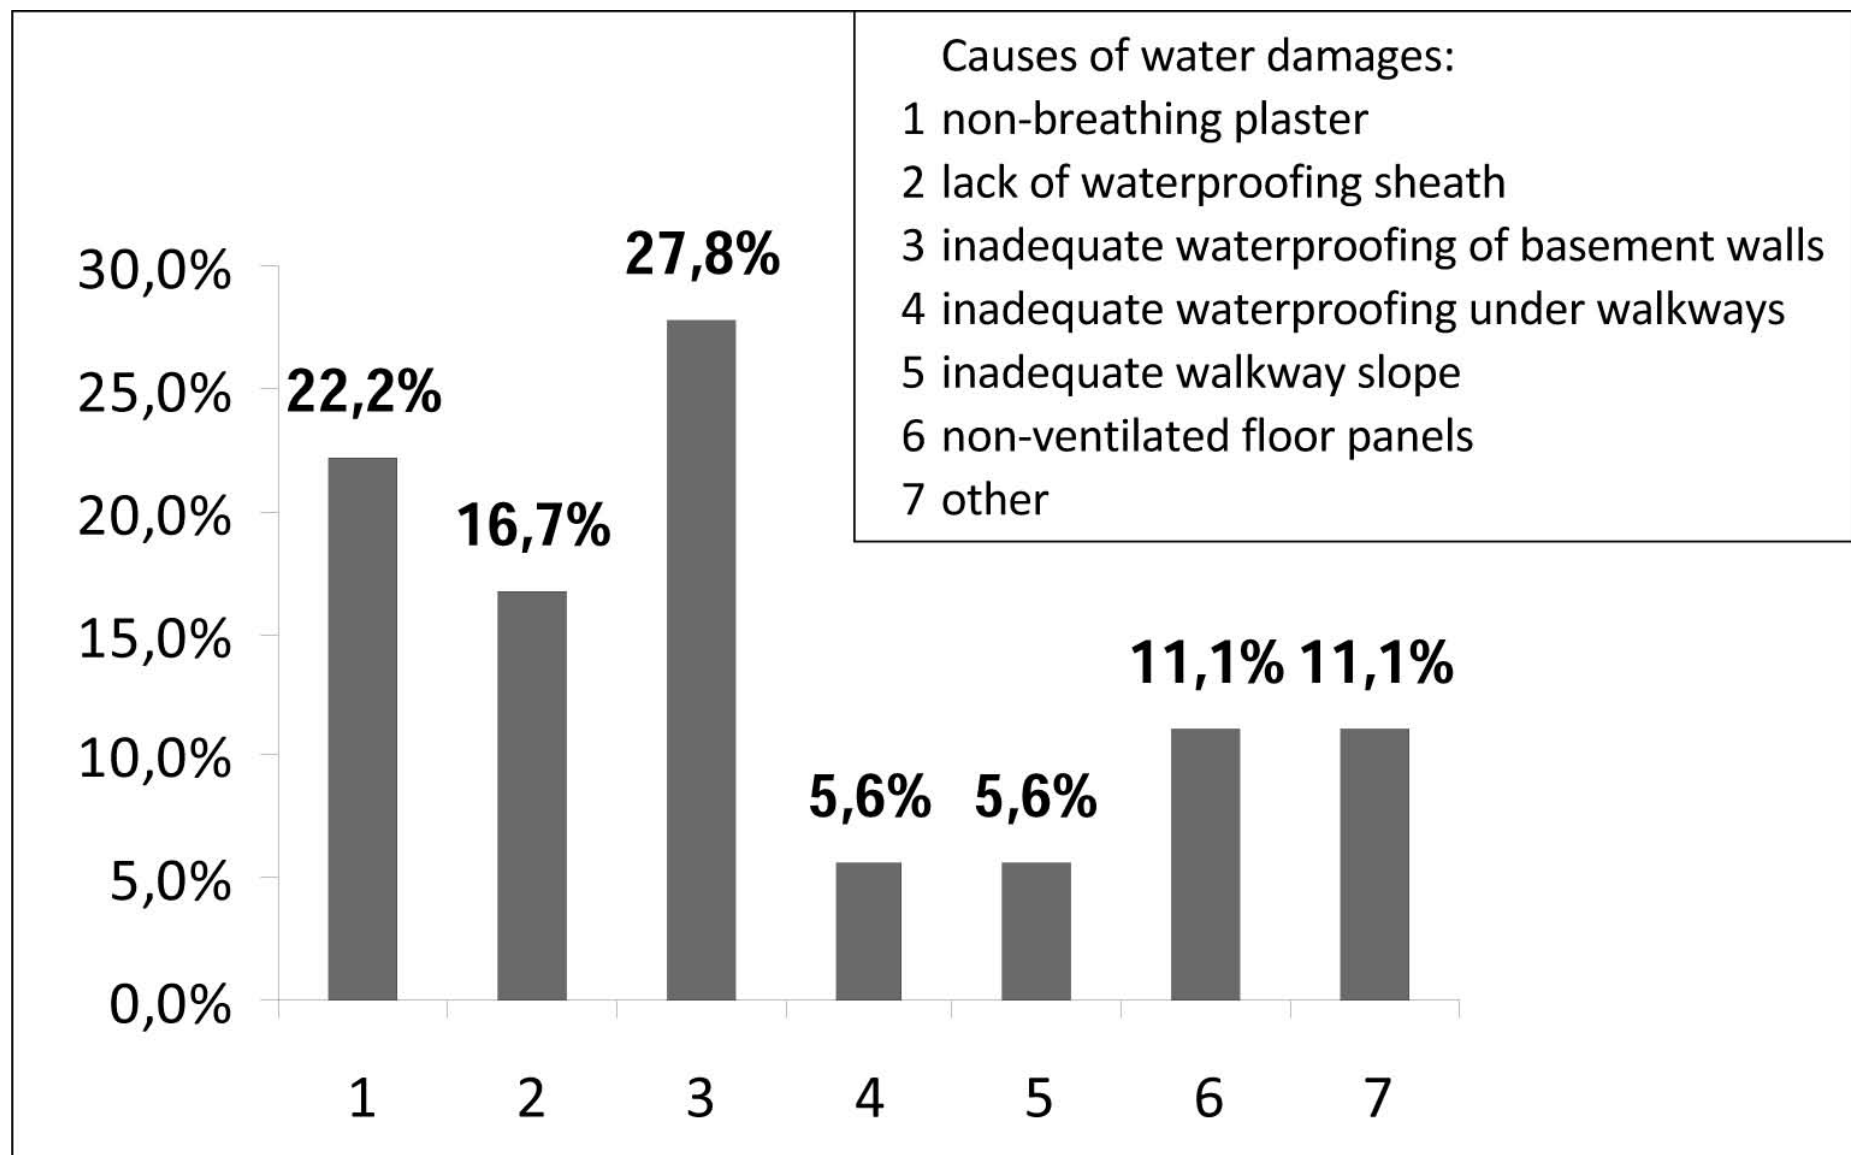
Fig. 8. Percentage distribution of the major causes of water damage to basement and ground floor.

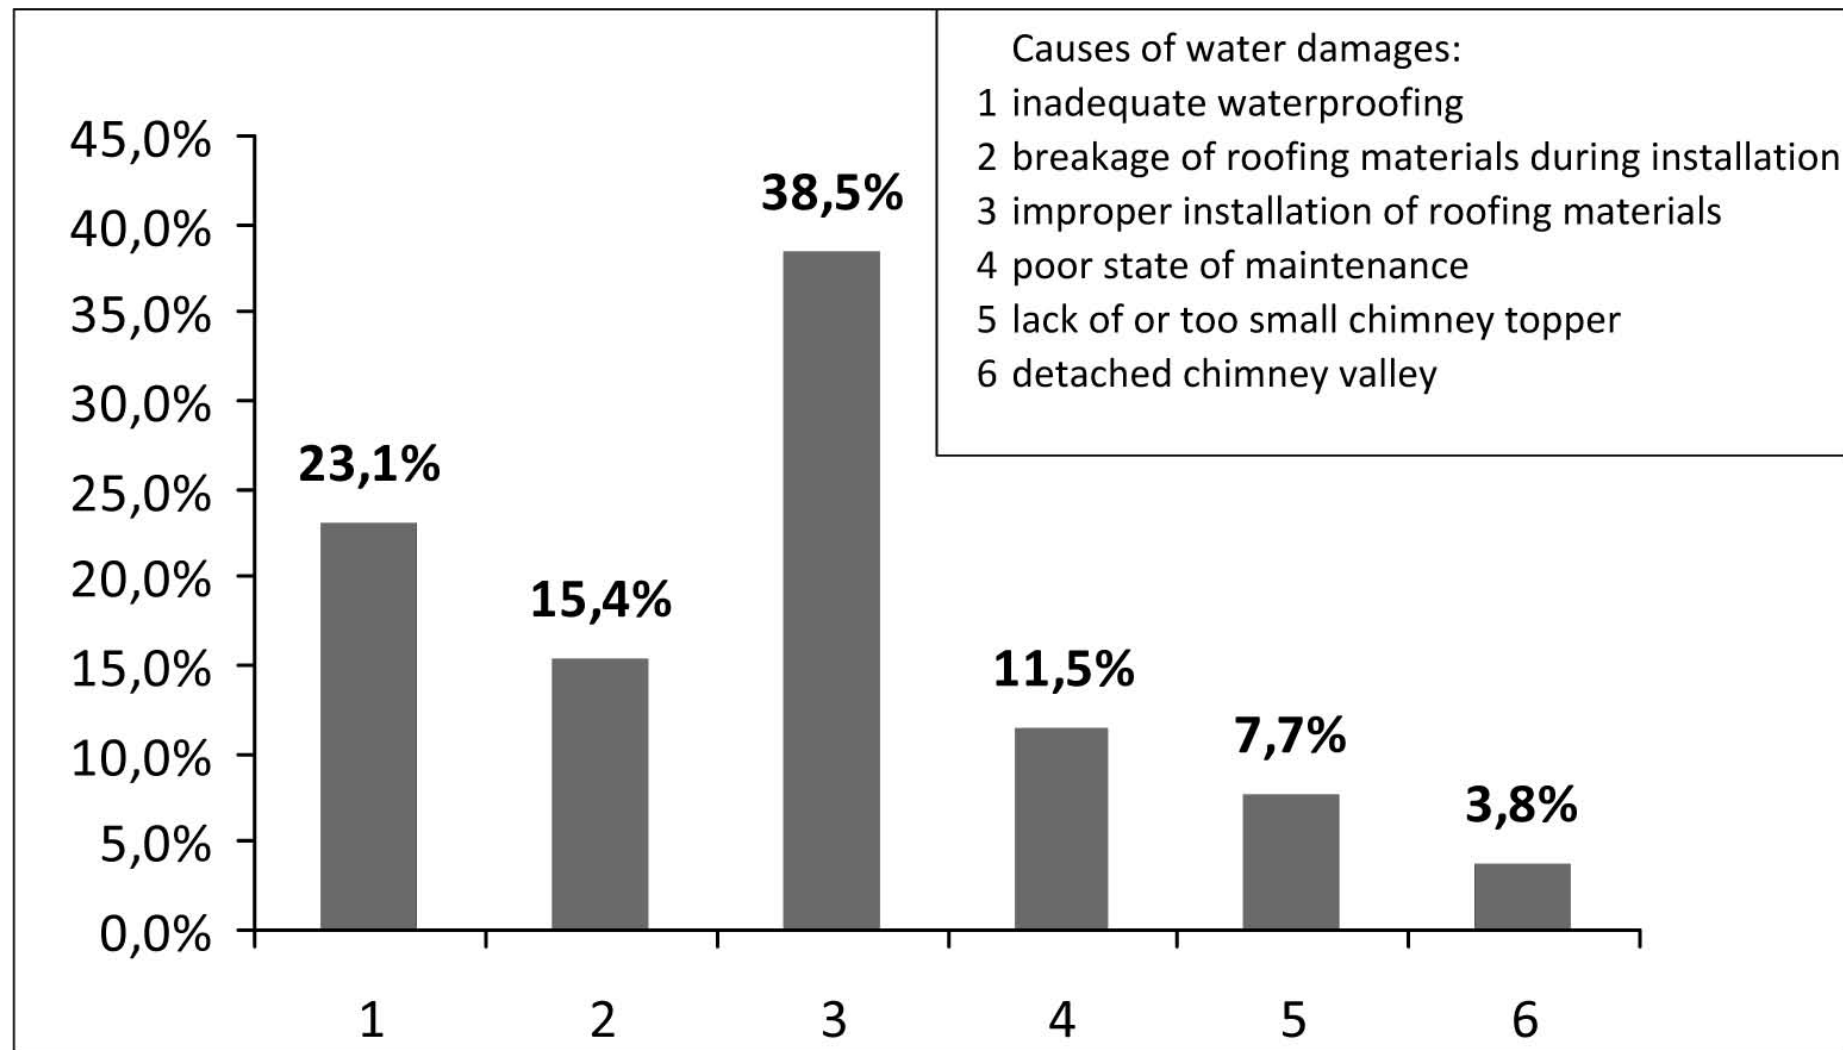
Fig. 9. Percentage distribution of main causes of leakage in pitched roofs.

With regard to roof leaks, in terracotta-tiled pitched roofs the fault lies mainly at the points of convergence of areas in different planes (ridges and valleys), the connections between roof and walls, and at the base of chimneypots. As in the case of industrial building roofs, which are usually composed of metal or plastic panels laid flat, overlapping areas of panels are the critical points of the system; such panels should be tightly adherent and properly sealed to avoid any effect on the building. Figure 9 instead shows the most frequently occurring causes of leaks in pitched roofs.

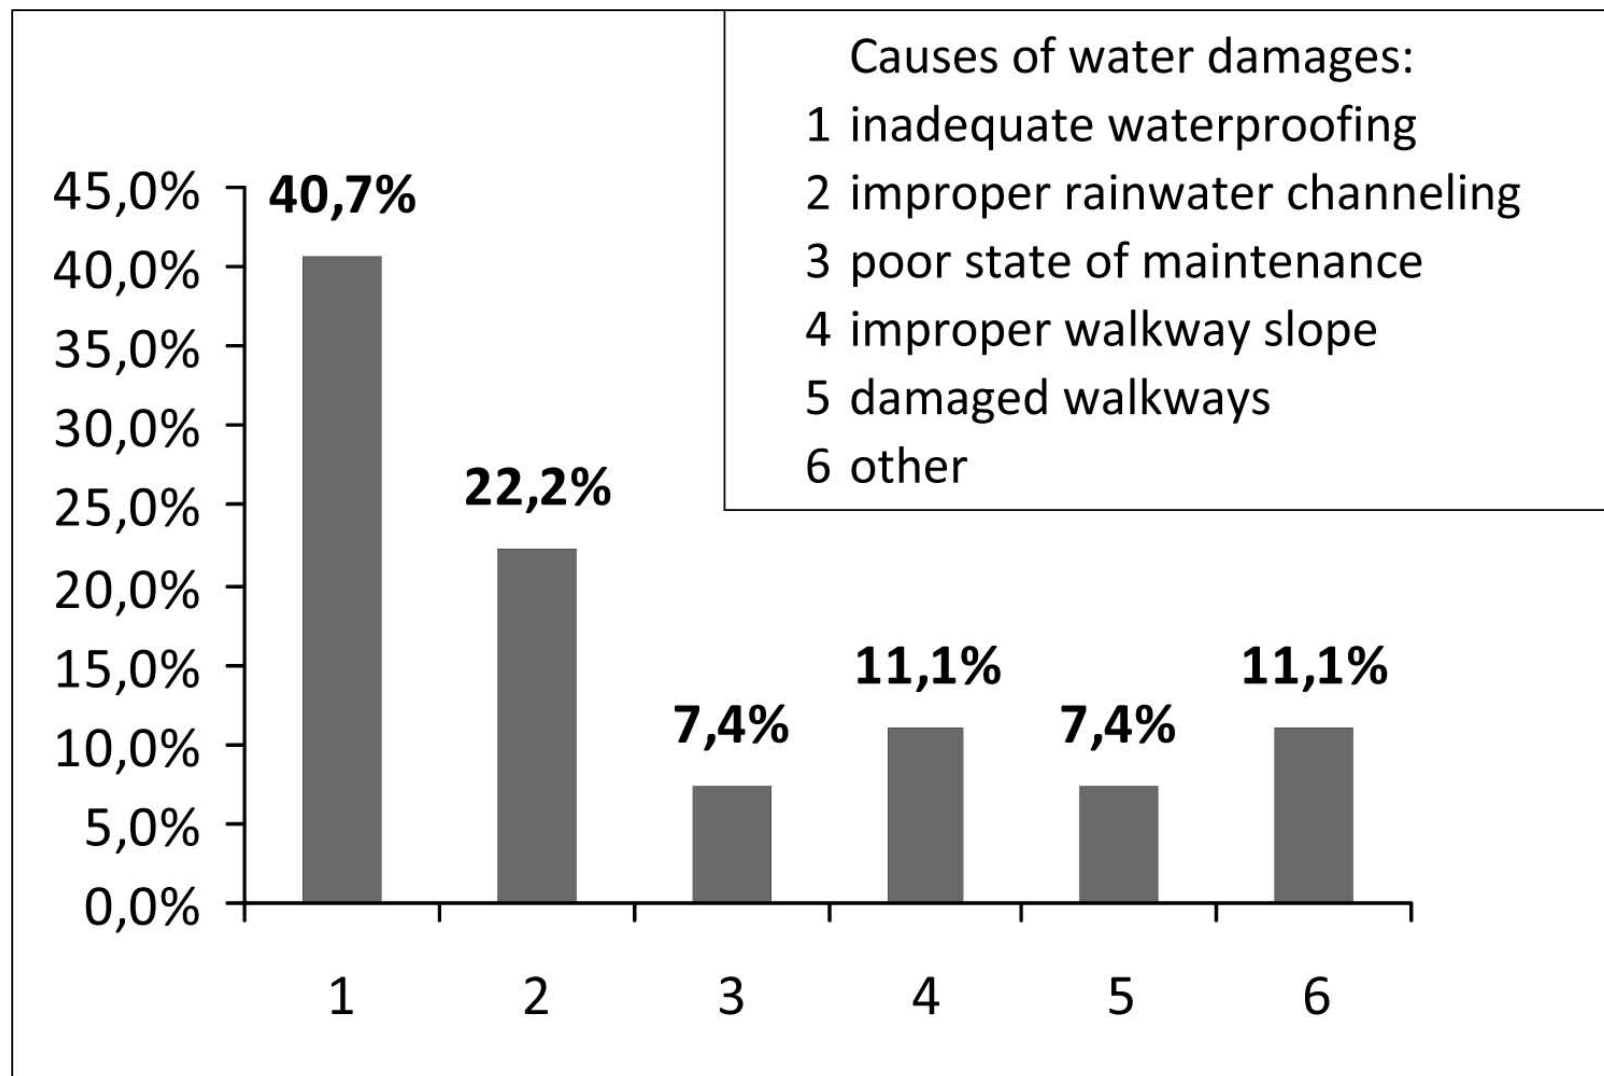
Fig. 10. Percentage distribution of main causes of water damage in flat roofs.

Most leaks from flat and terrace roofs are attributable to either the waterproofing system, the channels for rainwater drainage or the slope of the terrace floor. Figure 10 shows the percentage distribution of the major causes of leaks revealed in such roofs during the survey: seepage onto upper walls occurs in almost all cases in modern buildings, which are generally wholly lacking overhanging eaves, as previously illustrated in the examples.

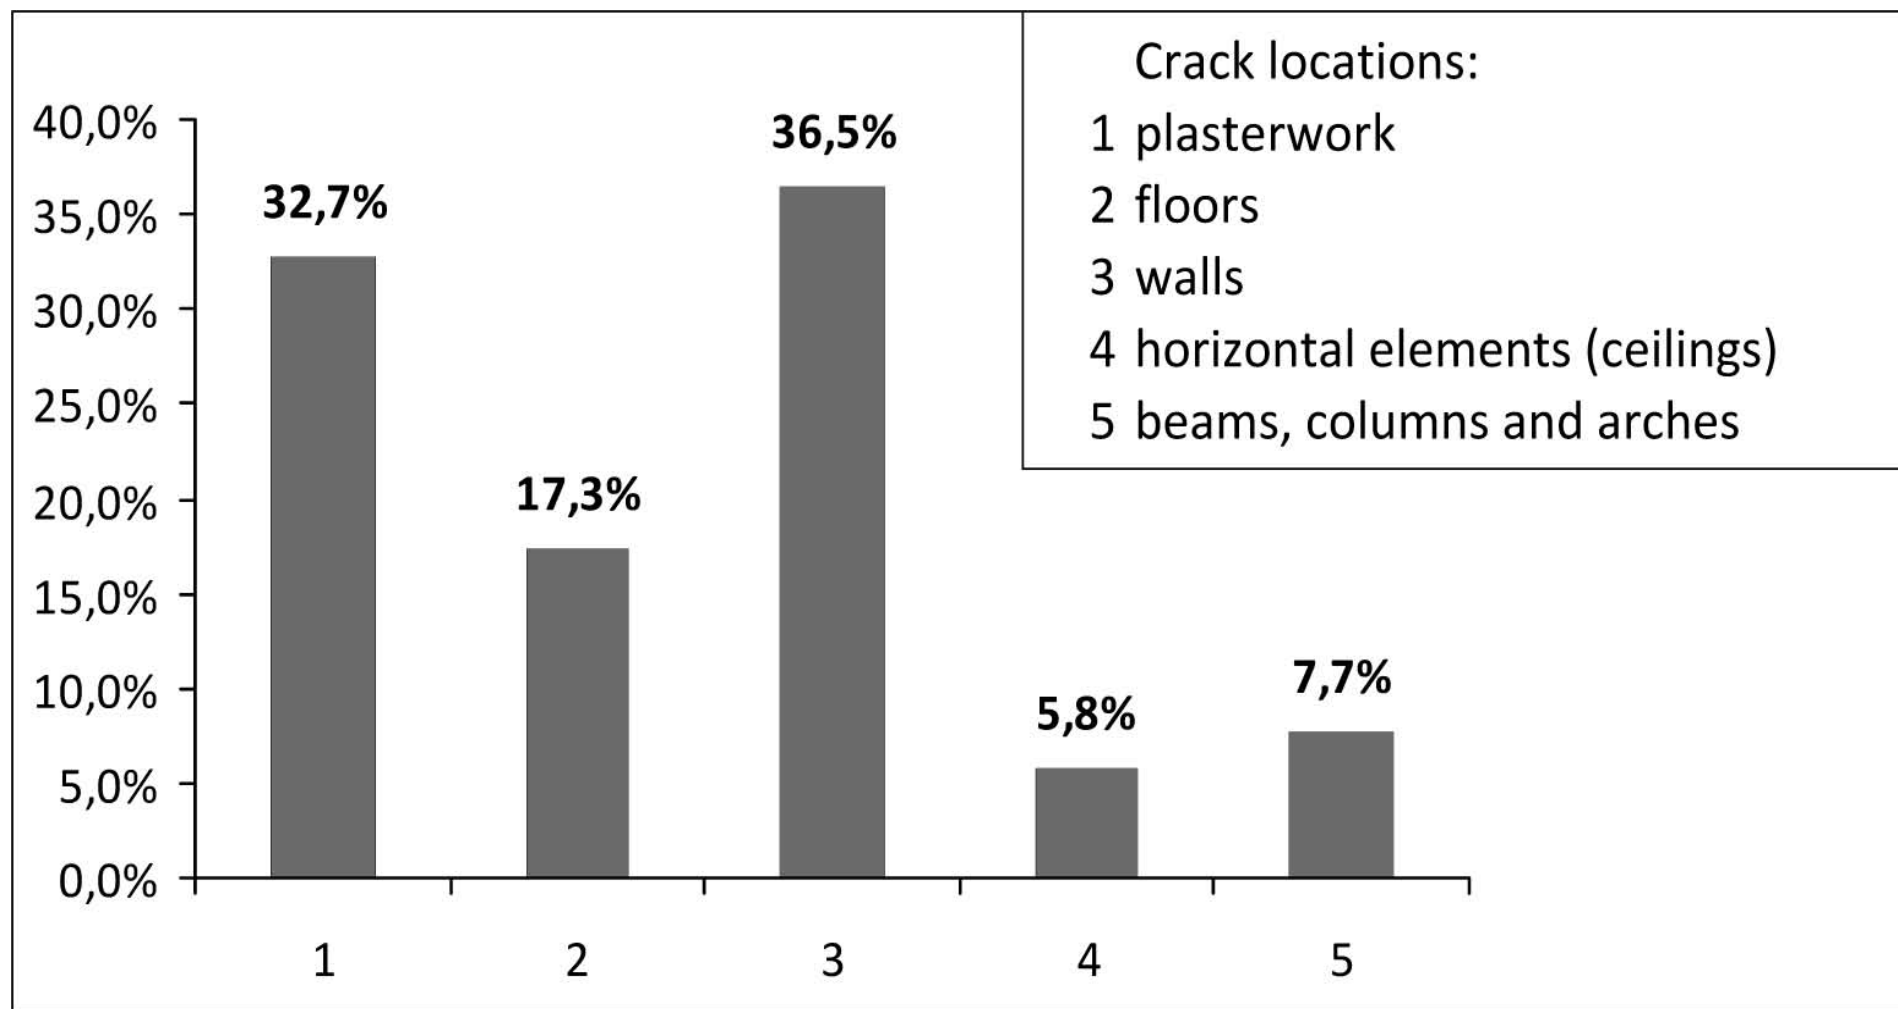
Figure 11. Partial incidence of crack location.

Fig. 11. Partial incidence of crack location.

Cracking phenomena are found equally often in structural elements, both load-bearing and non (walls, ceilings, beams, columns and arches), as well as in facings, such as plasterwork and floor and wall tiles. Figure 10 shows the percentage distribution of the location of cracks.

Non-load-bearing walls most often undergo more cracking with respect to structural elements: the initial defects manifest themselves in the contact areas between reinforced concrete frames and brick curtain walls. Most occur as a result of renovation or extension of existing buildings, the demolition and reconstruction of neighbouring buildings and differential subsidence of the foundation soil. Cracking and/or detachment of facing material is a defect that can come about as the result of other damage, such as structural failure, or may be the result of poor design choices or construction practices.
