Legal disputes and building defects: some data from Tuscany (Italy)

ABSTRACT

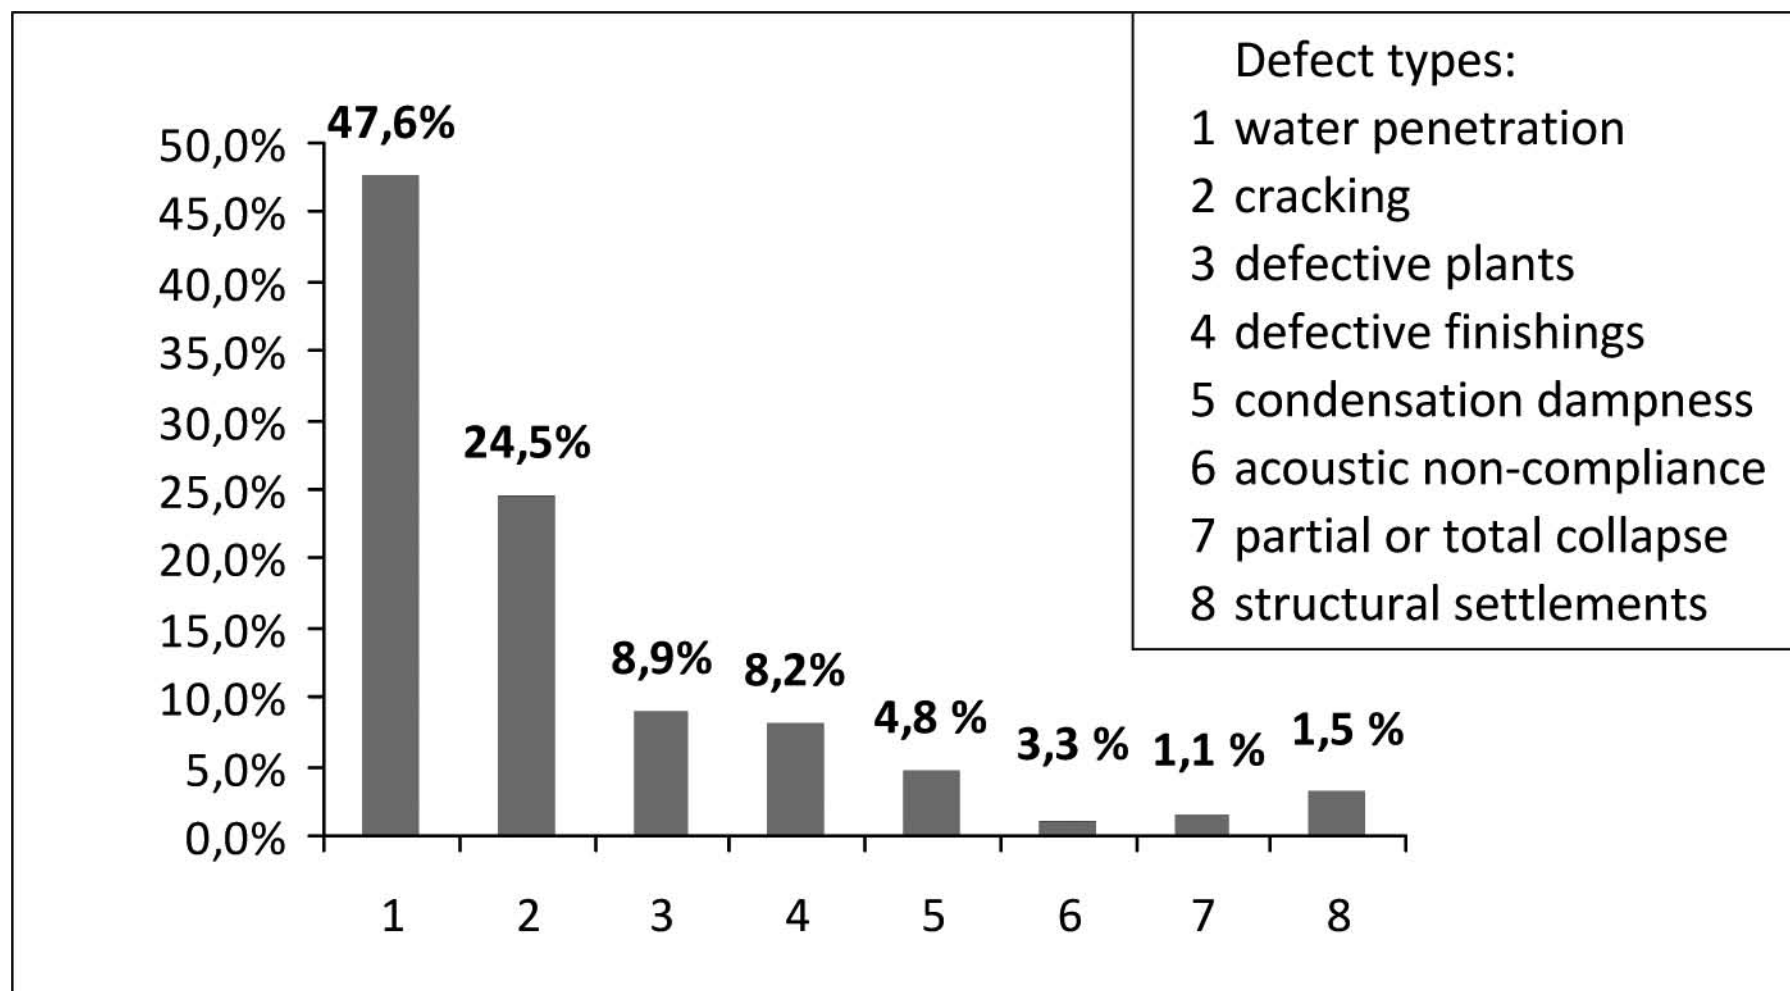
Fig. 12. Percentage distribution of construction defects reported in the district of Pisa for the period 1990 - 2011.

As stated, one aim of the study has been to look at the evolution of building practices over the years, in particular to see how technological advances have affected the quality of construction in recent years. To this end, we compared the results obtained in the current study with those from a similar survey carried out on legal suits for damages during the 90s, also in the district of Pisa. From the results obtained it is clear that the types of defects and their percentage occurrences have remained surprisingly similar over the past twenty years, especially with regard to the categories of the most frequent problems: water damage, cracking and condensation. This can be clearly seen by comparing graphs in figures 6 and 12, which

respectively show the percentage distribution of construction defects for the decade 2000-2011 and that for the 20-year period 1990-2011. Such a finding leads to the conclusion that although great advances have been made in construction technologies and scientific knowledge over the last two decades, their use has not been properly disseminated: most engineers, architects and builders prefer to carry on with their timeworn construction practices and only modify their approach to building when new regulations are issued (such as seismic codes).

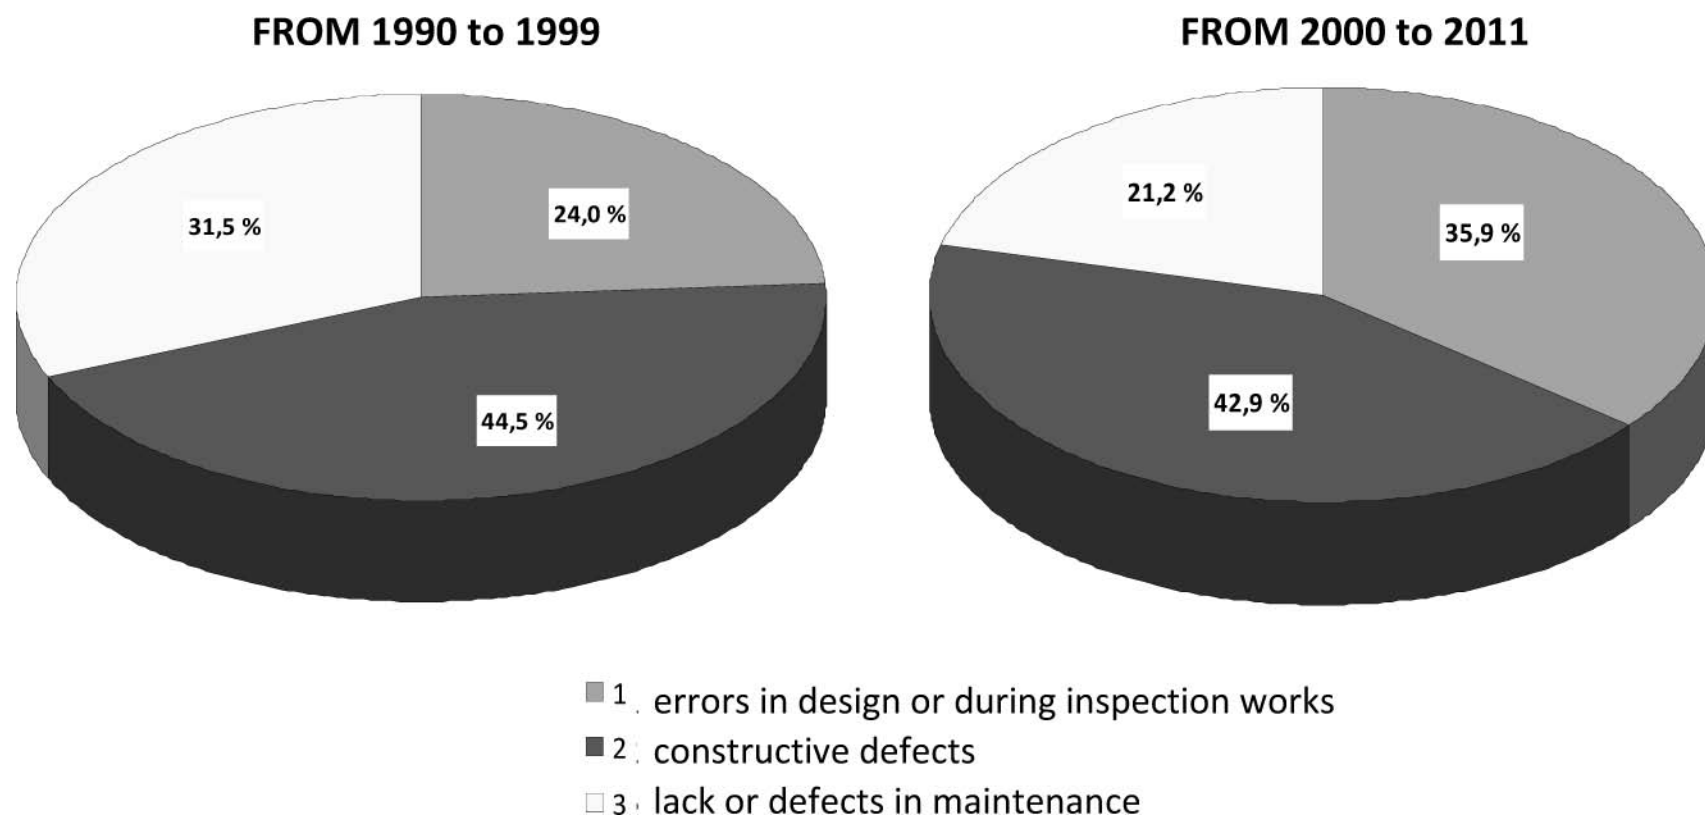
Fig. 13. Percentage distribution of the stages of the design/construction process giving rise to errors from 1990 to 1999 and from early 2000 to 2011

A second interesting finding is illustrated in the graphs of figure 13, which shows the percentage distribution of the construction stages deemed responsible (in the I.T.A.s) for errors for both the periods 1990-1999 and 2000-2011 (as per the conclusions of technical consultants). Note that in the last decade there has been a certain increase in the percentage of errors attributable to the design stage, rather than from interference by third parties, while the percentage of errors in construction has remained unchanged. This probably depends on improvements in investigative techniques, which are better able to identify the causes, and thereby avoid the simple solution of imputing liability to a lack of maintenance.
