Energy-based method for identifying vulnerable macro-elements in historic masonry churches

L. Giresini

Abstract

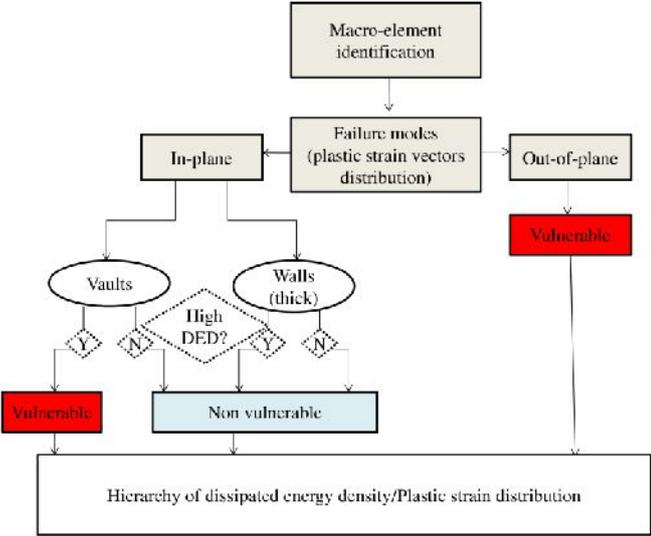
Fig. 1 Energy dissipation based method

The dissipated energy of each single macro-element is then considered, adding this aspect to the other ones adopted in the structural analysis (kinematic analysis for out-of-plane mechanisms and displacement based or stress based approaches for global behavior). If intrinsically vulnerable structural elements (such as thin walls or in folio vaults) are subjected to high dissipated energy, this can result in a too high demand for them. By contrast, if their dissipated energy is not relevant (for instance, in comparison with the total average one), they might be classified, from this point of view, as non-vulnerable. Intrinsically non-vulnerable elements (i.e. external thick walls), have a reduced vulnerability with respect to intrinsically vulnerable elements whether subjected to high values of dissipated energy. Indeed, under the hypothesis that the earthquake energy content is the same for a given acceleration time-history, is strongly to prefer to have the dissipation of energy concentrated on in-plane mechanisms (or high DED - Dissipated Energy Density), rather than on out-of-plane or on intrinsically vulnerable elements, as in folio vaults. These considerations are summarized in the flow chart of Fig. 1.

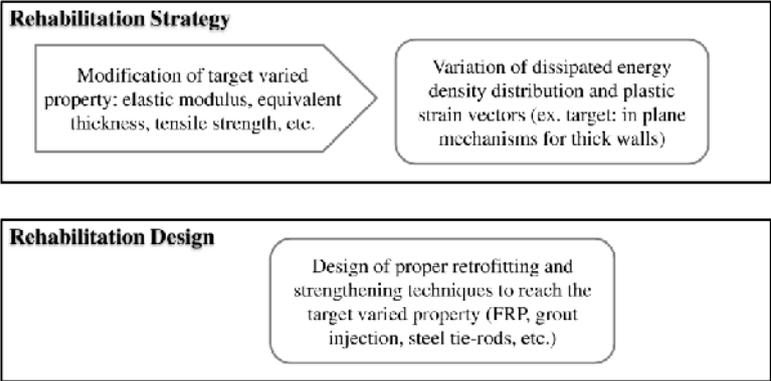
Fig. 2 Rehabilitation strategy and design

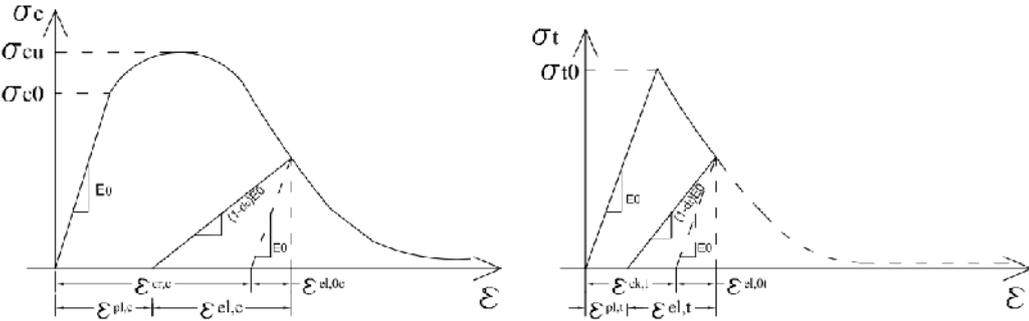
Fig. 3 Constitutive law in compression and tension adopted for masonry - adapted from (Abaqus CAE 6.12, User’s and Theory Manuals)

Masonry is modeled with 3D finite elements with homogenized properties. The nonlinear model, used to perform the proposed approach and suitable for describing the behavior of masonry or frictional materials, is the plastic-damage concrete model presented by Lubliner et al. (1989). The model is implemented in *Abaqus CAE 6.12* as Concrete Damaged Plasticity model (*Abaqus CAE 6.12, User's and Theory Manuals*). Initially born to describe the behavior of concrete material (Lee, Fenves 1998), the model was adapted to masonry (Wawrzynek, Cincio 2005). The post-elastic compression phase is described by an inelastic part with hardening and softening behavior and the tensile one by a brittle behavior with a softening curve (Fig. 3).

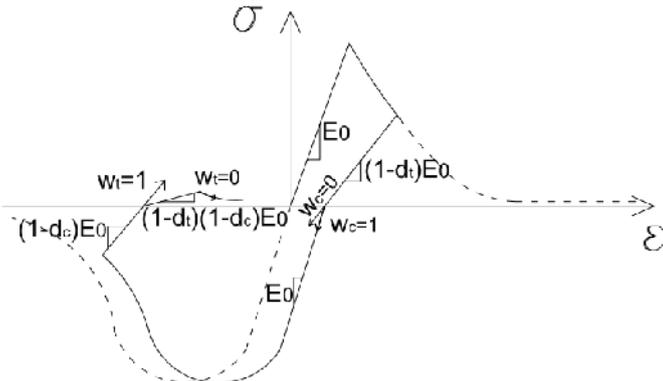
Fig. 4 Cyclic behavior (tension, compression, tension) and stiffness recovery effects adapted from (Abaqus CAE 6.12, User’s and Theory Manuals)

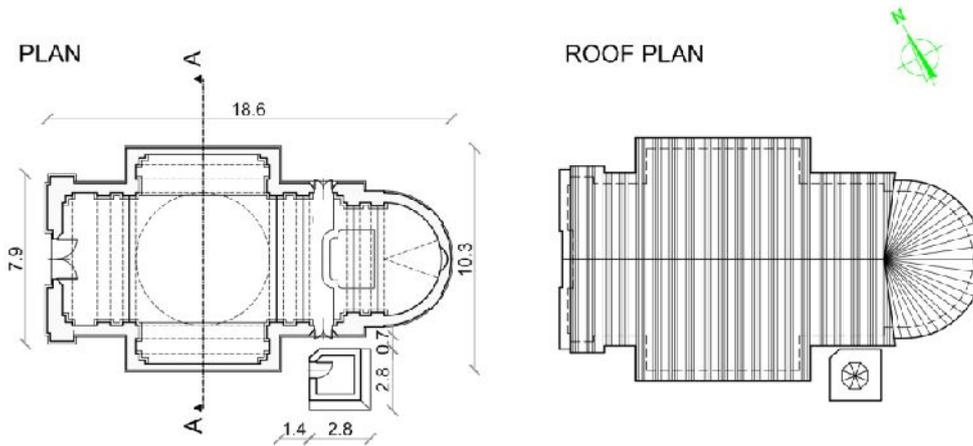
Fig. 5 St. Venerio church: plan and roof plan (measures in m)

The St. Venerio church is located in the centre of Reggiolo, about 20 km far from the epicenter of the earthquake that struck the Emilia Romagna Italian region in 2012, May 29th. The church was built in some constructive stages started in the 11th century, but it was demolished and completely rebuilt in the 18th century, therefore it can be considered as built in a unique phase. The church is isolated and its rectangular plan, 18.6x10.3 m, is constituted by a single nave with central layout (Fig. 5). The main neo-classic façade is oriented to north-west with maximum height of 11 m.

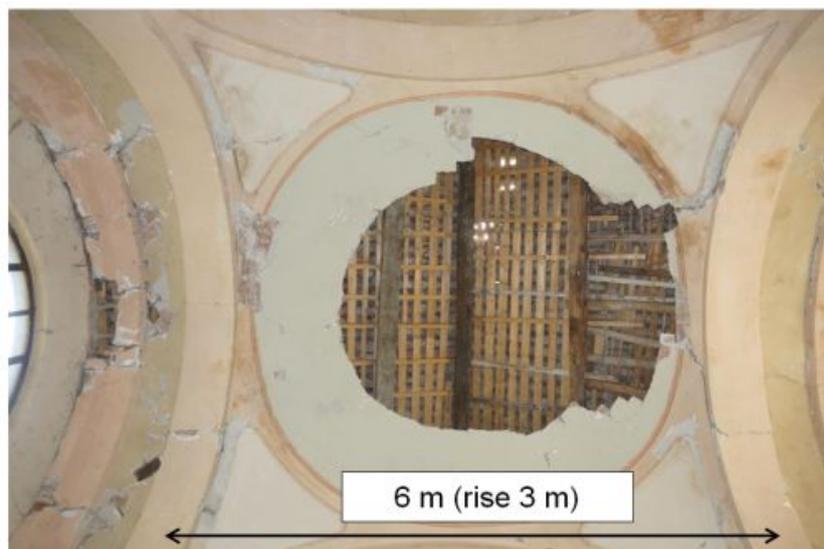
Fig. 6 Collapse of the central dome vault

The major earthquake in Reggiolo was on May, 29th and caused severe damages to large parts of the building. The collapse of the central dome vault (Fig. 6) was probably originated by its low thickness – 6 cm, *in folio* type – and by the strong vertical acceleration component which characterized this seismic shock.

The macro-elements that dissipated major energy are the central vault, followed by the left and right chapels, 30 cm thick. Indeed, the central vault collapsed (Fig. 6) and the right-left façades (Fig. 9) were strongly damaged by the ground motion, both in-plane and out-of-plane with incipient overturning.

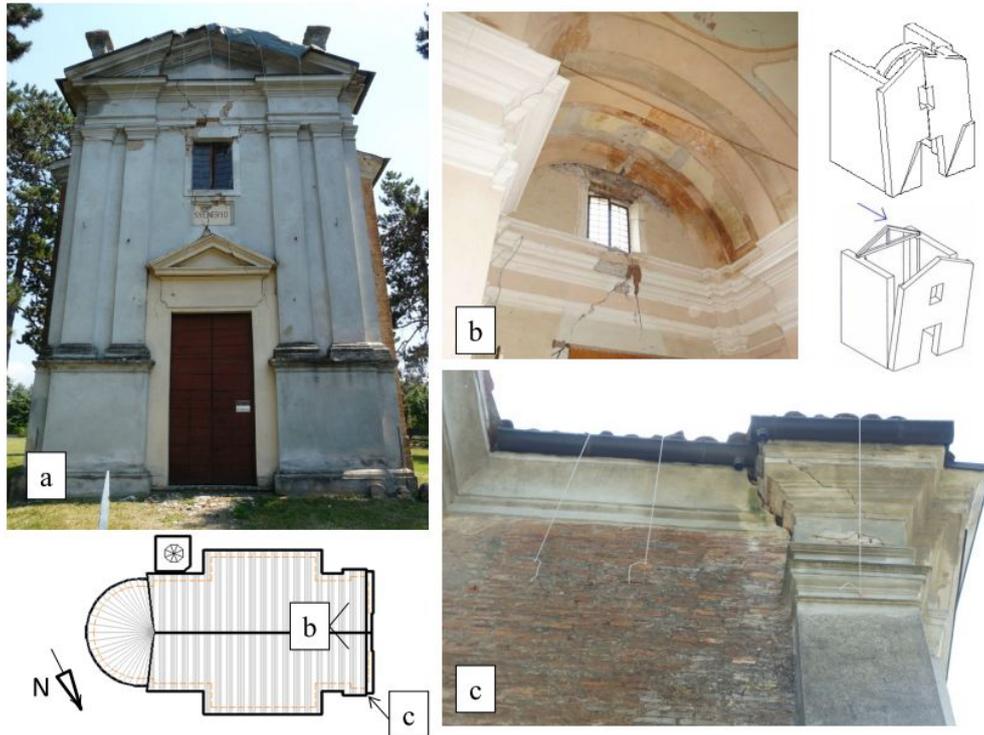
Fig. 7 In-plane shear mechanism (a,b) and out-of-plane overturning mechanism (c) of the main façade

The façade was subjected to two types of failures: an in-plane shear mechanism, which caused the typical X-shaped cracks at the spandrel above and below the small opening (Fig. 7(a), (b)), together with an incipient overturning of the upper part of the façade (Fig. 7(c)), probably due to ineffective connections with longitudinal walls. No overturning mechanism was observed in the tympanum.

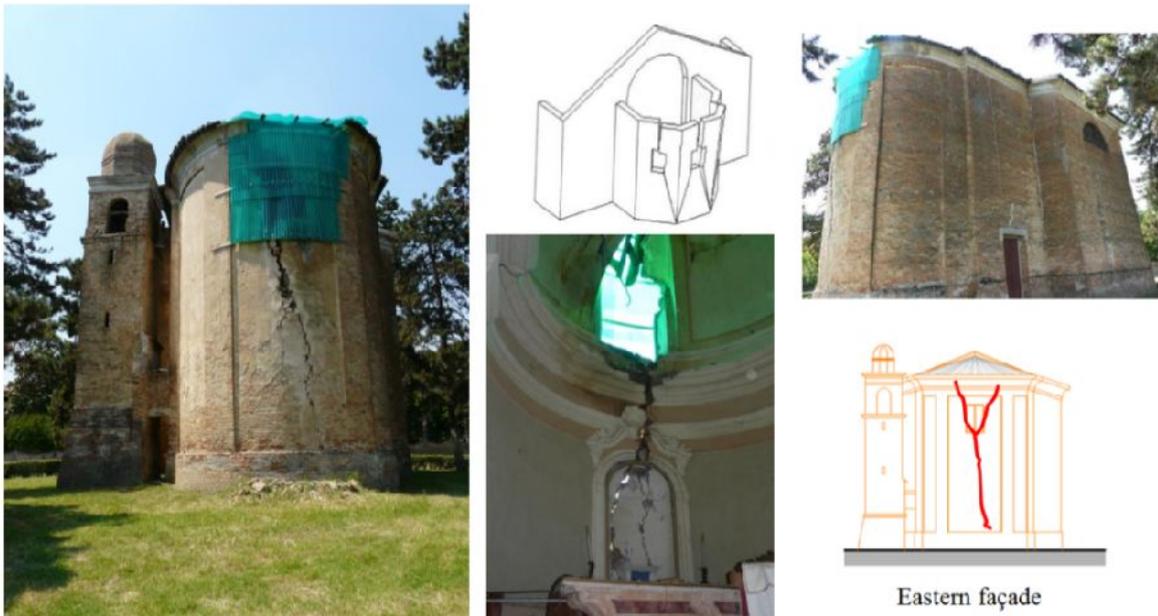
Fig. 8 Overturning mechanism of the apse

The apse suffered a severe overturning mechanism with the partial collapse of the vault wedge, 6 cm thick. The dynamic activation of the apse is due to previous damages, since a restored crack is still visible in the central part of the apse wall (Fig. 8).

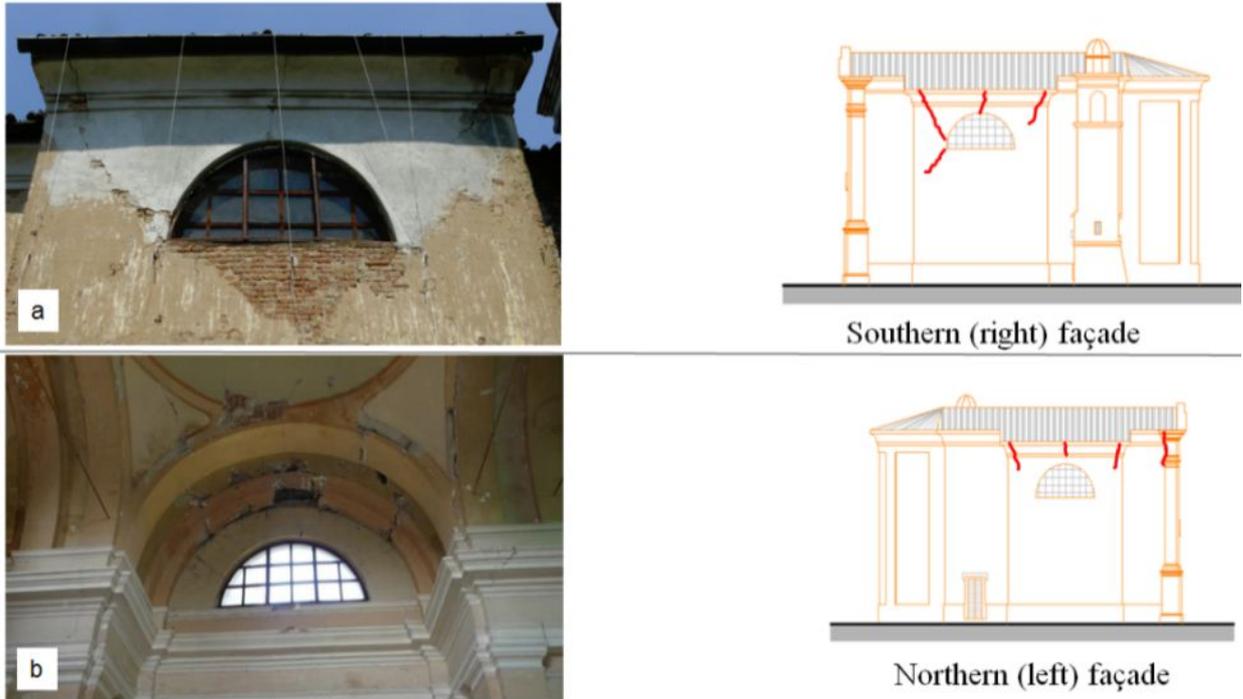
Fig. 9 In-plane and out-of-plane response of right (a) and left (b) chapels façades

Damages at left and right walls (called respectively “left chapel” and “right chapel” in the following pages) are also widespread, especially at the upper corners of the right wall and in the internal keystone of the adjacent arch (Fig. 9). Moreover, those mechanisms could permit a cross-evaluation of experimented PGA according to (Sassu et al. 2012). Based on this method, the calculation of the collapse multiplier of the main façade confirmed the value of the peak ground acceleration recorded by the accelerometers. Indeed, the collapse multiplier is lower than the acceleration experienced by the façade.

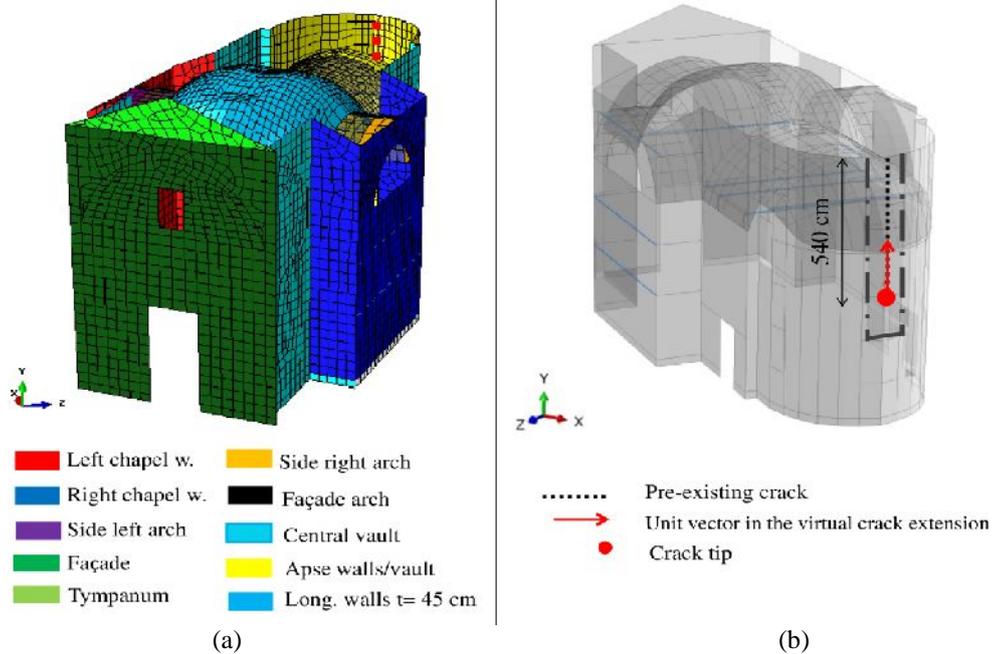
Fig. 10 Macro-elements in the finite element model (a) and pre-existing crack in the apse (b)

In Fig. 10 the existing steel ties are displayed: the longitudinal ones are asymmetric with a diameter of 10 mm, while the transverse ones, with a diameter of 20 mm, are concentrated in the apse zone. They are modeled in *Abaqus* as CONN3D2 elements. An existing crack in the apse (Fig. 8) was inserted in the model as initial crack, since it was present before the earthquake (Fig. 10). The calculation has been performed by means of the classical Rice J-integral, from Fracture Mechanics.

According to the classification proposed by Papa et al. (2011) and Lagomarsino et al. (1999), the macro-elements of the St. Venerio church have been identified (Fig. 10(a)): central vault, main façade, left and right chapels, namely the longitudinal walls 30 cm thick, apse walls and vault, side left and right arches, arch adjacent to the façade, longitudinal walls 45 cm-thick and tympanum. The remaining arches have not been considered since their contribution to the overall dissipated energy and the damages are limited. The behavior of the longitudinal 45 cm-thick walls is about the same for the left and right side, therefore results are provided only for one side. Finally, the façade in Fig. 10(a) includes the tympanum volume, also considered as separated macro-element.

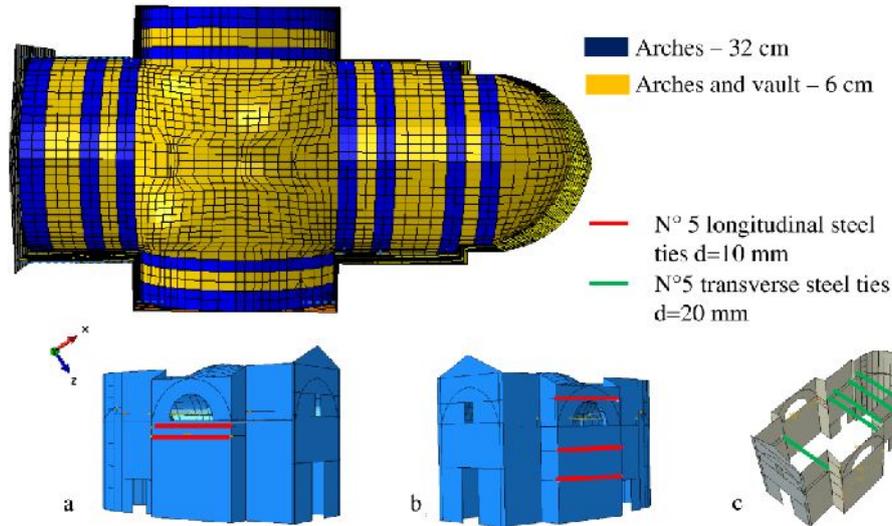
Fig. 11 Arches and vaults features, longitudinal steel ties in the (a) left and (b) right façades and (c) transverse steel ties

The church has been analyzed with a finite element model with homogeneous material formed by 18148 nodes, 5852 quadratic quadrilateral S8R and 165 triangular STRI65 shell elements (Abaqus CAE 6.12, User's and Theory Manuals) (Fig. 11).

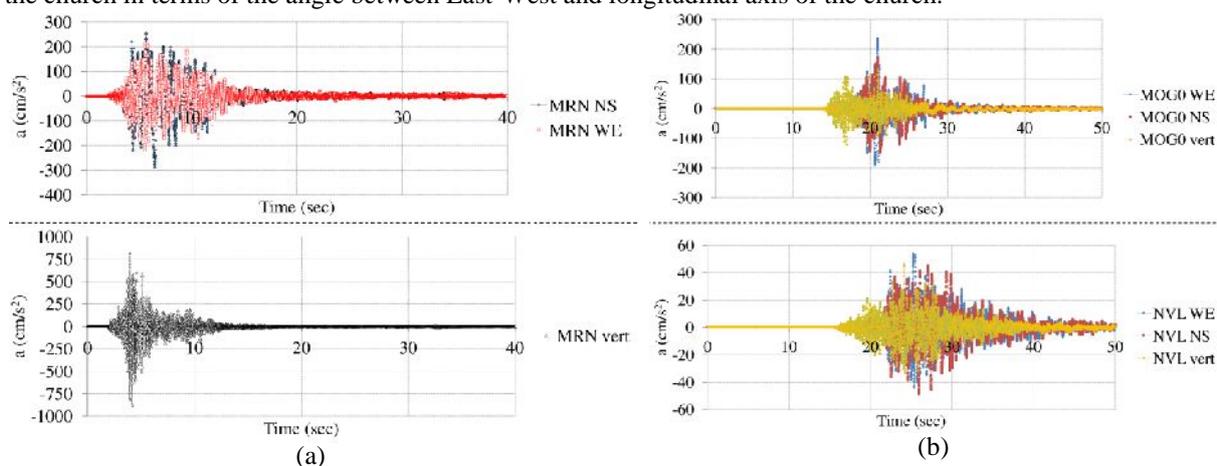
Fig. 12 Acceleration time-histories used in the transient analysis: (a) Mirandola record; (b) Moglia and Novellara records

The case study is located in the area hit by the 2012 Emilia earthquake, particularly near Reggiolo, a small village close to the epicenter of the two main shocks (May, 20th and 29th). The natural acceleration time-histories registered in three stations, Mirandola (MRN), Moglia (MOG0) and Novellara (NVL) are considered (Fig. 12, Table 2 Acceleration time histories characteristics (Accelerograms Database of seismic shocks on May, 29th2012, Emilia Romagna region (Italy). Department of Italian Civil Protection 2012)), referring to the May 29th shock, which caused relevant damages in the church. Since no sufficient information was available on the soil characteristics, the natural accelerograms have not been elaborated and used as they are, because Reggiolo is located between the considered stations. Nearby the village, many other historic masonry buildings were severely struck by that earthquake (Andreini et al. 2014). It is worthy to notice the relevant vertical component of the strongest acceleration time-history, MRN, with a peak of about 0.8g at 3.93 sec. The peak of the MOG0 is instead for the component West-East with a value of 0.23g at 10.9 sec. PGA are about 0.21g and 0.24g for MRN and MOG0 respectively, and 0.06g for NVL (West-East direction). All the acceleration time-histories are simultaneously applied to the models to simulate the real earthquake, taking into account the actual position of the church in terms of the angle between East-West and longitudinal axis of the church.

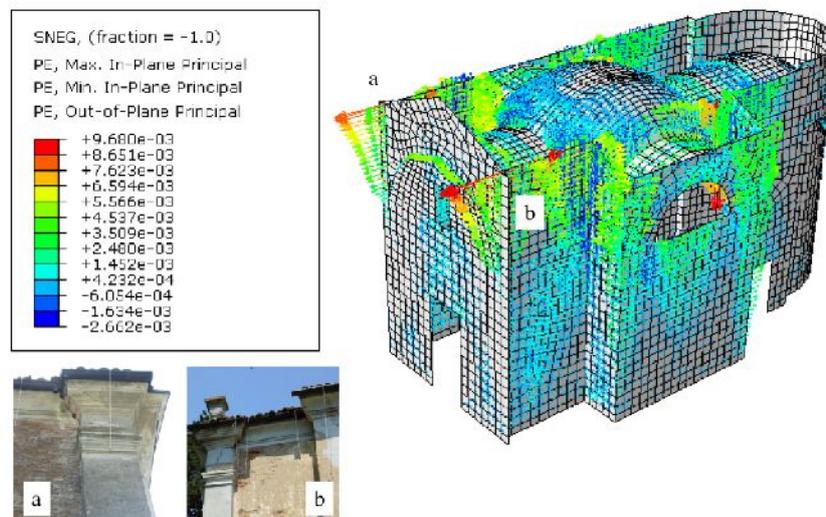
Fig. 13 Final plastic strain vectors distribution at the integration points (MRN seismic record and material parameters of Table 1)

Out-of-plane mechanisms have been identified for the church in the left and right chapels, in the apse and in the façade (Fig. 13) for the model with material properties reported in Table 1. Thus, these elements are considered vulnerable as understandable from the crack pattern given by plastic strain energy vectors. Analysts could possibly perform non-linear kinematic analyses to have an additional evaluation of their seismic vulnerability.

The 30 cm thick walls are affected by out-of-plane and in-plane behavior, with high DED value (Fig. 13). However, their DED value is higher than the average one computed for the whole church equal to 12 N/mm/m³. External walls with thickness 45 cm are considered less vulnerable than the external walls with thickness 30 cm since their response is only in-plane. The arch adjacent to the façade has a similar DED value as that of the apse vault.

Parametric analysis with different values of compressive strength, performed to detect its influence, showed no relevant differences in the response, confirming that the mechanical properties that most affect the masonry behavior are tensile strength f_t and fracture energy FE. The plastic strains vectors, which identify the cracks direction, are depicted in Fig. 16. It can be observed that the contour plots change in a negligible fashion supposing different f_t and FE values. The cracks are concentrated on the intersecting walls in the lateral façades, as actually occurred in terms of out-of-plane mechanisms. Moreover, in all four cases of Fig. 16, cracks at the intersection of the main façade with longitudinal walls are visible and reproduce the real situation shown in Fig. 7(c), in the incipient overturning of the façade limited in a small length from the top of the wall (Fig. 13).

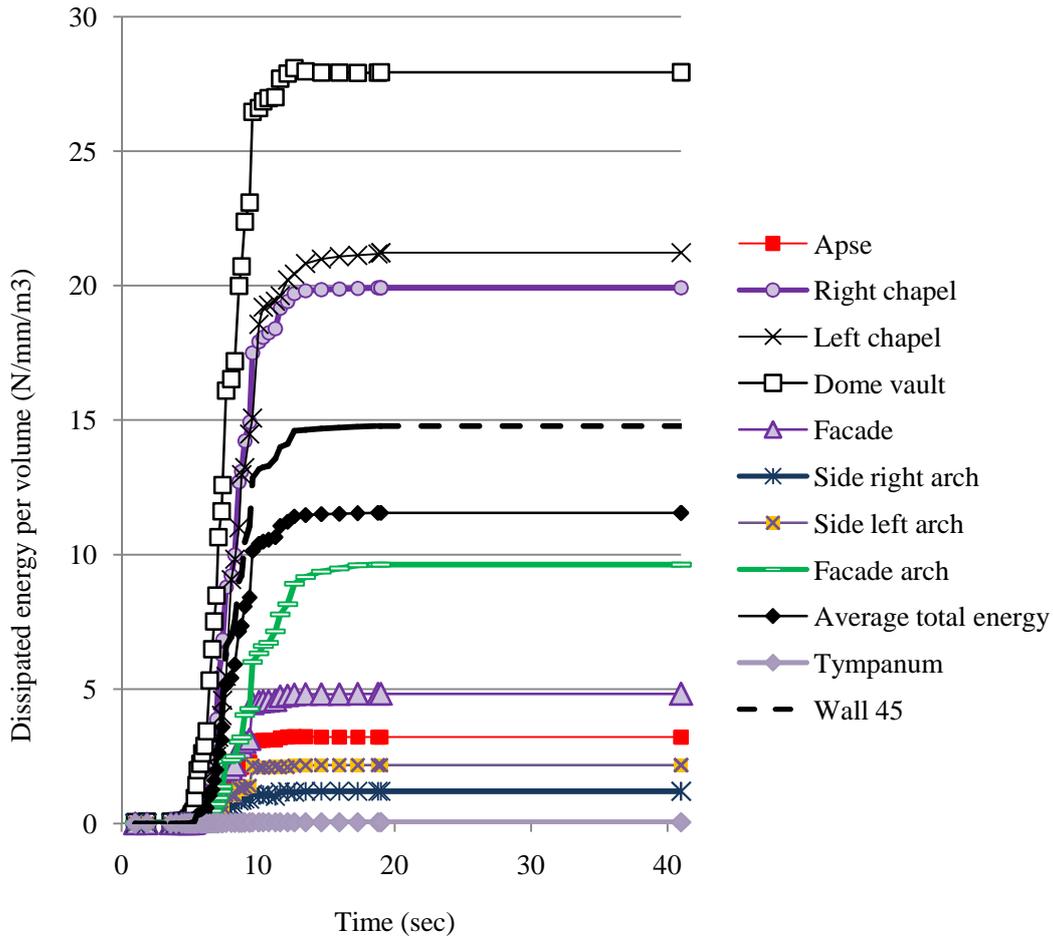
Fig. 14 DED evolution for the church subjected to Mirandola acceleration time history - $f_t=0.05$ MPa, $FE=0.001$ N/mm, quadratic S8R elements

Fig. 14 displays the DED evolution for the mechanical parameters reported in Table 1 during the MRN (Mirandola) earthquake. After approximately ten seconds of time-history analysis, the maximum value of dissipation energy is attained, and it remains constant, since peak accelerations are passed, after about twelve seconds.

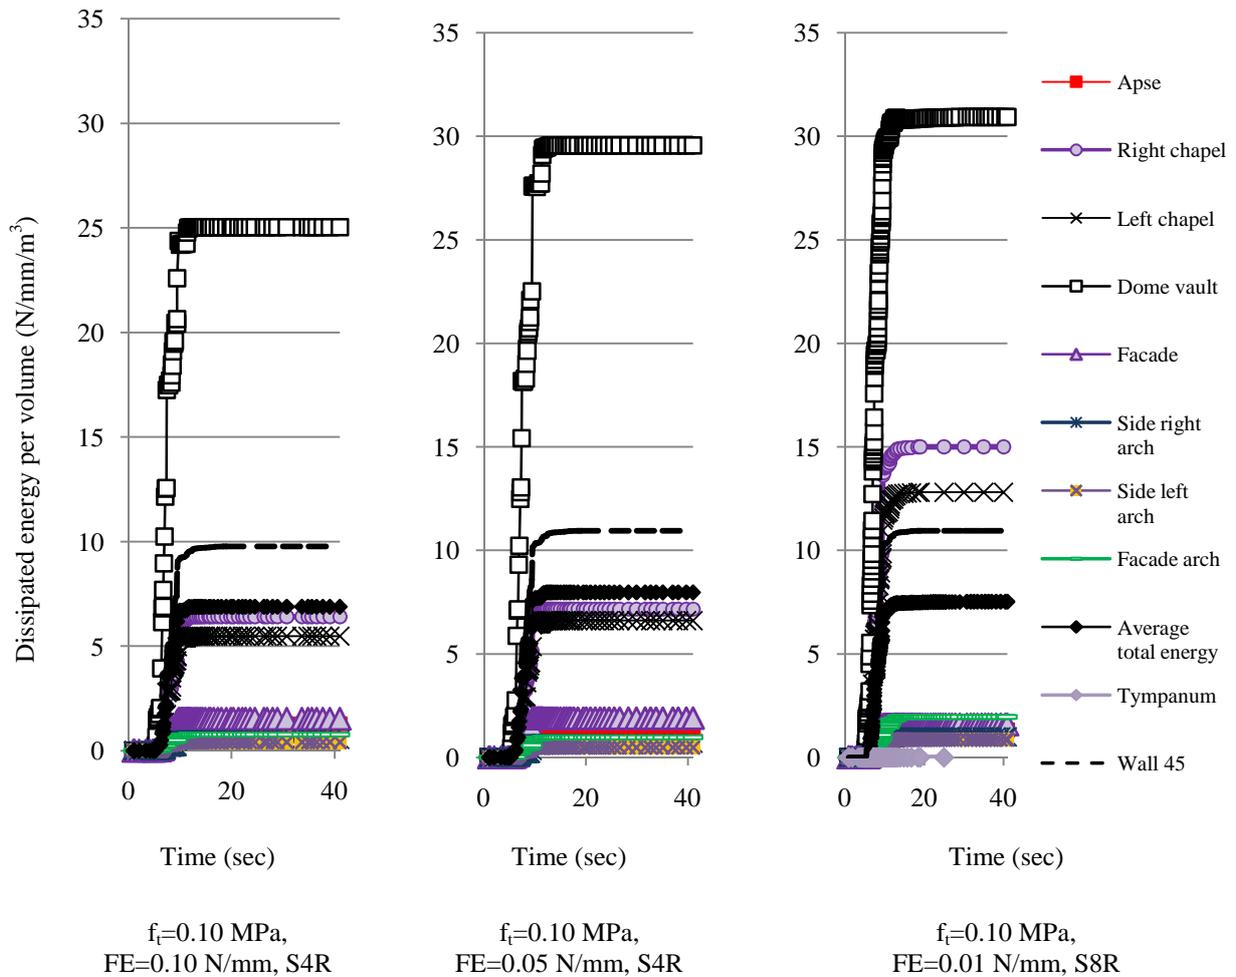
Fig. 15 DED evolution (MRN) for different values of fracture energy

Fig. 15 shows the dissipation energy per unit volume, over time, for different values of fracture energy (FE). Linear 4-nodes and quadratic 8-nodes elements are taken into account in the parametric analysis. One can notice that the evolution of damage is nearly the same, so the FE values do not modify the relative ratio between the DED of the several macro-elements of the church; although generally the absolute DED values increase if the fracture energy decreases: that is caused by the increasing number of cracked elements in each macro-element.

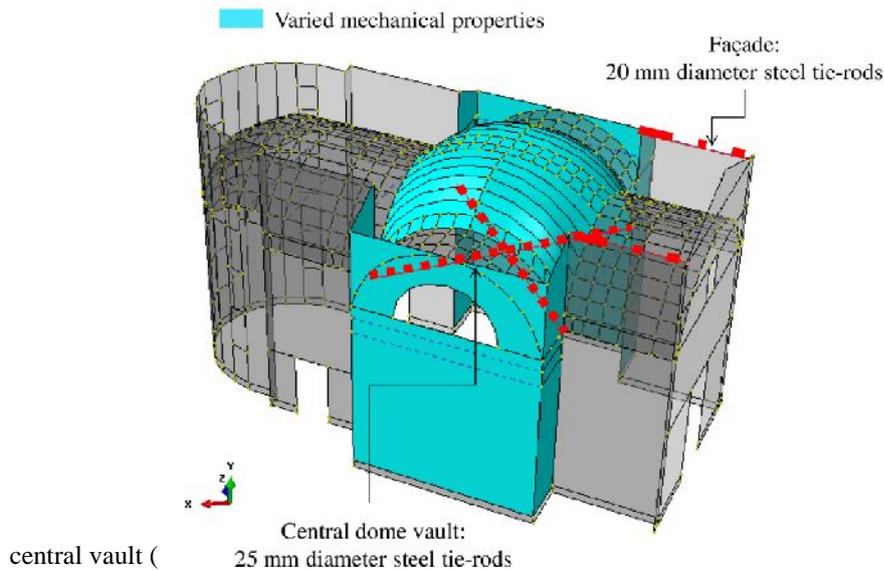
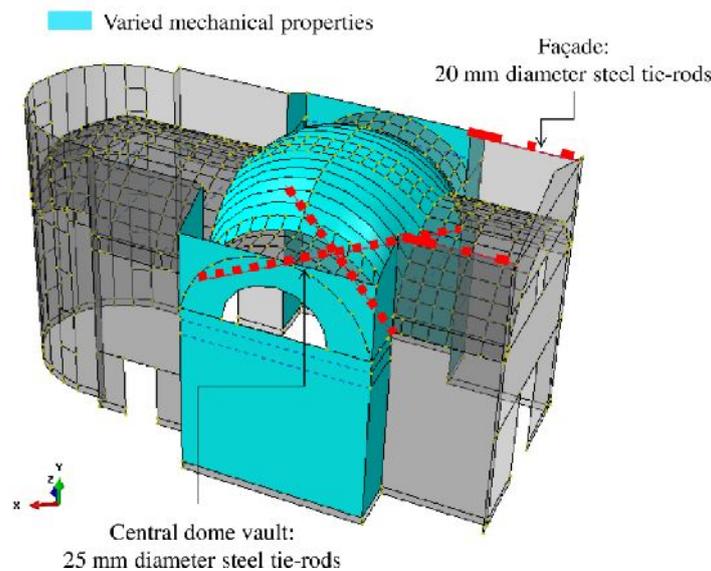
Fig. 17 Example of rehabilitation strategy: varied mechanical properties and steel tie-rods installment

The improvement obtained with strengthening measures, for the sake of brevity, is taken into account using modified geometric or mechanical properties of existing materials. That choice is part of the rehabilitation strategy illustrated in § 2, where a target parameter is varied to reduce damage and dissipated energy density in vulnerable macro-elements. Let us assume improved mechanical properties for tensile state of vulnerable elements, as classified in § 5.3. In particular, a fracture energy per unit of surface of 0.1 N/mm and tensile strength of 0.2 MPa have been assumed. This reinforced material is adopted for the central vault and the left and right chapels. In addition to the material modification, n. 2 steel 20 mm-diameter tie-rods are designed for the

façade, to limit the out-of-plane mechanism; n.2 diagonal tie-rods with 25 mm-diameter are also supposed in the

Fig. 17). That is aimed to reduce relative displacements between vault supports.

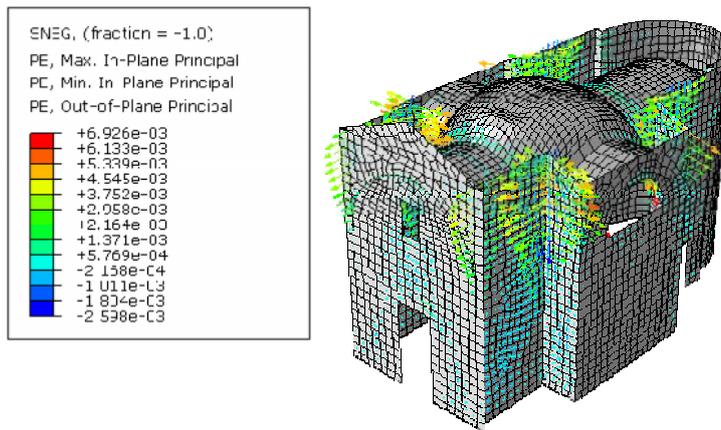
Fig. 18 Plastic strain vectors distribution in the rehabilitated case (max=0.0046 at the top of the façade)

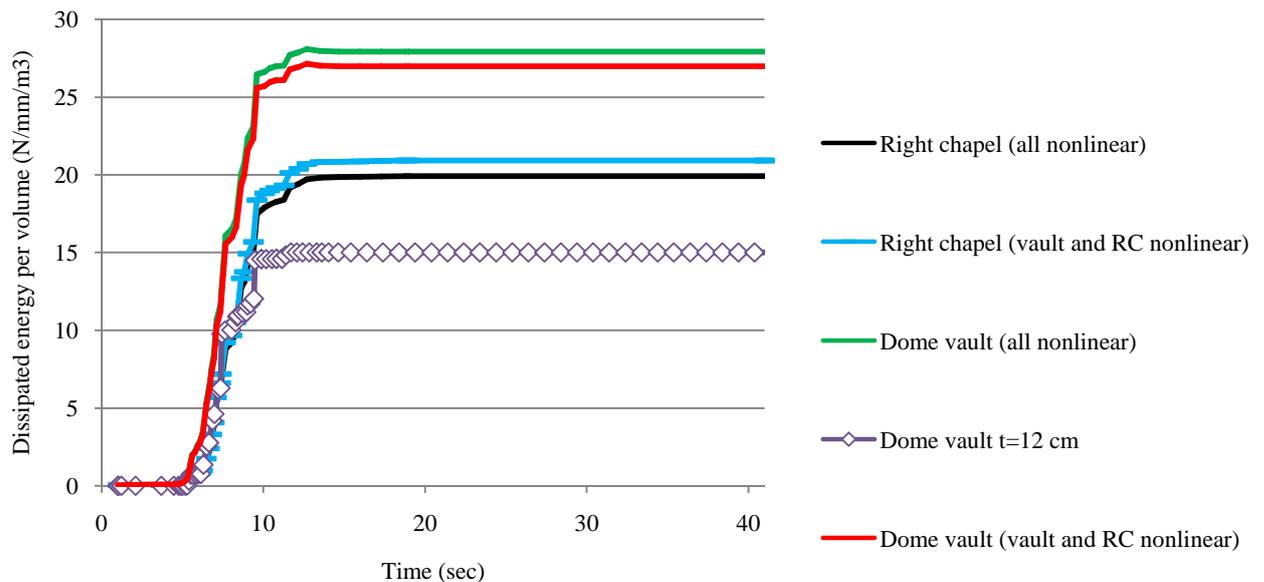
Fig. 19 Dissipated energy per unit volume with all nonlinear macro-elements and just the vault and the right chapel walls (RC) nonlinear – vault equivalent thickness: 12 cm

Other target parameters might be varied, for instance the central vault thickness (for instance with stiffening lightweight concrete and FRP). Fig. 19 shows the improvement achieved if one assumes a vault thickness of 12 cm instead of 6 cm, properly adapting the corresponding seismic mass (FE=0.5 N/mm, $f_t=0.15$ MPa, seismic record MRN). The value of the dissipated energy density changes from about 23 to 15 N/mm/m³, resulting in a reduction of the work required to the vault of 35%.
