Operational Modal Analysis as a tool for bridge model updating. Application to an unconventional case study

Keywords: Prestressed concrete bridge with post-tensioned cables, Visual inspections, On-site surveys, Dynamic behaviour, Operational Modal Analysis, Model updating.

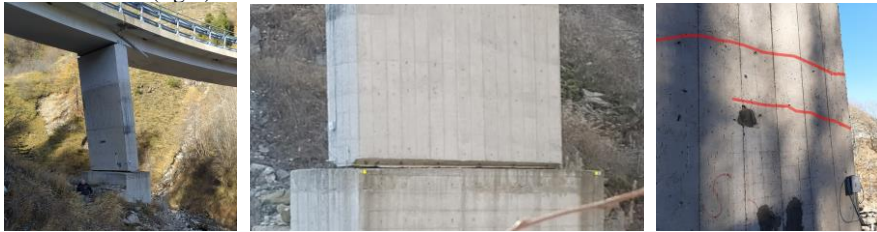
Fig. 2: View of the current configuration of pillar 1.

The case study bridge is a very peculiar structure located in a mountainous zone and bypassing a river. The three-span deck is constituted of a continuous pre-stressed reinforced concrete slab with post-tensioned cables, laying on two pendular pillars and two side abutments. Besides, the planar development of the deck is circular (Fig. 1). The location of the bridge has been interested by severe hydraulic and landslide phenomena, which mutually influenced and induced progressive damage in the structure. Looking at the bridge from the upstream, the active landslide is occurring close to the structure, on the right side. This phenomenon caused and is still making the bridge's right abutment and pillar's foundation move to the left. This movement is fairly visible from the current changing position of the composing elements: both the pendulum pillars rotated in and out of plane, with slight partial detachment of the deck and of the base of the pillar (Fig. 2 highlights this for pillar 1); the deck is progressively detaching

- the right end of the deck is lifted from the supports, while the back vertical face is partially detached from the abutment and partially in contact. This turned the original simply-supported configuration into a peculiar constraint, which behaviour is affected by the actual length of the portion of the deck in contact with the abutment and by the friction between the surfaces (Fig. 2 and Fig. 3a).

- The left end of the deck is totally locked in the left abutment, turning the simply-supported constraint into an almost fixed one (Fig. 2 and Fig. 3b).

- The pendular pillars rotated in and out of plane, with a partial detachment of the pillars' base from their basement and partial lift of the deck from the upper side of the pillar. This resulted in a different stress distribution along the height of the pillar for vertical loads, also highlighted by some horizontal cracks on the unloaded side (Fig. 2).

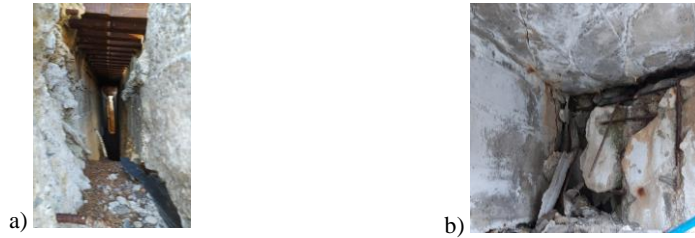
Fig. 3: a) Partial detachment of the deck from the right abutment; b) Progressive movement and locking of the deck toward the left abutment.

from the right abutment (Fig. 3a) and moving toward the left one, locking into it (Fig. 3b). Besides, the progress of the landslide is fed by the river, which contributes to the erosion of the riverbed. The different configuration of the main components of the bridge causes both local damage in the elements and may change the structural response of the bridge to external natural and man-induced actions (such as traffic load), hence the necessity of assessing the current safety level of the structure. For the structural assessment, it is fundamental to build a numerical model the most representative of the current configuration of the structure. To this purpose, the knowledge process to the evaluation of the safety level has been structured as in the following: a) research of original documentation about the structure, including technical drawings, structural details, material certifications, possible previous surveys; b) on-site inspections for the evaluation of the conservation status and of current damage of the components; c) geometric survey for the assessment of the actual spatial configuration of the structural elements and preliminary assembly and definition of the numerical model; d) characterization of the dynamic response of the bridge through Operational Modal Analysis; e) numerical model updating. In this paper, a focus is made into highlighting the main elements which affect the changing the structural response of the bridge, with respect to the original concept, and on the techniques and instruments adopted for the construction and the calibration of the numerical model: the damage detection, the geometrical surveys for the real configuration of the structural elements, and the OMA to obtain a well-calibrated and representative structural response.

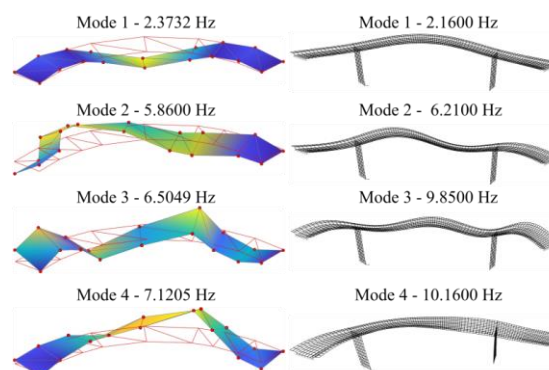
Fig. 8: Comparison between the first four experimentally identified natural frequencies and mode shapes and the preliminary model's numerical ones.

Differences between numerical and identified modes are notable (Fig. 8), thus the FE model needs to be updated to better represent the actual state of the bridge. The main damage phenomena are the changes of the external restraints from the design ones due to the settlements caused by the landslide. Therefore, the parameters of interest for the update of the model are the stiffness of the restraints and their reciprocal ratio. To simulate the loss of support and to permit the torsional mode at the south abutment only a small central part of the slab has been restrained with vertical springs (Fig. 9a). At the south pier, the slab shows a torsional motion and diagonal cracks consistent with a lack of torsional restraint, thus the inner connection pier-slab has been modeled only for half of the pier's width (Fig. 9b). Furthermore, the pier's base is restrained only for half of its width, as in the preliminary model (Fig. 9c). Because the slab is forced into the north abutment by the landslide, the radial restraint at the north abutment is considered fixed, whereas, in the vertical and tangential direction, it is modeled as springs (Fig. 9d).
