Application of Sonic, Hygrometric Tests and Infrared Thermography for Diagnostic Investigations of Wall Paintings in St. Panfilo's Church

Results of the II National Research Project of AIAr: Archaeometric Study of the Frescoes by Saturnino Gatti and Workshop at the Church of San Panfilo in Tornimparte (AQ, Italy)

Featured Application: Non-destructive testing techniques, namely sonic pulse velocity, hygrometric tests, and infrared thermography, were employed for inspecting late XV-century frescoes to evaluate the state of conservation of the plaster-masonry structure.

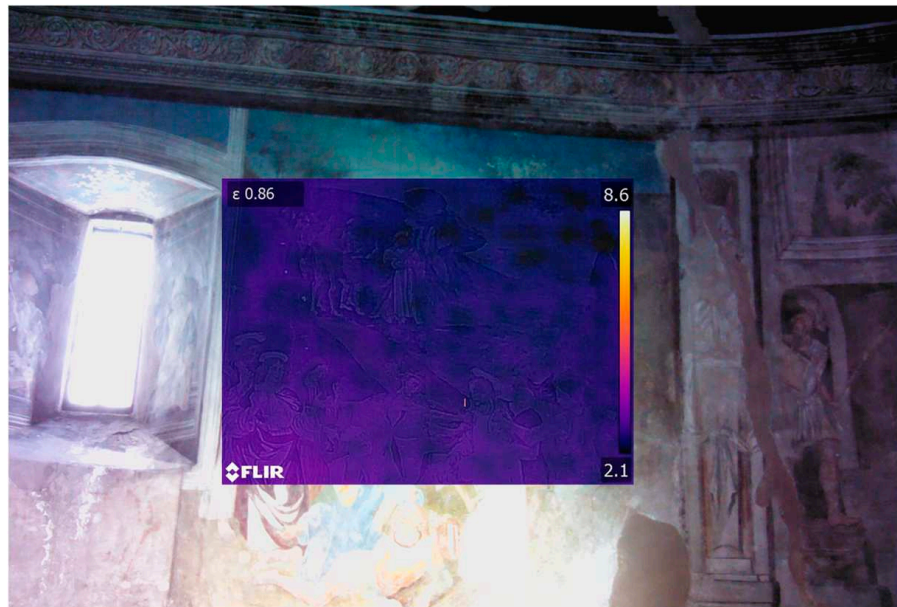
Figure 2. Example of passive thermography analysis used to identify the support wall texture. Stones with irregular shapes can be distinguished behind the fresco.

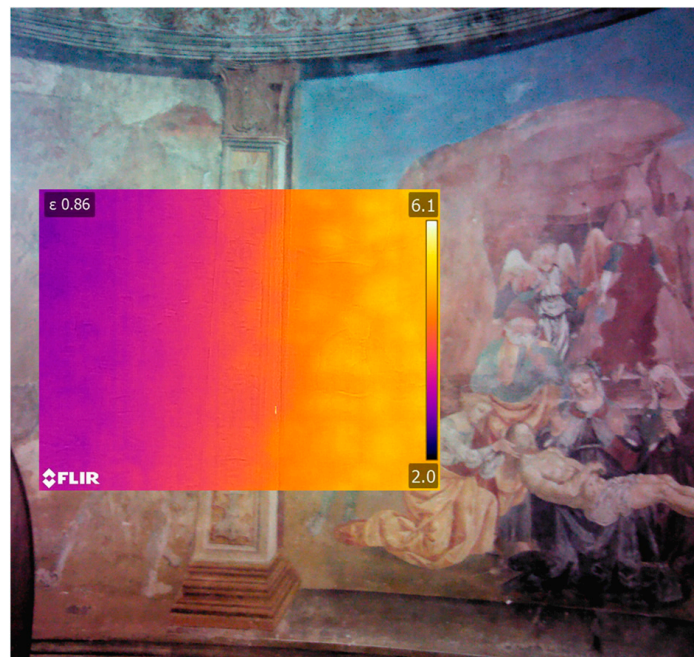
PIRT is useful to identify potential detachments, part of the wall structure, and a presumable humidity area. Figure 4 shows a part of the apse between two panels of the frescoes and precisely between the central one and that on the left (between panels A and B), which is the one with the worst degree of conservation and that was probably retouched in the past several times. A quite large and abrupt average measured temperature discontinuity between the central-right side of the apse and the left side can be seen, which was confirmed by the other images collected.

As mentioned above, this can be due to the position of the left side relative to the cardinal points, even if at the time of the measurement, the left side was exposed to the sun, but probably also to differences in the structure that affect the emissivity (e.g., materials, construction techniques, plaster characteristics, and later works such as the construction of the sacristy). This difference between the left and right sides is confirmed by the PIRT images shown in Figure 5 and collected over the same areas imaged with SPV and HT, reported in Figure 3. The subplots are named according to Figure 3.

Figure 4. Passive IRT image of the attachment point of panels A and B. An abrupt discontinuity in the average emitted radiation can be seen.
