An HBIM Approach for Structural Diagnosis and Intervention Design in Heritage Constructions: The Case of the Certosa di Pisa

Keywords: Certosa di Pisa; architectural heritage; HBIM; 3D modeling; safety assessment

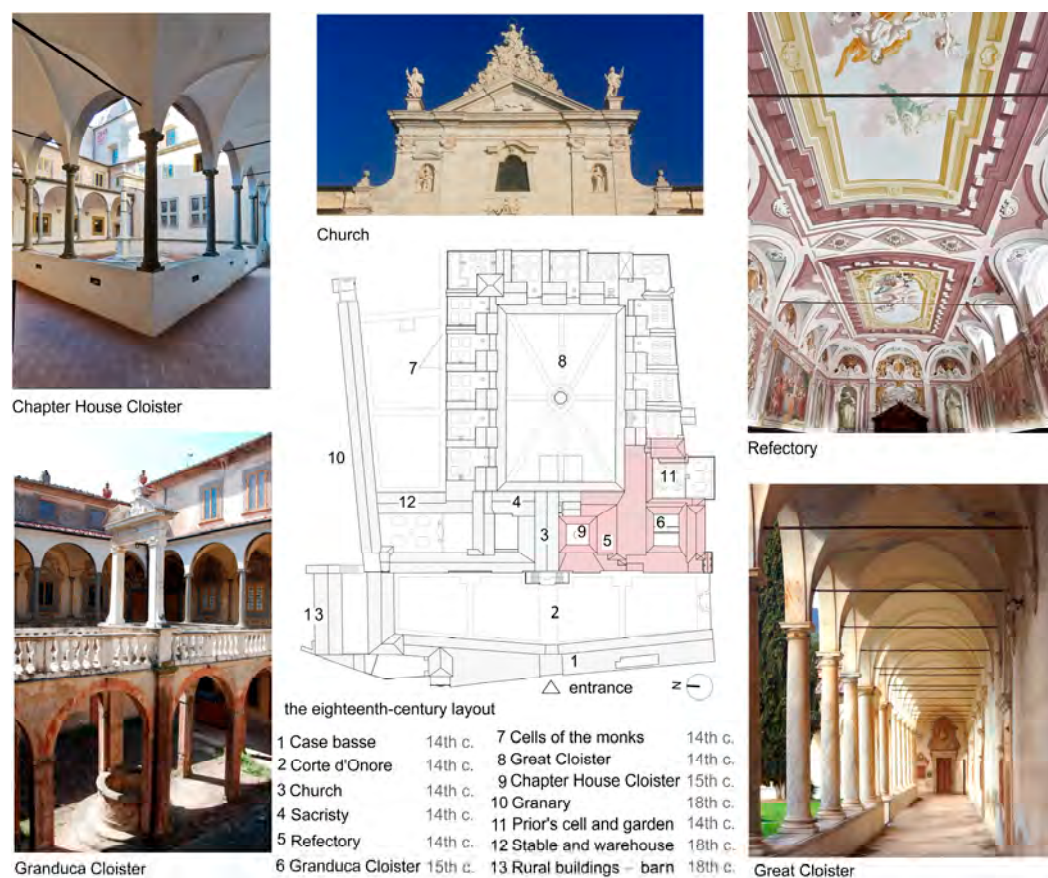
Figure 2. Intended uses in the 18th century layout of the Certosa, with indication of the study area.

The complex comprises multiple buildings, each serving specific functions (Figure 2). The western façade houses a building aggregate known as Case Basse, which spans approximately 150 m and consists of two aboveground stories. This structure hosted various services for the charterhouse, including the pharmacy, San Sebastiano Chapel, and the parlor, which were accessible to residents as well. In front of the Case Basse there is the actual cloistered monastery, an imposing three-story edifice with the main façade facing west, separated from the Case Basse by a large green area called Corte d'Onore. At the center of the complex there is the church, originally built for the exclusive use of the monks. The church features a grand double-ramp staircase, a magnificent façade covered in white marble and decorated on the tympanum by a statue of the Assumption surrounded by angels (Figure 2).

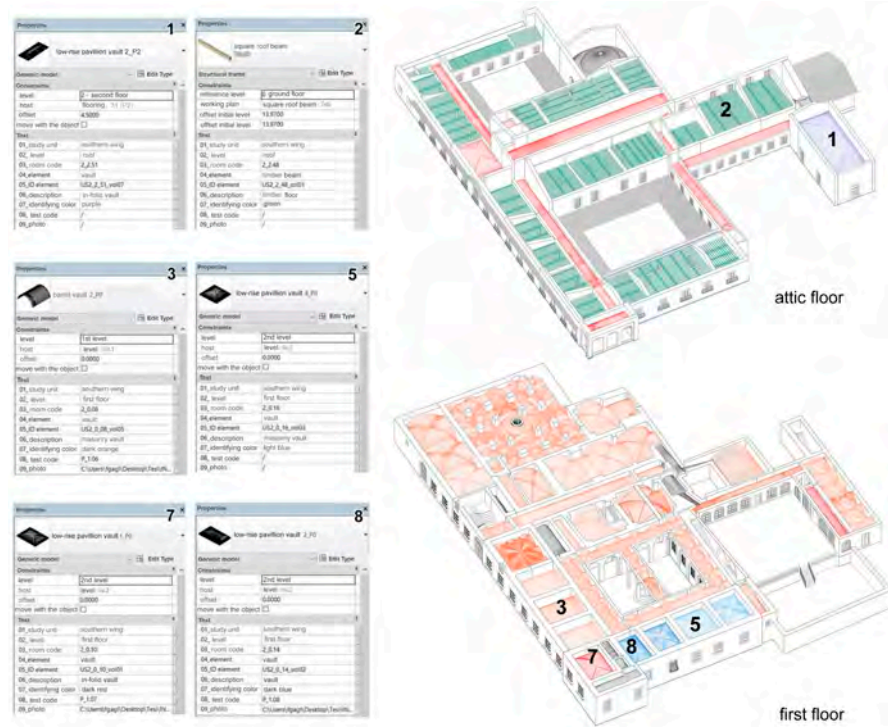
Figure 7. Views of the horizontal structures of the attic floor and the first level of the study area, with relative forms.

The resulting model collects various information on structures such as floors, vaults, and masonry walls; construction phases of the historical building; load measurements on metal tie-rods; three-dimensional representations of crack patterns on vertical walls and vaults; and the results of approximately 80 onsite tests. The model allows one to generate plans, elevations, sections, detail drawings, and tables. The first interesting result is the representation of load-bearing elements. This product, which facilitates the understanding of the organization of the structural system, represents the first step towards the diagnosis and planning of interventions, especially in such a complex context of spaces and shapes. Figure 7 displays two examples of three-dimensional views of the horizontal structures—those of the attic rooms and the first floor, respectively—accompanied by tables containing detailed information on each element.

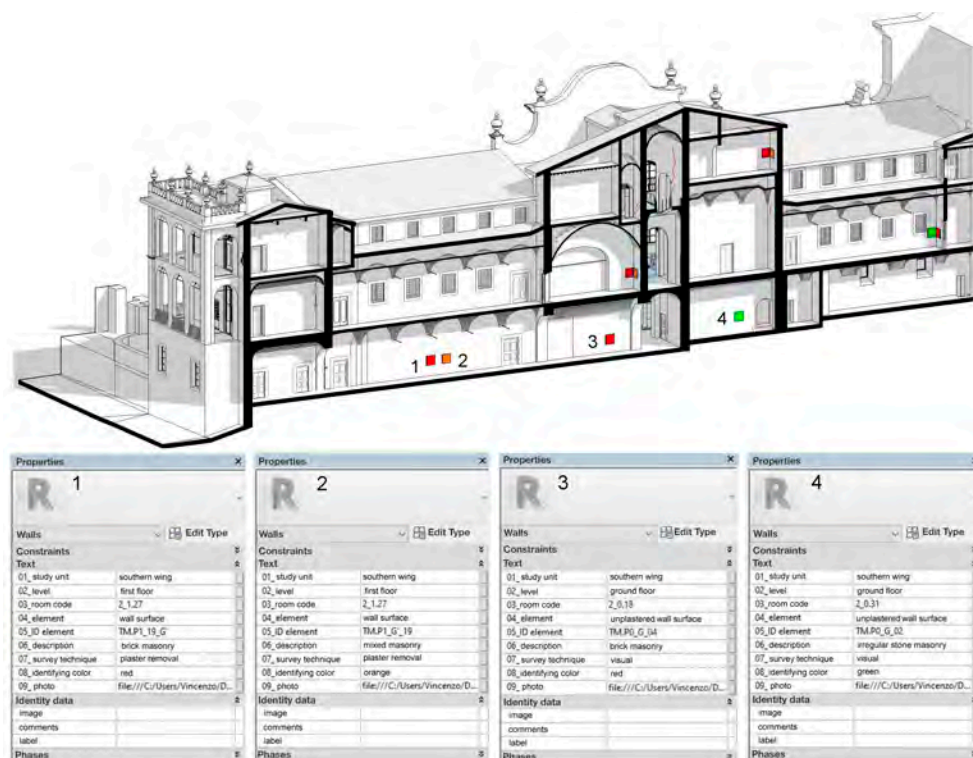
Figure 9. North-south section of the model, with the position of the onsite tests.

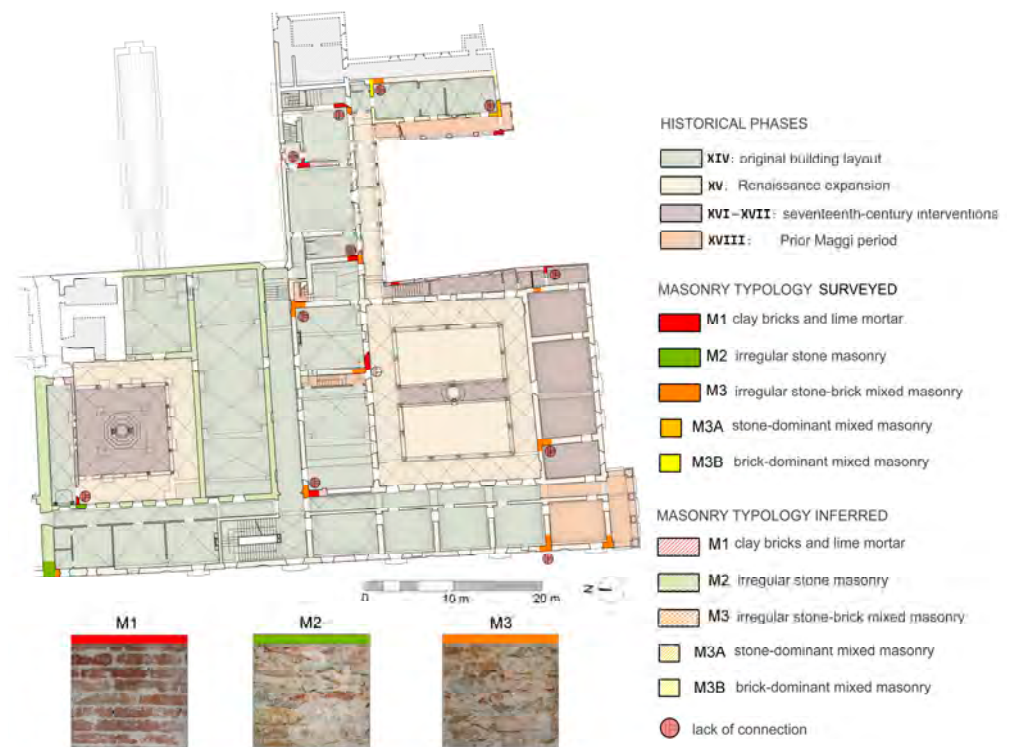
Figure 11. Map of wall macro-categories—first-floor plan of the study area.

In this study, masonry was classified into three main categories: M1, M2, and M3, along with subcategories based on the constituent materials of the units and their arrangement. The initial phase of the structural diagnosis of the southwest portion of the Certosa relied heavily on this outcome. It was supplemented by information concerning issues affecting the structures, materials, and decorative elements. In this context, the model showcases its ability to visualize the crack pattern in three-dimensional mode, displaying them on both faces of the walls through the transparency option.

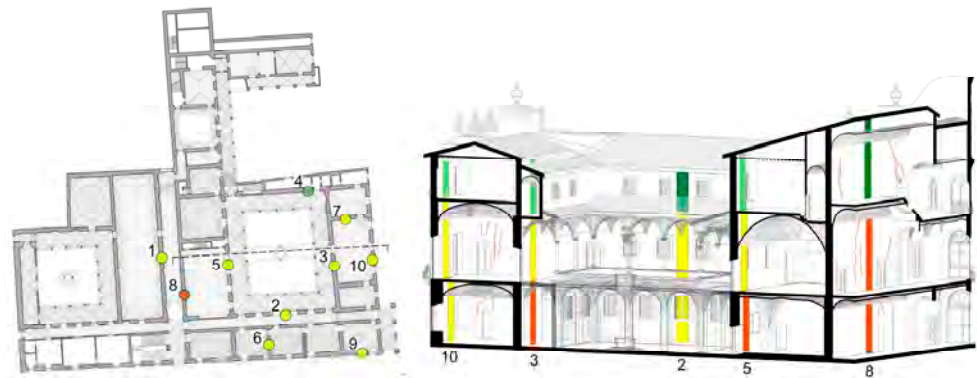
Figure 13. Visualization of the results of the safety assessment of walls in the ten sections (numbers 1–10) under gravity loads in the HBIM environment.

In this context, automating structural analyses within a BIM environment can help provide an initial overview of areas in need of more detailed assessments. In Figures 13 and 14, some results are shown regarding the static analysis of the masonry walls and the seismic analysis of the collapse mechanisms, respectively. In Figure 13, a graduated color bar from green to orange represents the safety level of each wall panel under gravity loads: green indicates safety levels higher than 2, while orange indicates values close to 1. Figure 14 shows some portions of masonry that could be affected by seismic collapse mechanisms. These include the loggia at the southwestern corner and decorative elements on the upper part of the façade, visualized in the HBIM, along with the numerical results included in the object’s property sheet. Overall, the seismic analysis revealed high vulnerability, particularly in slender elements, vaults supporting partitions, and upper portions of walls at elevated positions.

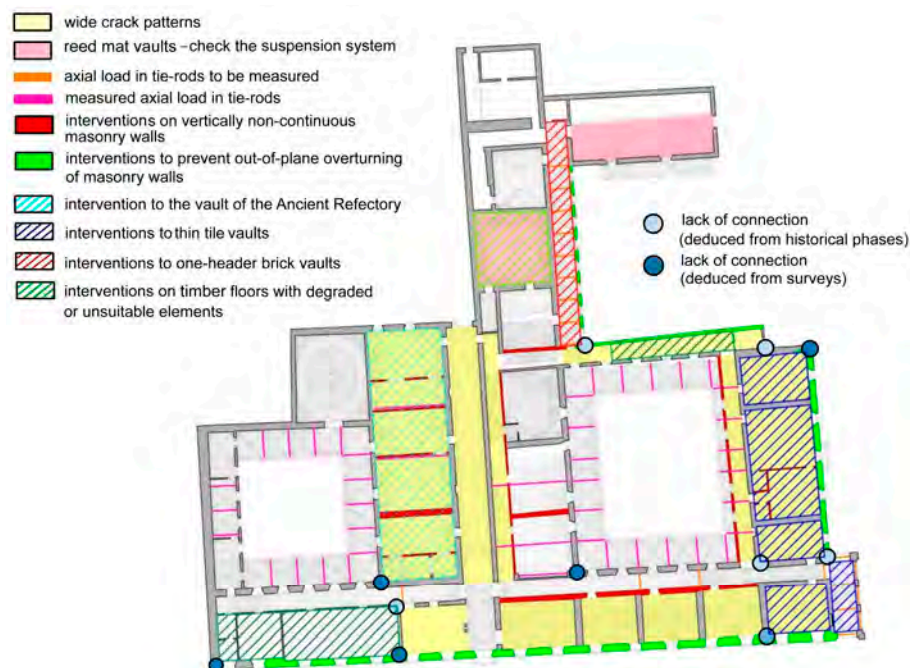
Figure 15. Plan of the second floor of the study area: the map summarizes the detected critical issues, the intervention categories, and the new knowledge needs.

The database enables interactive three-dimensional visualization of structural elements and critical areas, facilitating the identification of those requiring further analysis or consolidation interventions. Based on this analysis, critical situations and areas needing further investigation can be identified and visually represented on synthetic maps. This aids in depicting the current state and identifying the need for new tests for more in-depth structural analyses, forming the basis for the subsequent consolidation project. Figure 15 illustrates a sample summary map on the plan of the second floor, detailing major critical issues, new investigations to be carried out, and the macro-categories of intervention types proposed in this preliminary study.
