CHAPTER 9: AQUEDUCTS – A CASE STUDY

Pietro Croce¹, Maria Luisa Beconcini¹, Martina Muzzi¹, Elisa Rosso¹, Francesca Marsili¹

¹Department of Civil and Industrial Engineering – Structural Division – Univ. of Pisa, Italy

The Medicean Aqueduct of Pisa (Tuscany, Italy), is a relevant historical infrastructure built at the end of the XVI century, composed of 954 masonry arches over a total length of 6 km. Many of the arches are affected with several decay phenomena, which occurred during the years. These have changed the original static arrangement, so that several arches are collapsed or degraded.

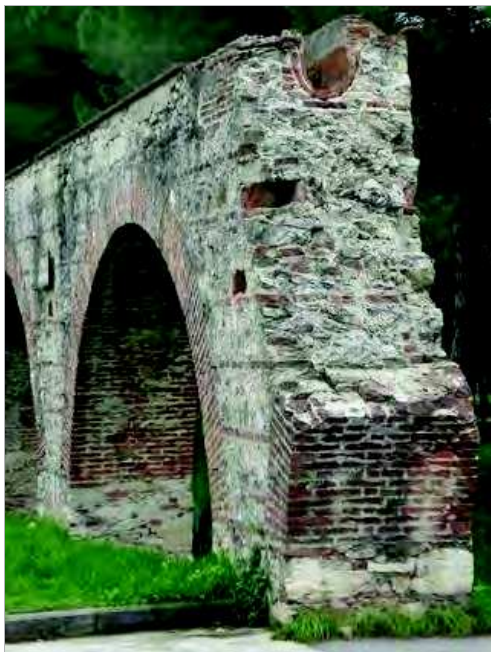
Figure 8 Arch nr. 58, where the core structure and the clay pipeline are visible

As said, the clay pipeline (fig. 8), with a semi-elliptical section, runs over the arches, covered by a sheet of stone (fig. 9) with protecting function. Nowadays, in the most degraded sections, the sheets of stone are no more in place.

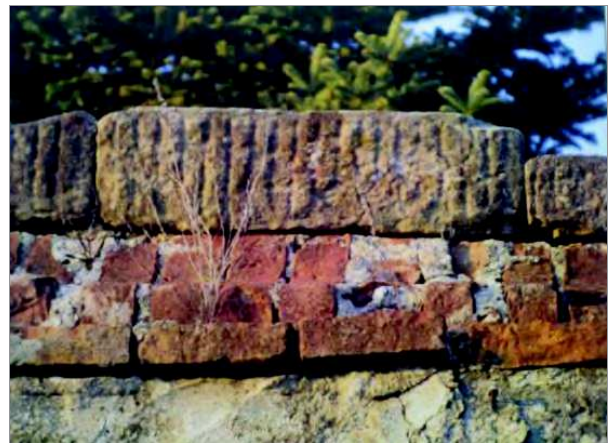
Figure 9 The sheet of stone that covers pipeline

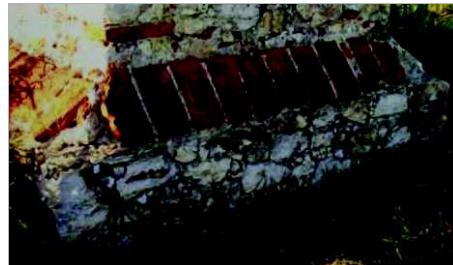
Figure 19 Large base under the pillar, between arches nr. 502-503

According to the practice of construction, typical of that area and time, we assumed that timber piles have variable length from 6 to 10 m (fig. 18). Approaching the centre of the town, the soil becomes more resistant, therefore the pillars have no pile foundation but a large base which gradually becomes wider (figures 19 and 20).

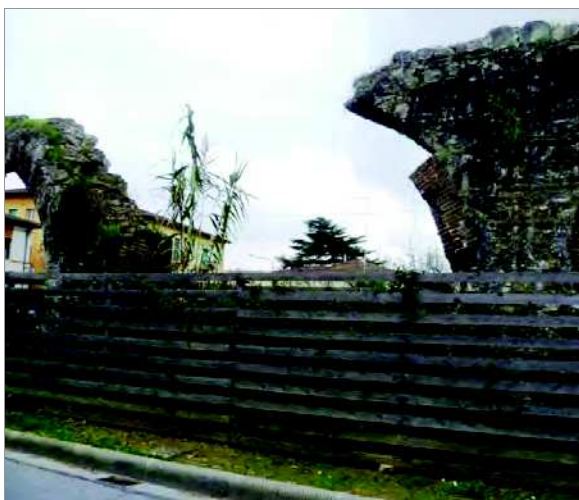
Figure 21 Arch nr. 99, collapsed

Nowadays, the observation of the work shows that it is in very critical condition: some arches are collapsed (fig. 21), other are damaged by vehicles impacts (fig. 22); many of them present various decay phenomena: the most evident are cross cracks and organic patinas, such as moisture stains or efflorescence. Over the years some elements, more probably those made almost exclusively in bricks, have been completely or partially rebuilt (figs. 23, 24).

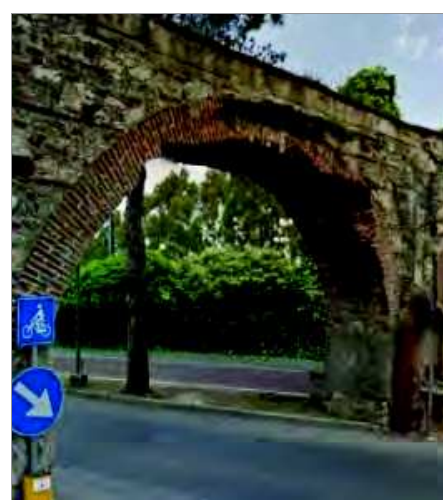
Figure 22 Arch n°162, damaged by vehicles impact

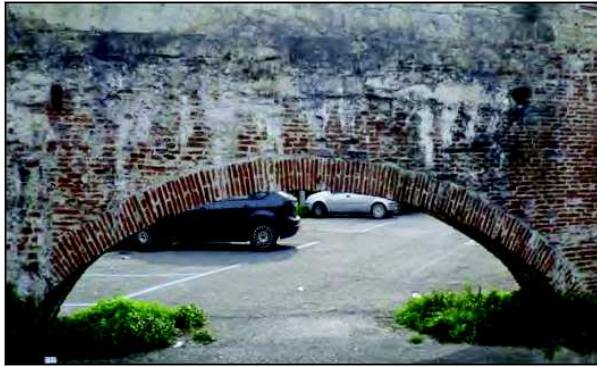
Figure 23 Arch nr. 49, rebuilt in bricks

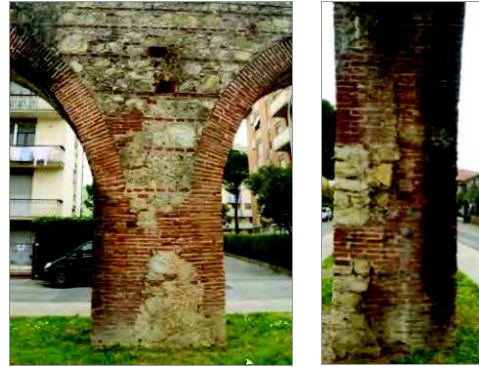
Figure 24 Pillar of arch nr. 130, rebuilt in bricks

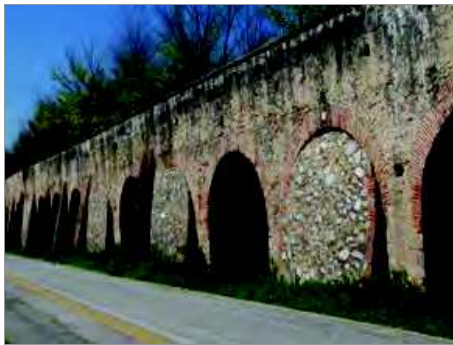
Figure 25 Some of the stopped up arches, from nr. 685 to nr. 694

The most degraded arches are in the upstream portion of the aqueduct: many of them have been filled with mixed masonry (fig. 25), often different in quality from the original one. The arches that showed an imminent crisis have been provisionally supported by steel or timber scaffoldings (figs. 26, 27 and 28) in the last 30 years.

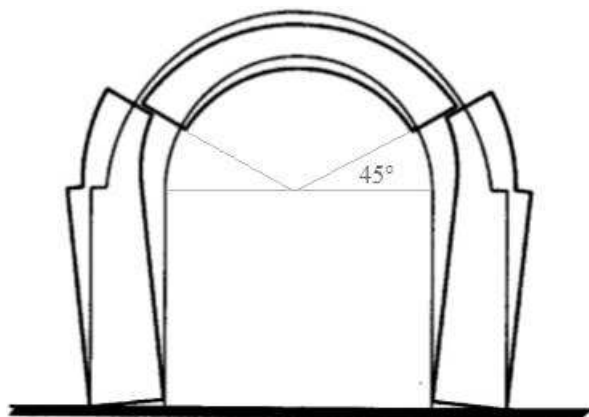
In the De La Hire and Belidor’s arch sliding mechanism (fig. 29), the central part of the arch is considered to behave like a wedge, sliding between smooth frictionless surfaces. In the model, the failure occurs when the central body slides down, while the pillars rotate outwards.

Figure 29 De La Hire and Belidor’s sliding mechanism of the arch

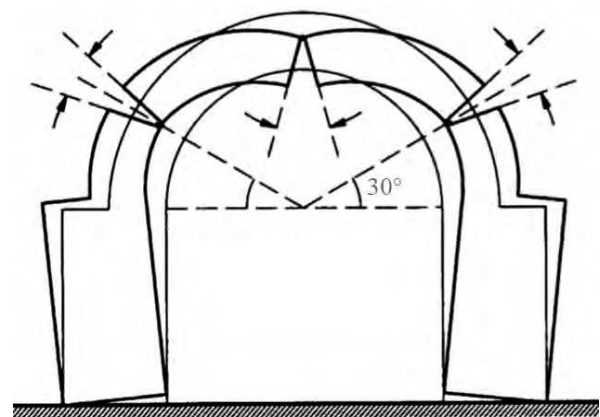
Figure 30 Mascheroni’s flexural failure mechanism of the arch

In Mascheroni’s flexural failure mechanism (fig. 30), the collapse occurs due to the formation of hinges, one at the crown on the extrados and two at the haunches on the intrados, and the rigid rotation of the pillars.

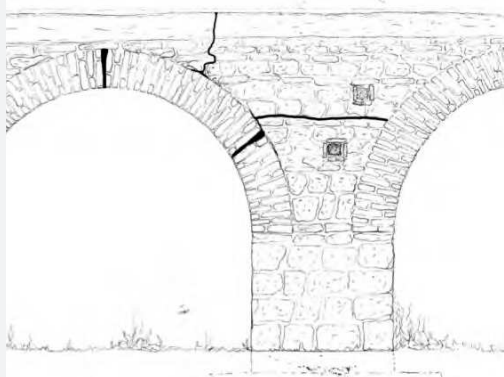
CLASS	GRAPHIC SCHEMES	DESCRIPTION	TAG
(A) CROSS CRACKS

Cracks at the haunch, visible on the arch's bricks and extended through the whole depth	A1
		Cracks at the crown, visible on the arch's bricks and extended through the whole depth	A2
		Horizontal cracks visible on the masonry wall (backfill) and extended through the whole depth	A3
		Vertical or oblique cracks, visible on the masonry wall (backfill) and extended through the whole depth	A4

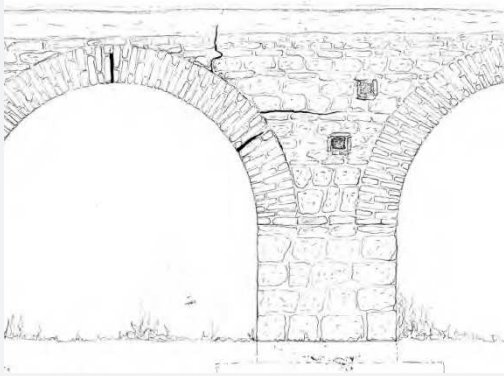
(B) NOT CROSS CRACKS

Cracks on the voussoir, visible on the arch's bricks but not extended through the whole depth	B1
		Cracks at the crown, visible on the arch's bricks but not extended through the whole depth	B2
		Horizontal cracks, visible on the masonry wall (backfill) but not extended through the whole depth	B3
		Vertical or oblique cracks, visible on the masonry wall (backfill) but not extended through the whole depth	B4

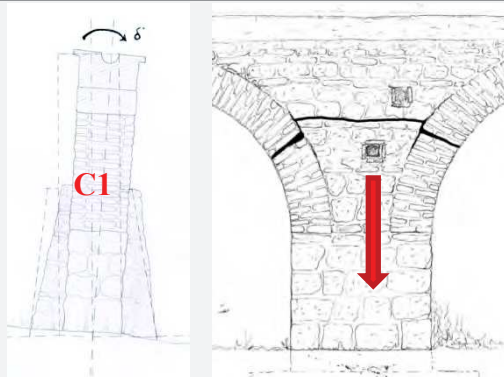
(C) SETTLEMENTS

Settlement of foundation that involves an out of plane rotation of the pillar's foot	C1
		Vertical settlement of foundation	C2

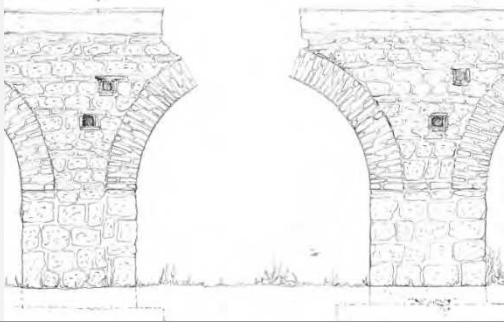
A cross-sectional diagram of a stone archway. The central part of the arch is missing, and the remaining stone blocks on either side are shown with jagged, broken edges, indicating a partial collapse.	Partial collapse of arch elements (arch, masonry backfill or buttress) D1

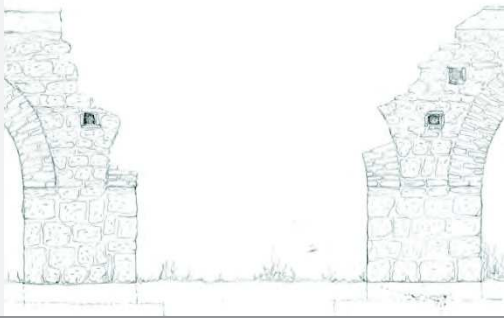
A cross-sectional diagram of a stone archway. The entire arch structure is missing, leaving a large, empty rectangular opening between the remaining stone walls on either side.	Total collapse of an arch. D2

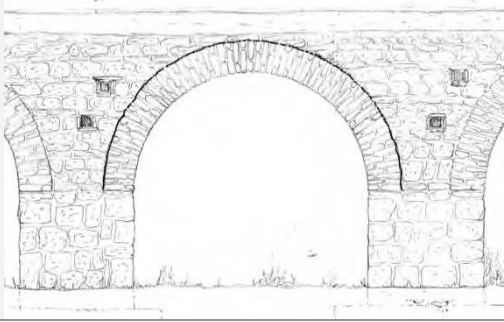
A cross-sectional diagram of a stone archway. The arch is shown as a separate, curved structure that has become detached from the surrounding masonry walls, creating a gap between them.	Detachment between the arch and the masonry backfill. E

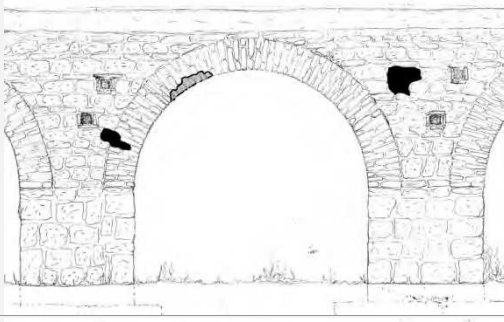
A cross-sectional diagram of a stone archway. Several individual stone blocks within the arch and the surrounding masonry are shown with irregular, pitted, and eroded surfaces, indicating general deterioration.	Deterioration of masonry elements. F

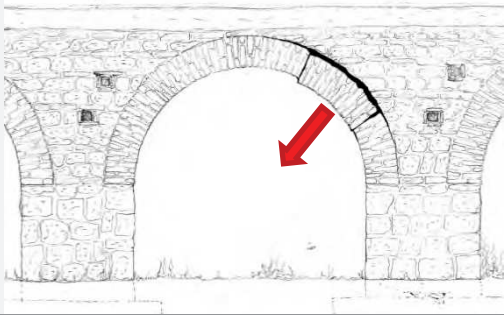
A cross-sectional diagram of a stone archway. A red arrow points to a specific mortar joint between two stone blocks, where a curved line indicates that the blocks have shifted relative to each other.	Relative displacement along the mortar joint plane. G

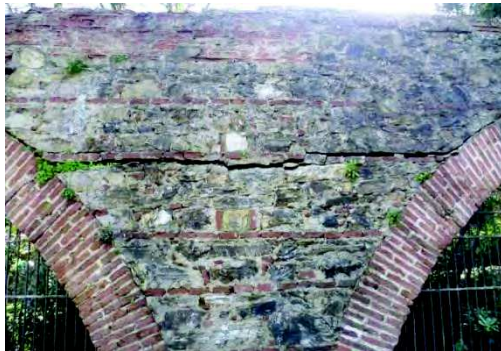
Arches n. 8, 9 – Side A

A3: horizontal crack in the masonry wall (backfill)

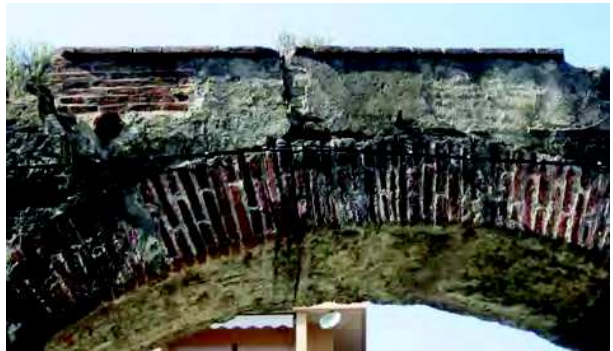
Arch n. 145 – Side B

A4: vertical crack in the masonry wall (backfill)

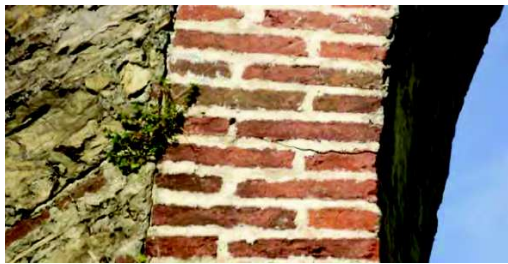
Arch n. 251 – Side B

B1: crack visible on the arch's bricks, placed in the haunch

Intrados crack detail

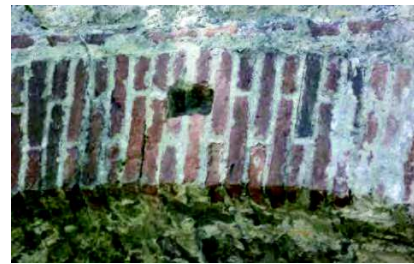
Arch n. 211 – Side B

B2: crack in the crown, visible on the arch's bricks

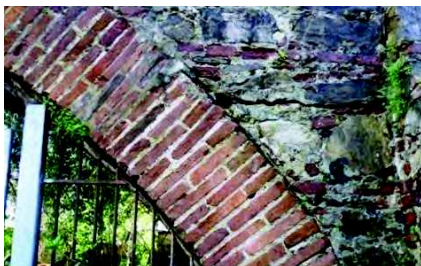
Arch n. 17 – Side A

B3: horizontal crack, visible on the masonry wall

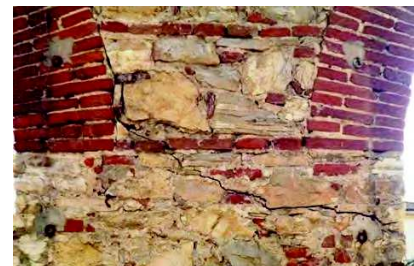
Arches n. 101, 102 – Side A

B4: oblique crack, visible on the masonry wall

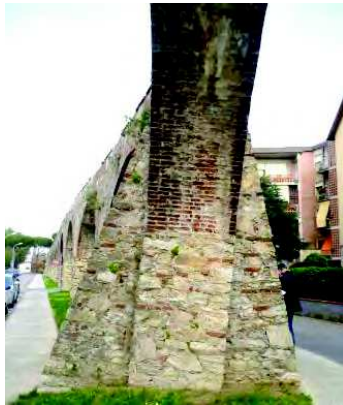
C1: settlement of foundation that involves the out of plane rotation of the pillar

Arch n. 144 – Section
Out of plane rotation (9°) of a pillar between buttresses

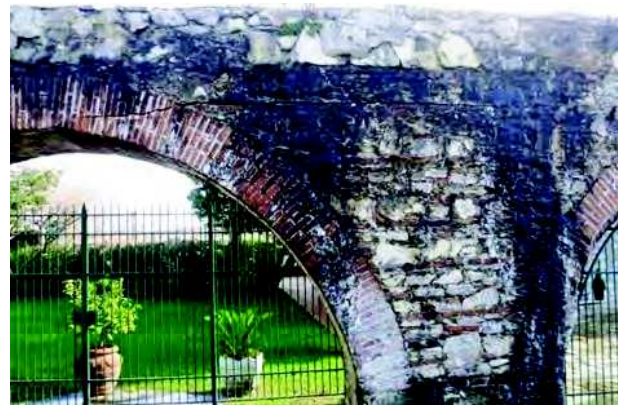
C2: vertical settlement of foundation

Arch n. 16, 17 – Side A
Vertical settlement appearing by a crack in the backfill, extended to arch's brick

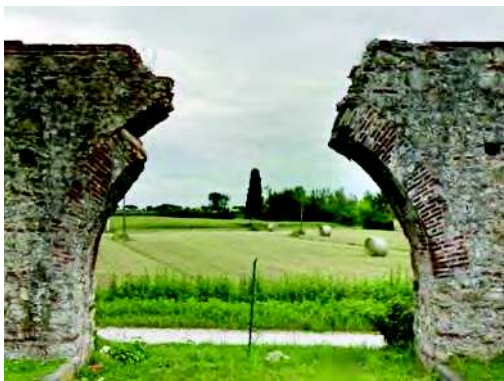
D1: partial collapse of arch/masonry wall (backfill)

Arch n. 395 – Side A
Partial collapse of arch

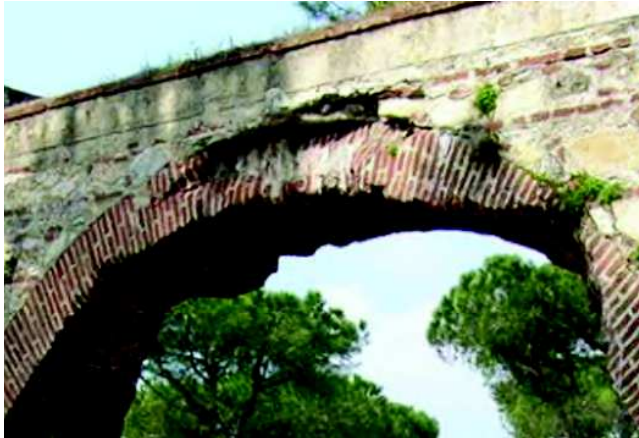
F: deterioration of some masonry elements

Arch n. 163 – Side A
Deterioration of arch's bricks at the extrados and intrados, caused by lorry impact

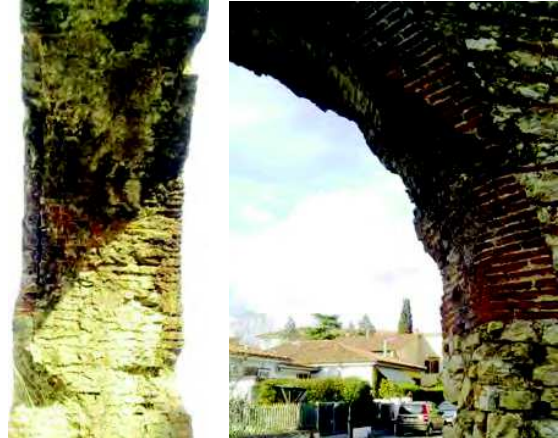
Arch n. 163 – Side A
Deterioration at the intrados of the arch and deterioration of the façade of the arch

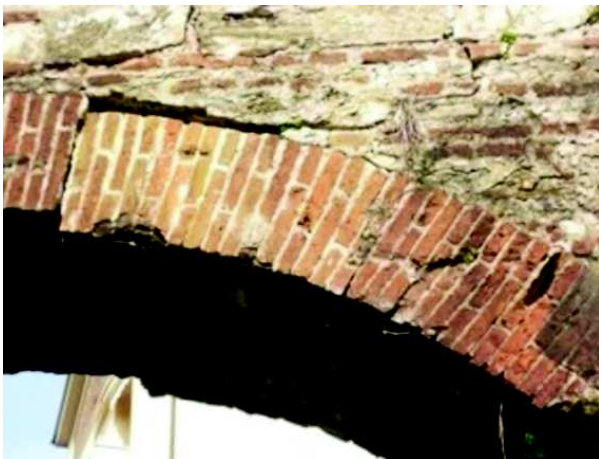
G: displacement of a voussoir along the mortar joint plan

Arch n. 101 – Side A
Relative displacement in the mortar joint plane

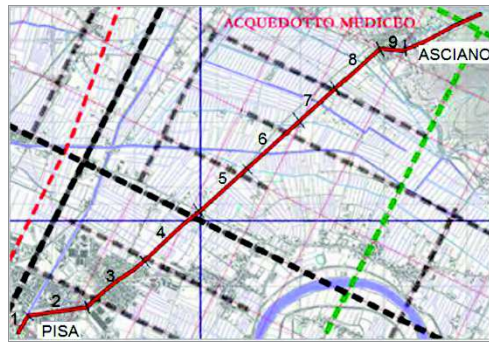
Figure 40 Aqueduct layout divided into 9 sections

In order to store the results of the survey, the whole Aqueduct has been subdivided in 9 sections (fig. 40); the original numbering of individual arches, ascending from the town centre towards upstream, has been maintained. The survey has been carried out filling the specific *arch survey form* shown in fig. 41, one for each side, A and B, of every arch. All the collected data, both geometric and related to deterioration, have been collected in summary tables (eg tables 4, 5).

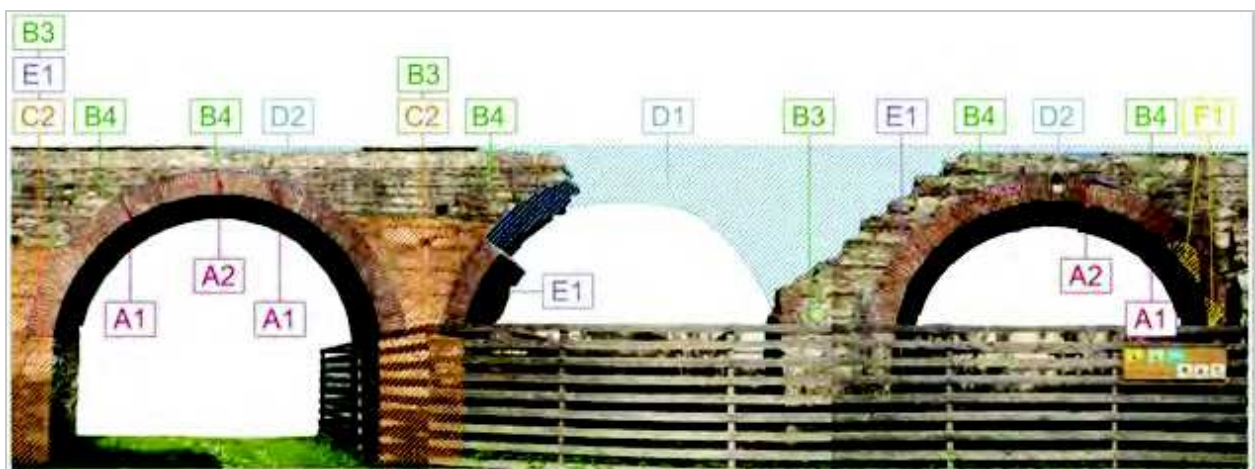
Figure 44 Crack pattern of arches n. 98, 99 and 100 – side B

In the following, the product of the survey is illustrated for a relevant portion of the examined sample, corresponding to the three arches numbered 98, 99 and 100 (fig. 44). The cracks, identified by codes accordingly to the classification described above, are highlighted and labelled in different colours. The dimensional data and the crack patterns detected during the survey and previously classified, are summarized in tables 4 and 5. Some other decay phenomena, such as plants overgrown and efflorescence, are evident, but in this case they do not seem to have played a primary role in damaging the structure. For this reason, mainly primary causes have been investigated in assessing the reliability of the structure.

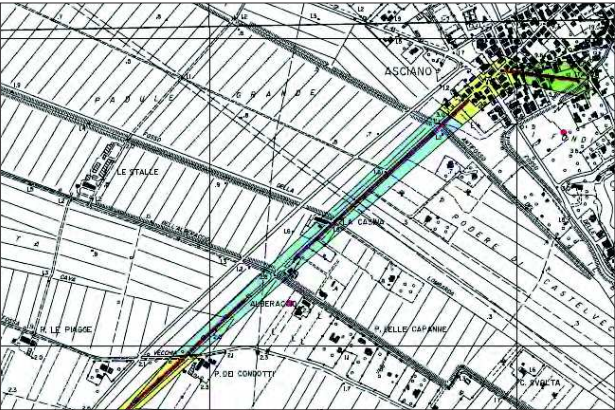
Figure 45.a Geographical framework–upstream

The “yellow” areas in Figure 45 mainly consist of outcropping recent silty – sandy alluvial deposits. On the other hand, the “blue” areas mainly consist of clay or peat clay.

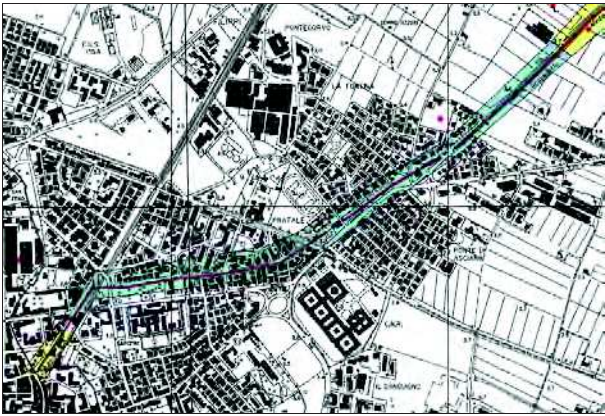
Figure 45.c Geographical framework – downstream section

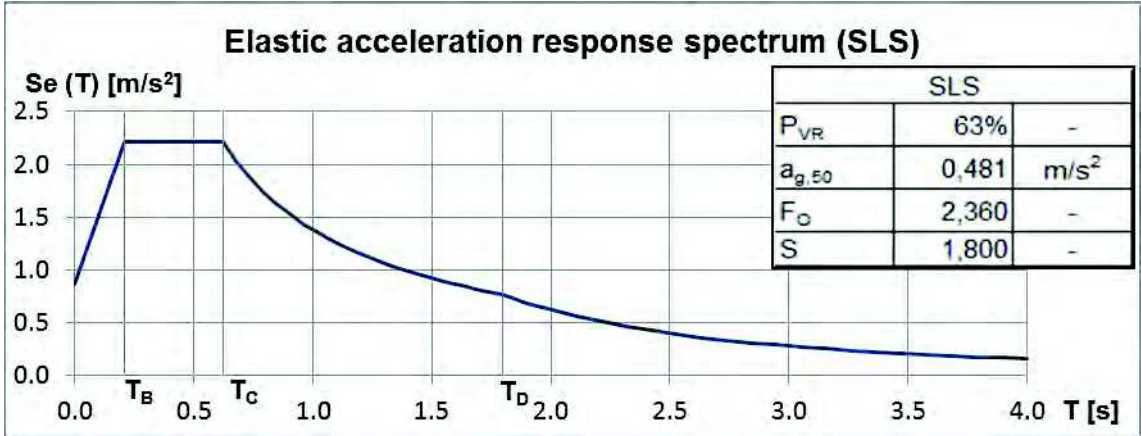
Figure 47 Elastic response spectrum of the horizontal component of the acceleration at SLS

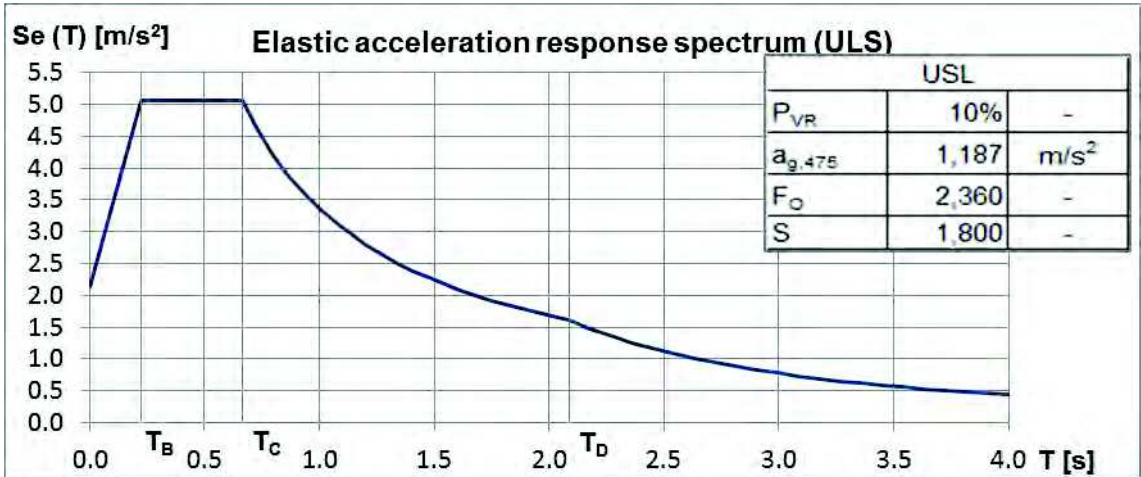
Figure 48 Elastic response spectrum of the horizontal component of the acceleration at ULS

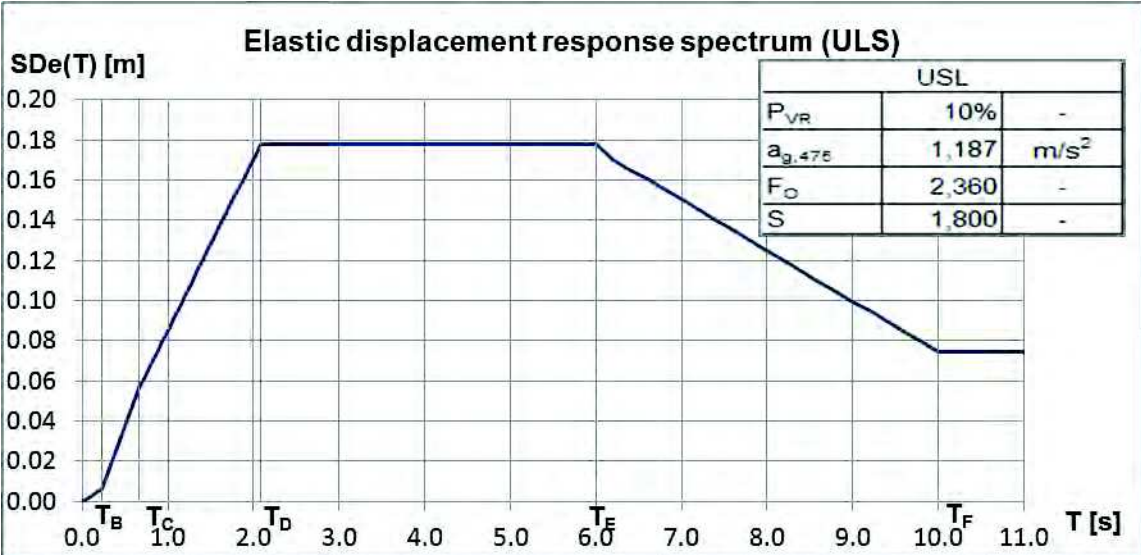
Figure 49. Elastic response spectrum of the horizontal component of the displacement at ULS

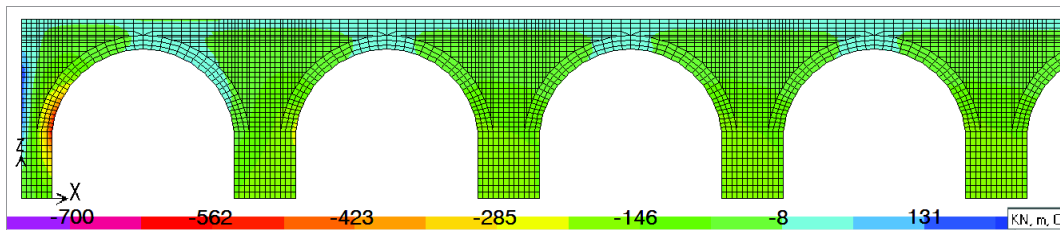
Figure 51 Level of stress, on the shells positive face, along Z direction, in self-weight condition (values expressed in kN/m^2)

On the same model, vertical settlement of foundation and out of plane rotation of the pillar's foot were imposed alternately on different pillars, to evaluate how the level of stress evolves, on varying of assigned actions: the vertical settlement was applied with an increase of 10 mm at a time, from 0 mm to 40 mm, and the out of plane rotation was applied with an increase of 1° at a time, from 0° to 4° . In fig. 52 the level of stress associated to self-weight and a vertical settlement of 30 mm is shown; in fig. 53, it is shown the level of stress associated to self-weight and an out-of-plane rotation of 4° applied to the pillar's foot.

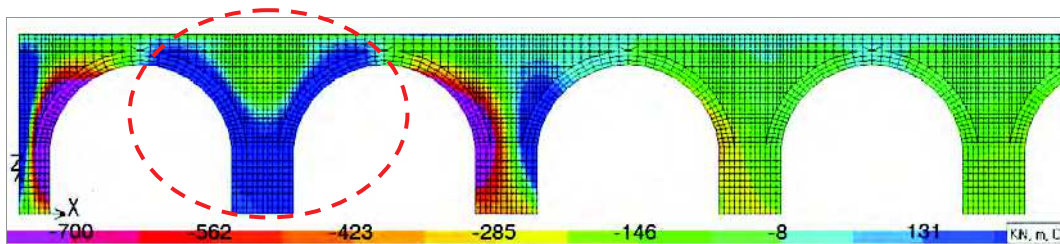
Figure 52 Level of stress, on the shells positive face, along Z direction, self-weight + vertical settlement of 30 mm applied at the foot of the highlighted pillar (values expressed in kN/m^2)

The pattern of stress shown in fig. 52, suggests that, when settlement of foundation occurs, a horizontal cross crack forms in the pillar, and a new mechanism may establish, formed by an arch which includes the two pillars adjacent to the one affected by settlement (fig. 54).

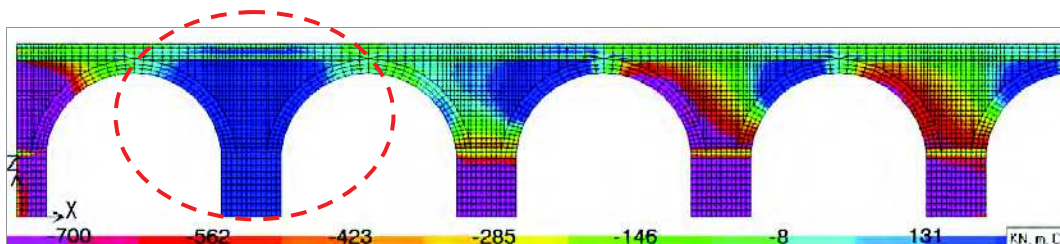
Figure 53 Level of stress, on the shells positive face, along Z direction, self-weight + out-of-plane rotation of 4° applied at the foot of the highlighted pillar (values expressed in kN/m^2)

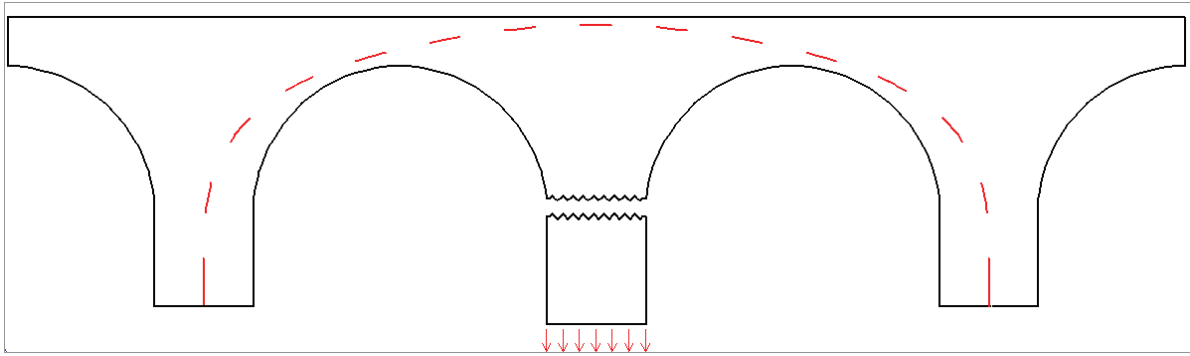
Figure 54 Probable formation of a new mechanism due to the vertical settlement of a pillar

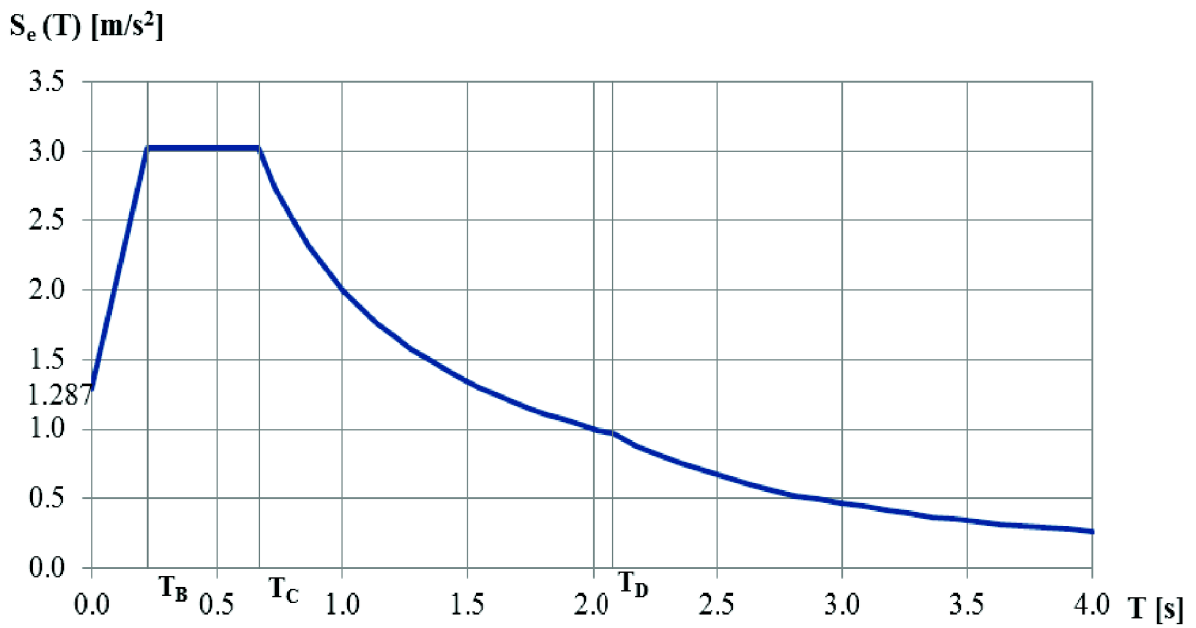
Figure 58 Reduced acceleration response spectrum

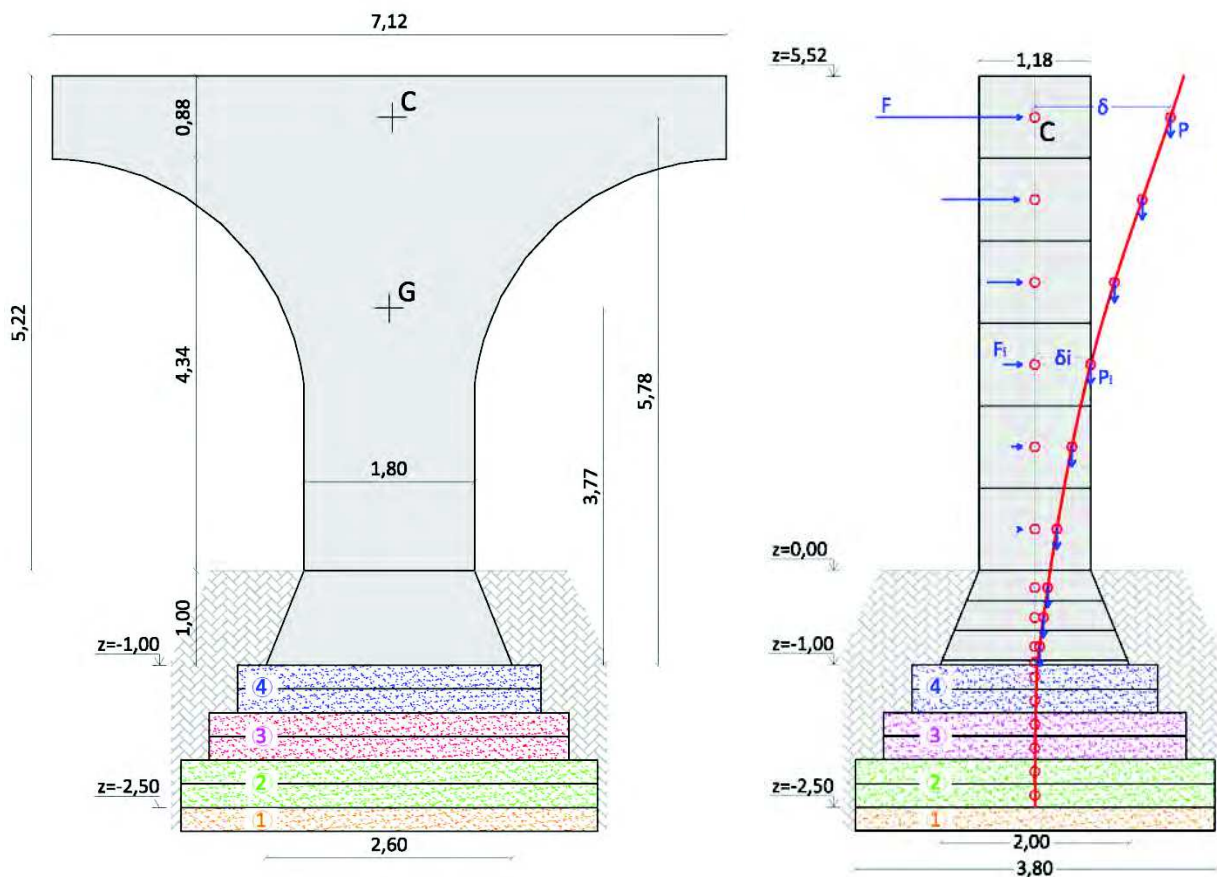
Figure 59 The system element+foundation+soil, modelled as a series of overlapped layers

The geometric characteristics of the system are illustrated in fig. 59. The element and the foundation are subdivided in layers, whose mechanical properties are those indicated in table 6 and illustrated in fig. 60; the soil interacting with the element is modelled by layers of elasto-plastic material, 50 cm thick and with horizontal dimensions increasing with depth; the mechanical characteristics of the layers change with the depth, as indicated in fig. 61, taking properly into account the over-consolidation effect.

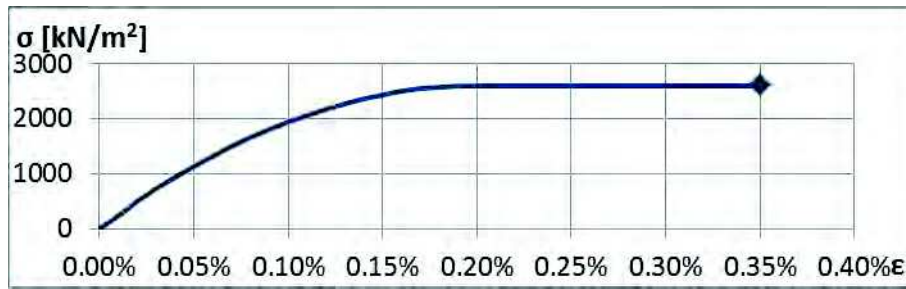
Figure 60 Stress-deformation diagram for masonry

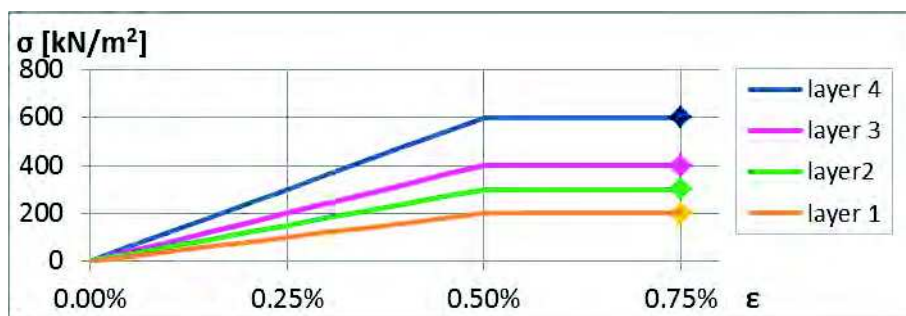
Figure 61 Stress-deformation diagrams for the 4 layers of soil at different depths

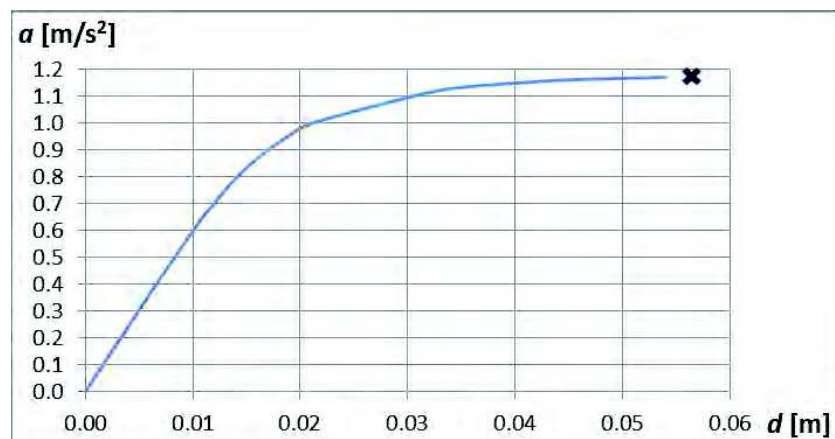
Figure 62 Capacity curve

It can be noted that the seismic vulnerability evaluated taking into account the behaviour of the soil and the second order effect is slightly lower than that in the hypothesis of linear behaviour.

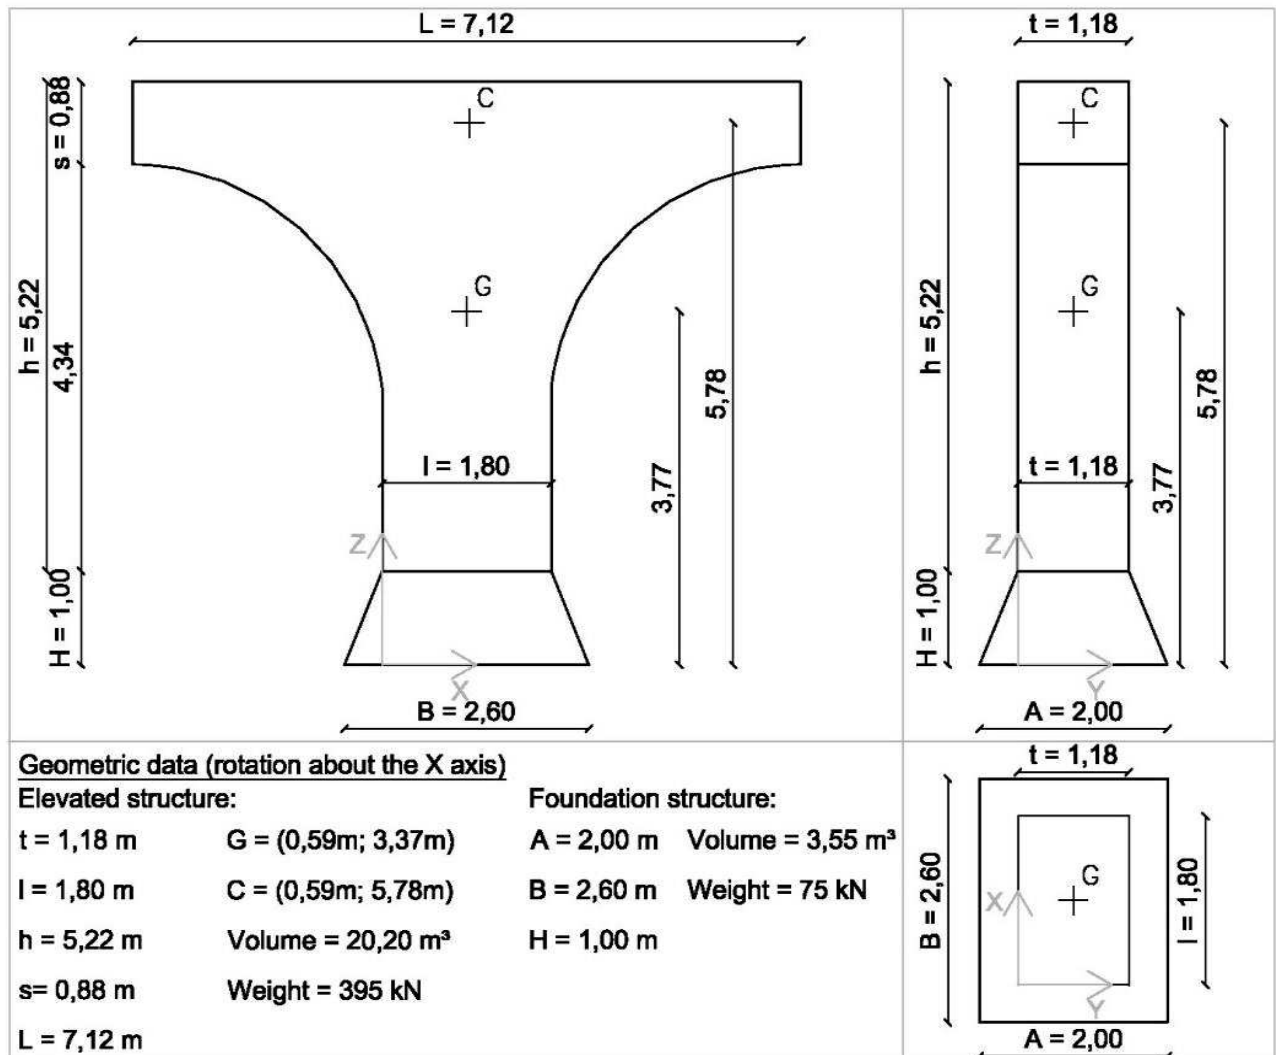
Figure 64 Kinematic Analysis – geometric properties of the macro-element

- case A) macro-element in situation 1), i.e. isolated, subjected to the self-weight and to lateral forces simulating the seismic actions, rotating as a rigid body around a cylindrical hinge placed at the edge of the pillar's base; also the cases of macro-element initially rotated by 5° or 9° have been studied;
- case B) evaluation of the stabilizing forces acting in situation 2);
- case C) macro-element in situation 2), subjected to the self-weight, to lateral forces simulating the seismic actions and to the stabilizing actions (from case B), rotating as a rigid body around a cylindrical hinge placed at the edge of the pillar's base.

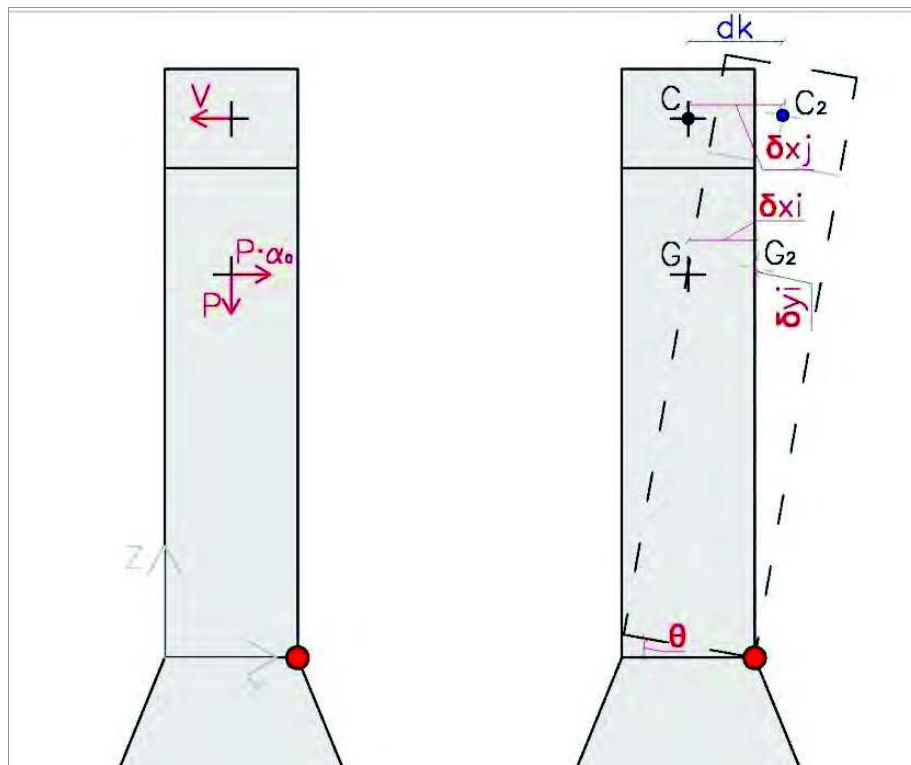
Figure 65 Macro-element as a single degree of freedom body

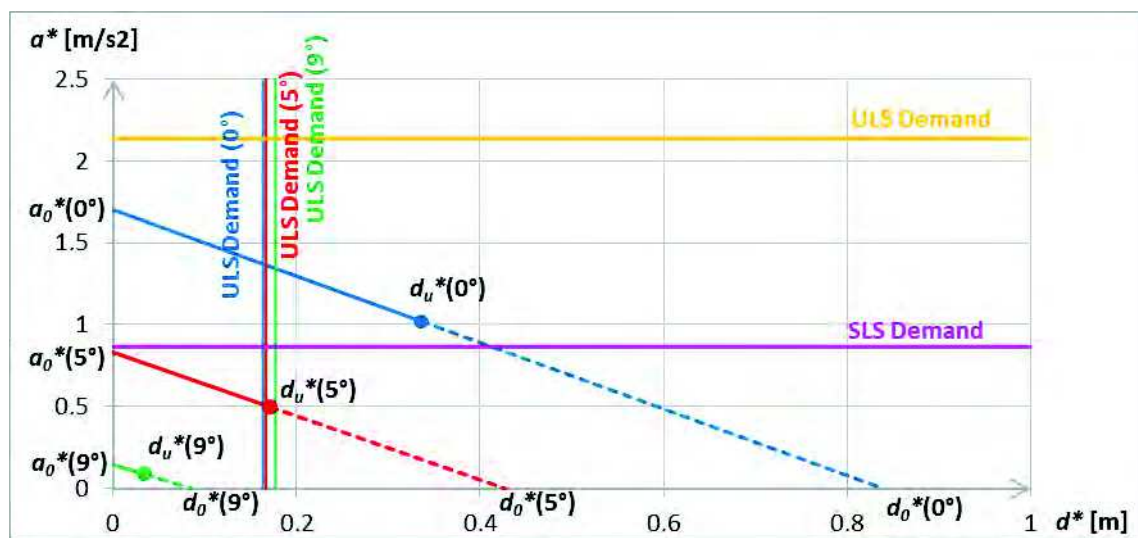
Figure 66 a^* - d^* capacity curves ($\varphi=0^\circ, 5^\circ, 9^\circ$) compared with demand values

CAPACITY			DEMAND				VERIFICATION ULS	
φ	d_0^* [m]	θ_{max} [°]	d_u^* [m]	d_s^* [m]	a_s^* [m/s ²]	T_s [s]	$S_{De}(T_s)$ [m]	$d_u^* > S_{De}$
0°	0,839		0,336	0,134	1,430	1,925	0,164	YES
5°	0,427	10°	0,171	0,068	0,698	1,964	0,167	YES
9°	0,086		0,034	0,014	0,121	2,110	0,177	NO

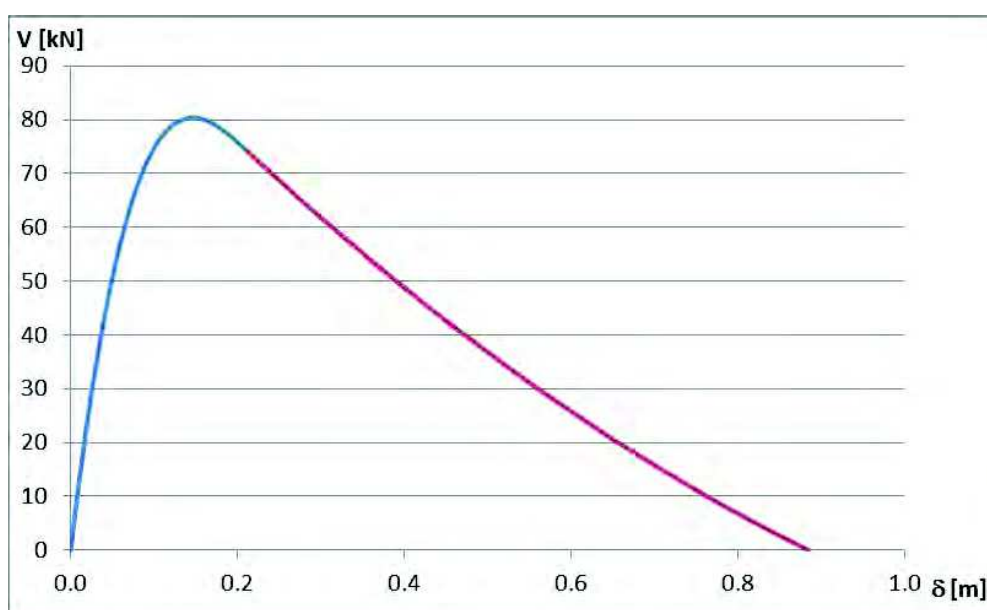
Figure 67 Diagram of V as a function of δ

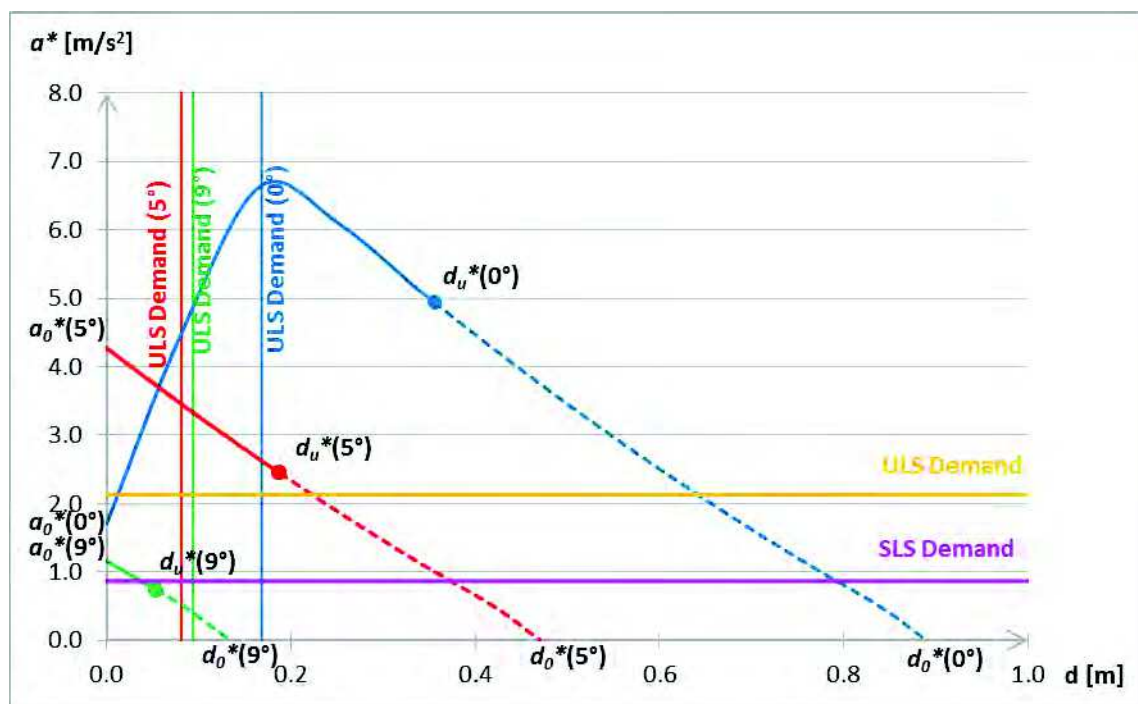
Figure 68 a^* - d^* capacity curves ($\varphi=0^\circ, 5^\circ, 9^\circ$) compared with demand values

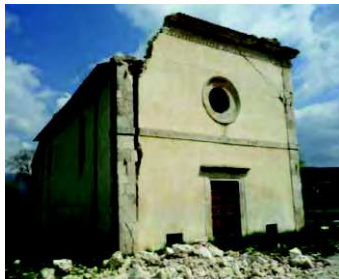
Figure D.1 Overturned tympanum and cracks indicating incipient overturning of the building facade

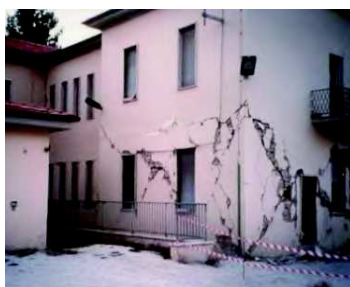
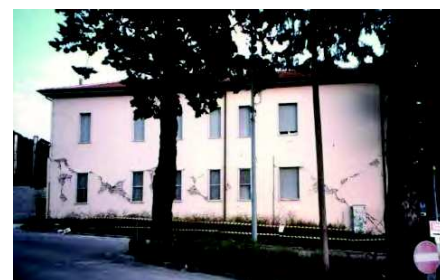
Figure D.3 Diagonal shear cracks in a masonry wall

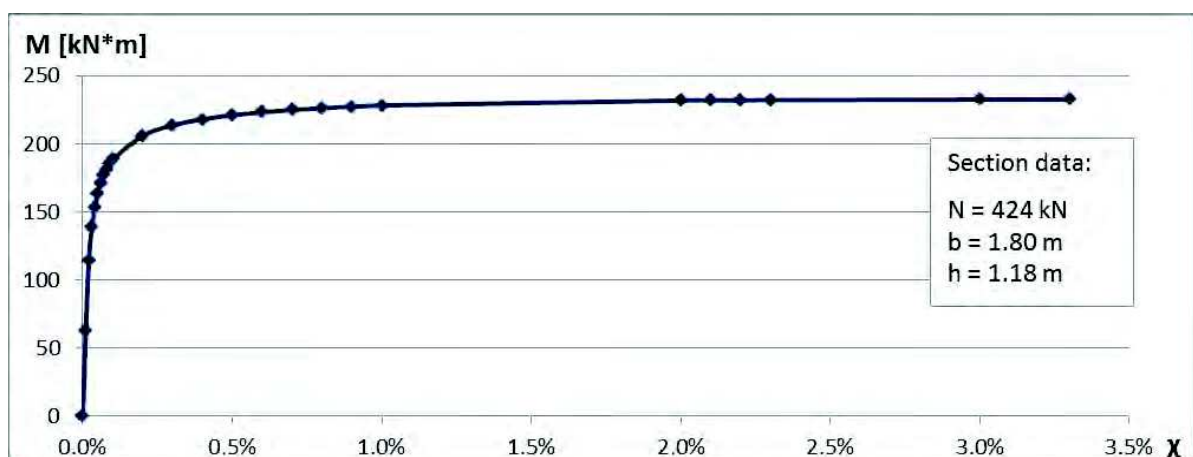
Figure E.1 Moment-curvature diagram corresponding to masonry section n°10

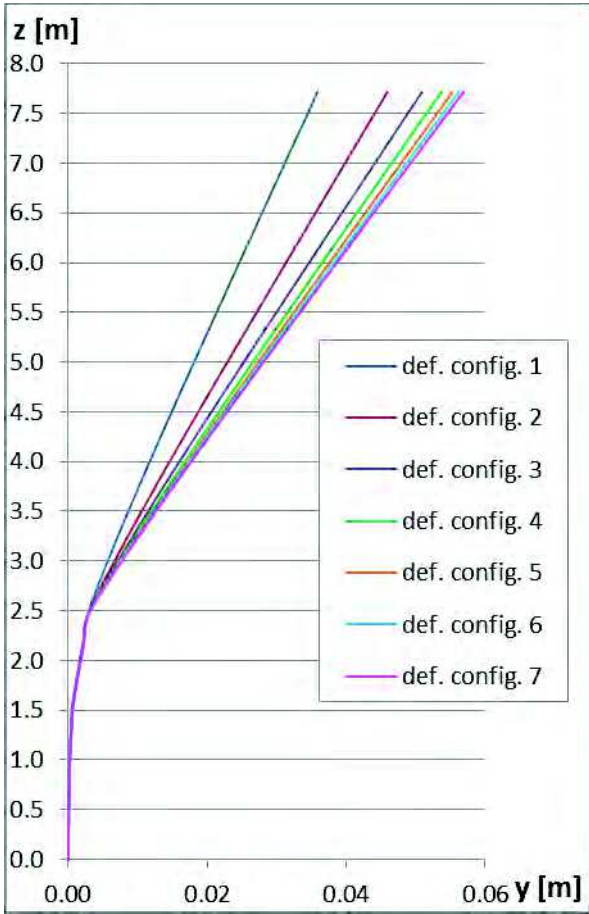
Figure E.2 Deformed configurations at each step for $a = 1,17 \text{ m/s}^2$

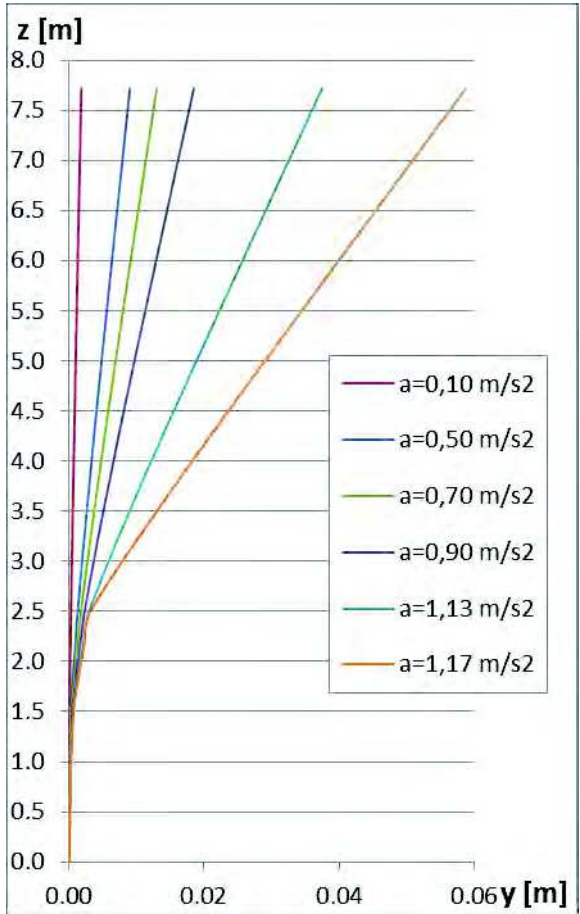
Figure E.3 Final deformed configurations corresponding to different values of a

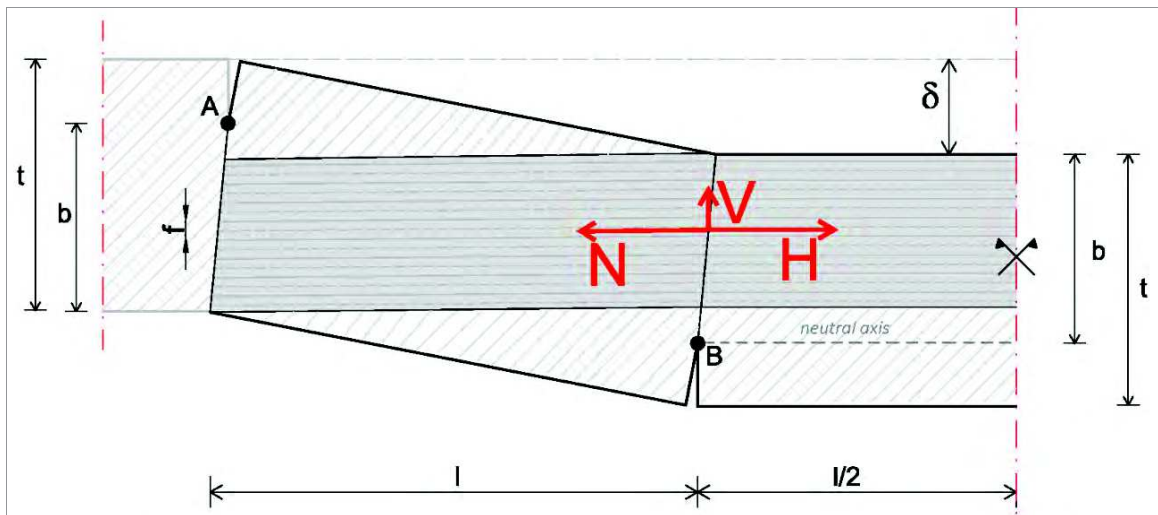
Figure F.1 The arch mechanism
