CHAPTER 9: AQUEDUCTS – A CASE STUDY

Pietro Croce¹, Maria Luisa Beconcini¹, Martina Muzzi¹, Elisa Rosso¹, Francesca Marsili¹

¹Department of Civil and Industrial Engineering – Structural Division – Univ. of Pisa, Italy

The Medicean Aqueduct of Pisa (Tuscany, Italy), is a relevant historical infrastructure built at the end of the XVI century, composed of 954 masonry arches over a total length of 6 km. Many of the arches are affected with several decay phenomena, which occurred during the years. These have changed the original static arrangement, so that several arches are collapsed or degraded.

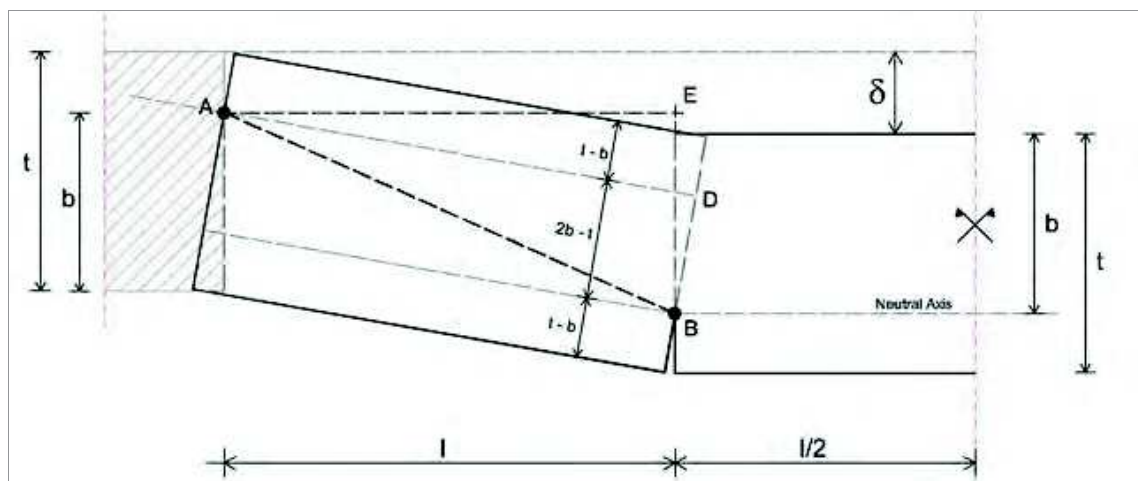
Figure F.2 The arch mechanism
