Evaluation of structural safety and seismic vulnerability of historical masonry buildings: studies and applications in the Tuscany Region

S. Caprili, F. Mangini & W. Salvatore

Department of Civil and Industrial Engineering, University of Pisa, Italy

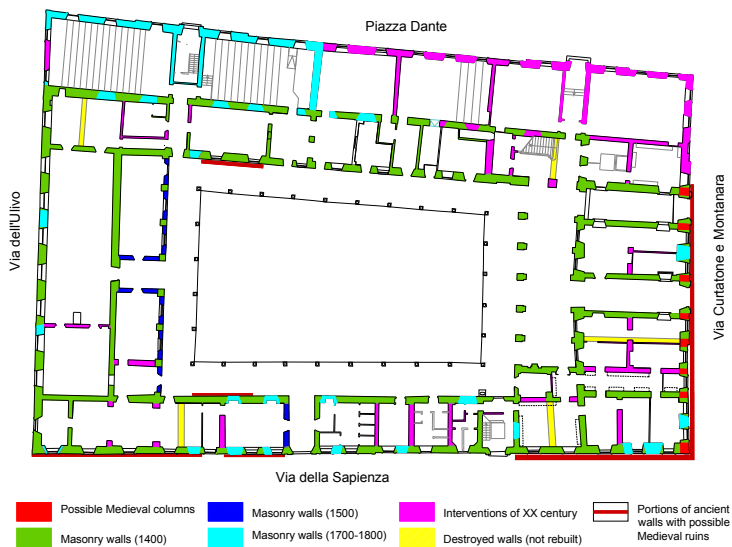
Figure 3: Evolutive development of Palazzo La Sapienza (ground floor).

with different profiles) are present; the useful height of the ground floor varies from 4.30 m to 5.50 m. The situations are similar on the first and second floors, where the maximum heights attained are respectively equal to 5.60 m and 5.20 m. Figure 3 shows the ground floor of the building with the indication of the construction period of the different portions.

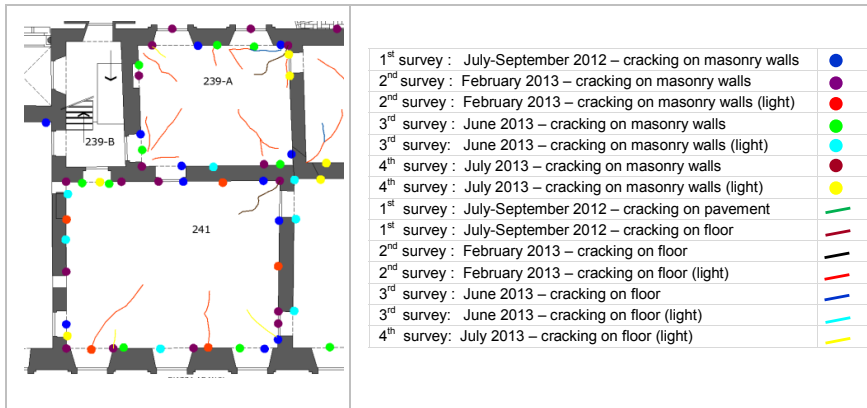
Figure 9: Example of the evolution of the cracking scenario in Palazzo Ducale during the period July 2012–July 2013.

Similar investigations were executed in correspondence of the masonry walls and vaulted surfaces of Palazzo Ducale. The cracking scenario affecting the historical building was revealed just from its constructions, due to the progressive enlargement of the structure itself. In recent years, the building suffered the consequences of the Emilia-Romagna earthquake (5.8 and 5.9 Richter, respectively in the dates 20.05.2012 and 29.05.2012), that was the cause of the beginning of vulnerability assessment and analysis of the actual state of the palace. The first cracking survey was executed in the period between July and September 2012, while four additional campaigns were executed until July 2013, after the earthquake that stroke the near region of Lunigiana (4.4 Richter, 13.06.2013). The results of the survey of the evolution of the in situ cracking scenario, in the period July 2012–July 2013, is simply represented in the Figure 9 for one of the main

rooms of the ground floor of the building. The analysis of the cracking scenario allowed the individuation of the most critical portions of the Palace, and the following organization of monitoring and local repair measures.
