APPLICATIONS OF THE INFRARED THERMOGRAPHY TO THE ASSESSMENT OF HISTORIC BUILDINGS: A CASE STUDY IN PISA

Franchetti Palace in Pisa

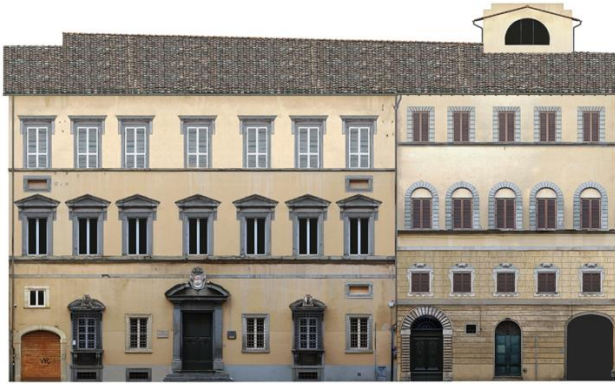
Fig. 2. The facade on via San Martino.
