2 The “Triple R” approach on the restoration of 3 archaeological dry stone city walls: procedures and 4 application to a UNESCO World Heritage site in 5 Southern Arabia.

6
7 Mauro Sassu^{1,*}, Juris Zarins² Linda Giresini¹ and Lynne Newton³

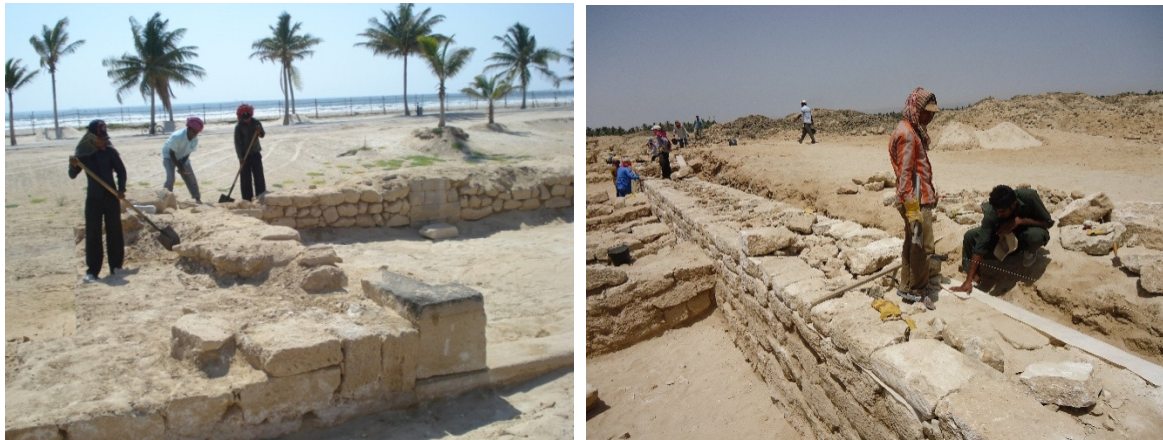
Figure 2- Cleaning (left) and laying geotextile (right).

129 b. Placement of a geotextile layer on the base of the reconstruction zone. This separated the
130 reconstructed part from the original wall (Fig. 2).

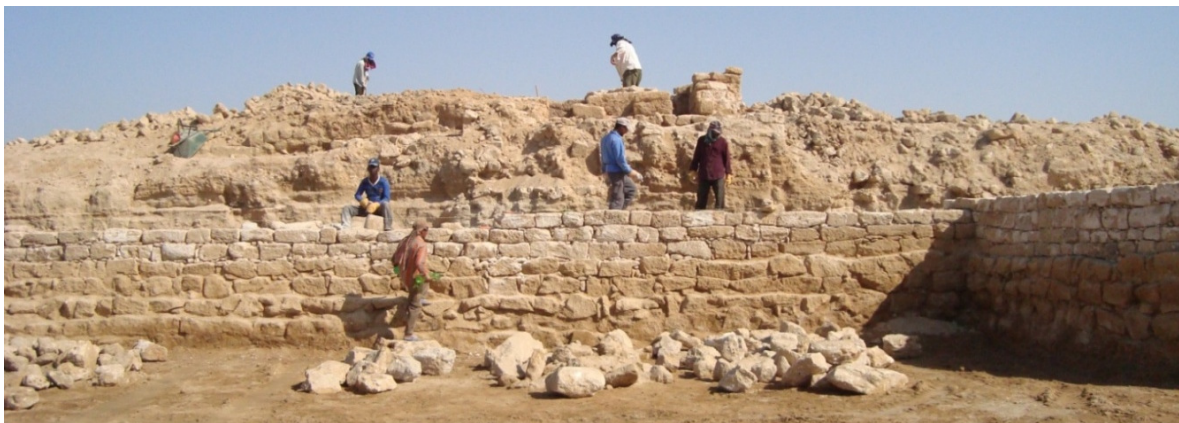
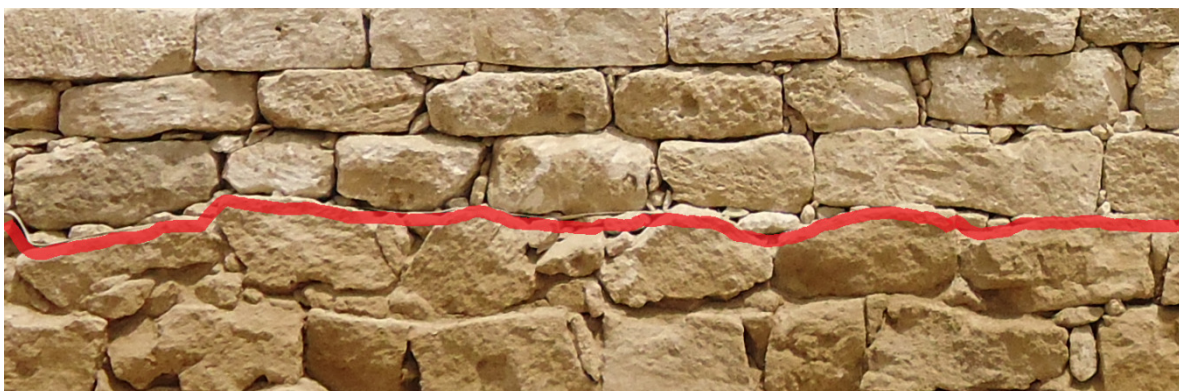
151 Figure 3. Piece-by-piece reconstruction phases: (upper) works in progress, (lower) wall textures with
 152 indication of the geotextile (original-under the line, reconstructed-over the line).
 153

131 c. Selection of useful piece-by-piece blocks, in terms of color and shape, from the existing
132 blocks to use for various reconstruction activities (Fig. 3).

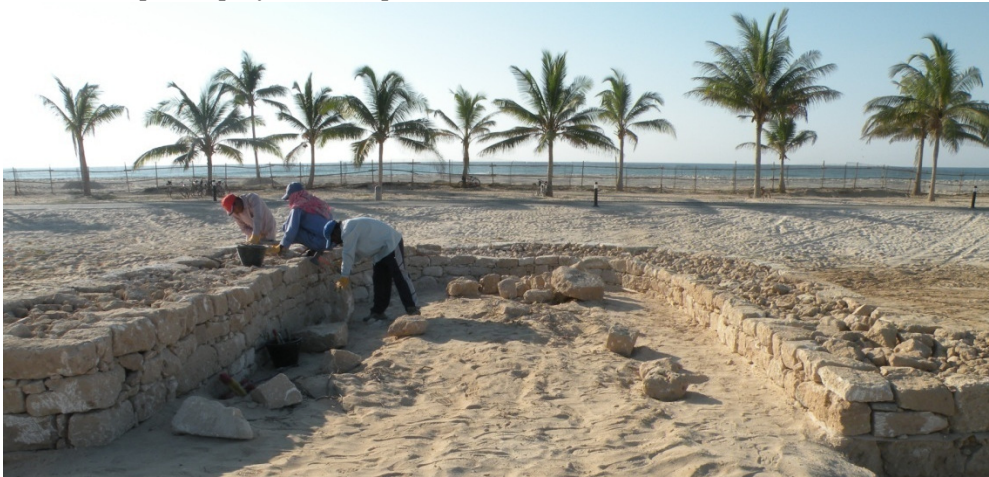
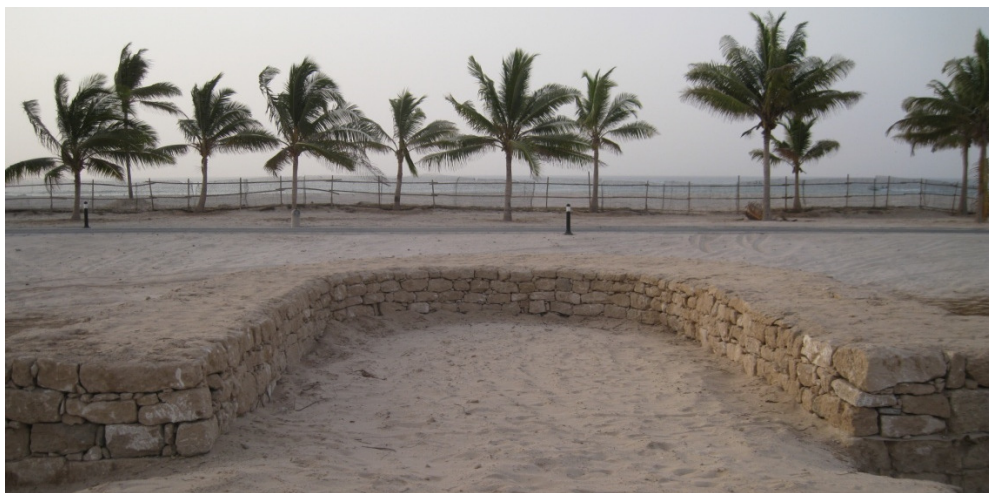
178 Figure 4 - Bastion before (upper) and after (lower) completion.

161 After achieving a sufficient height of the walls from an aesthetic point of view, it was deemed
 162 necessary to cover the top of the rebuilt walls using a reversible and recognizable technique. The soil
 163 excavated around the walls is characterized by a mix design of clay, lime and sand: when water is
 164 added, it reaches an acceptable cohesion to sustain wind erosion. It was then decided to use the
 165 adjacent soil to arrange a cover on top of the walls. The constructive phases were as follows (Fig. 4):

- 166 a. uniform manual application of a layer of the soil matrix;
- 167 b. compaction of the layer by spraying water with low pressure;
- 168 c. cleaning of any ground spills by manually brushing the stone surfaces.

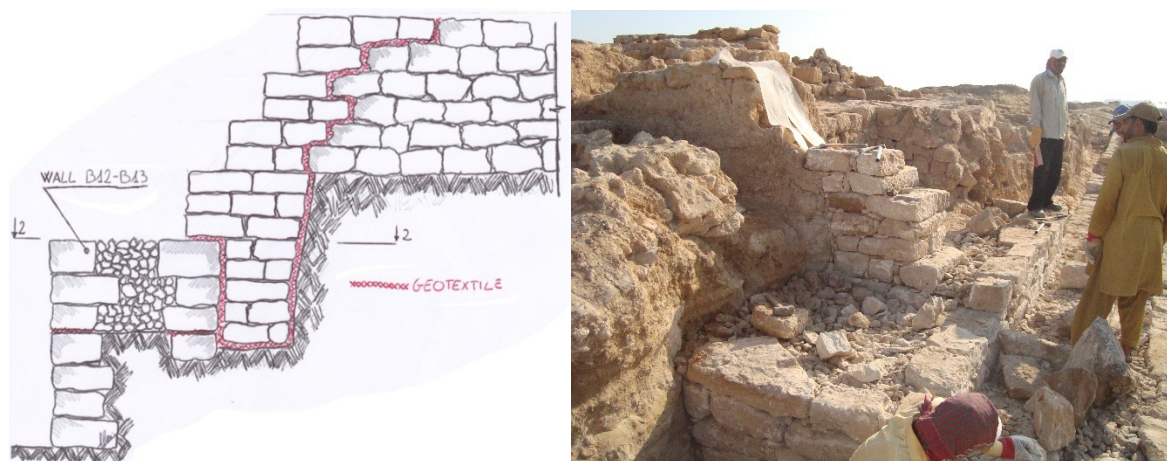
Figure 5 - New buttresses to sustain the building behind city walls

- 205 1 – Regularization of the trench behind the wall and use of geotextile.
 206 2 – Filling the trench with small stones up to the level of the newly rebuilt and constructed wall
 207 foundations.
 208 3 – Construction of support walls in front of any areas with higher soil levels.
 209 4 – Construction of barriers to support old walls,
 210
 211

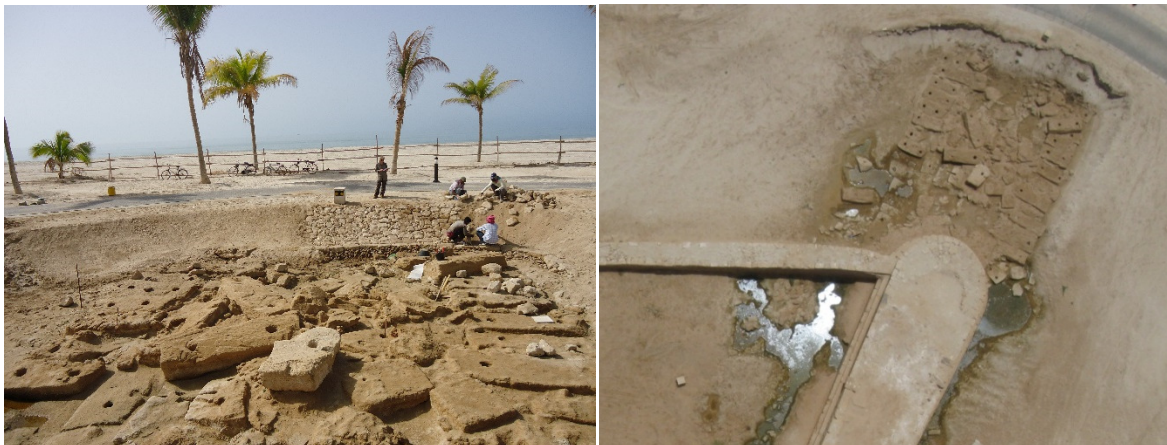
Figure 6 - Construction of the protective slope.

229
 230 In front of the eastern breakwater the excavations brought to light large rectangular stone
 231 blocks, each pierced with couple of holes, likely supported wooden posts for a deck. Accordingly, it
 232 was decided to use only stone and sand available at the site; the consolidation steps were (Fig.6):

- 233
 234 1. construction of the semicircular base layer with large stone blocks (height about 40 cm)
 235 2. cleaning of the slope by removing loose small stones by hand
 236 3. positioning medium size and flat stones over the ground compacted with dark sand and water
 237 leveling of the slope manually
 238 4. superficial covering of the stone blocks with white sand to reach the desired aesthetic result.
 239

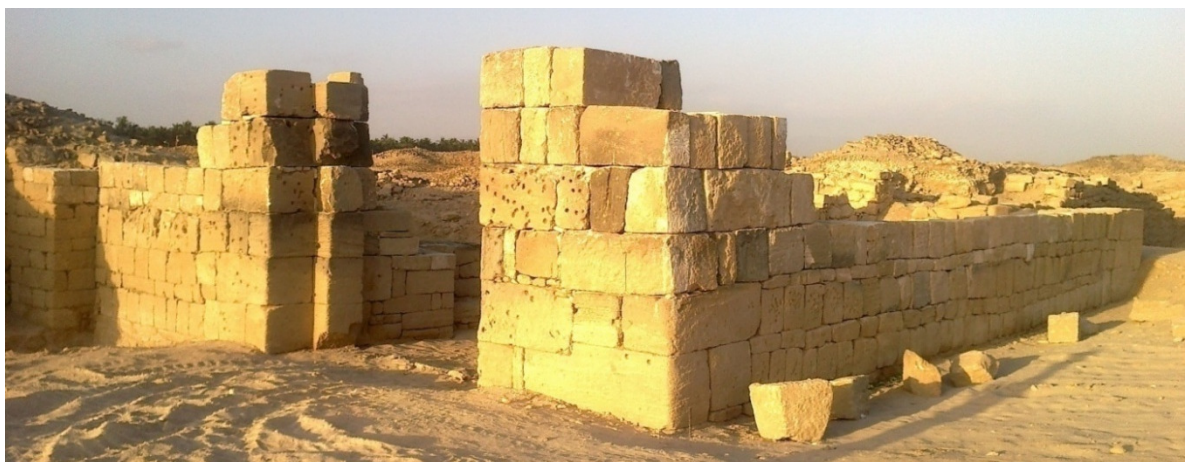
Figure 7 - Sketch of the "stone puzzle" and the main gate after restoration

268 Particular interest was dedicated to gate n.5. It probably represents the Main Gate to the city
269 (Fig.7). It is located on the south-western side and connects the waterfront to a street that runs
270 directly to the Citadel and the Great Mosque. The analysis of shape and dimensions of the stones of
271 the entire gate revealed some errors in previous restoration attempts (Fig.8). Once rectified, these
272 incorrectly placed stone blocks were then put in their proper position.

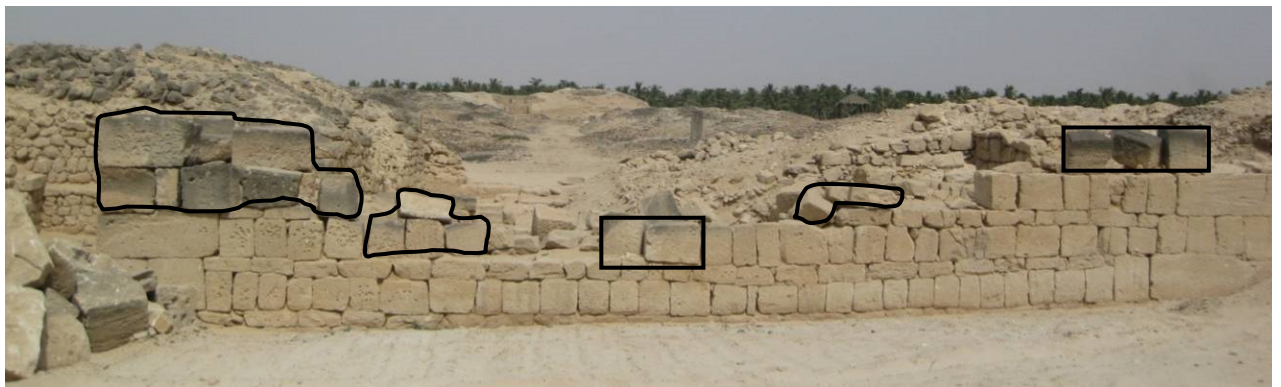
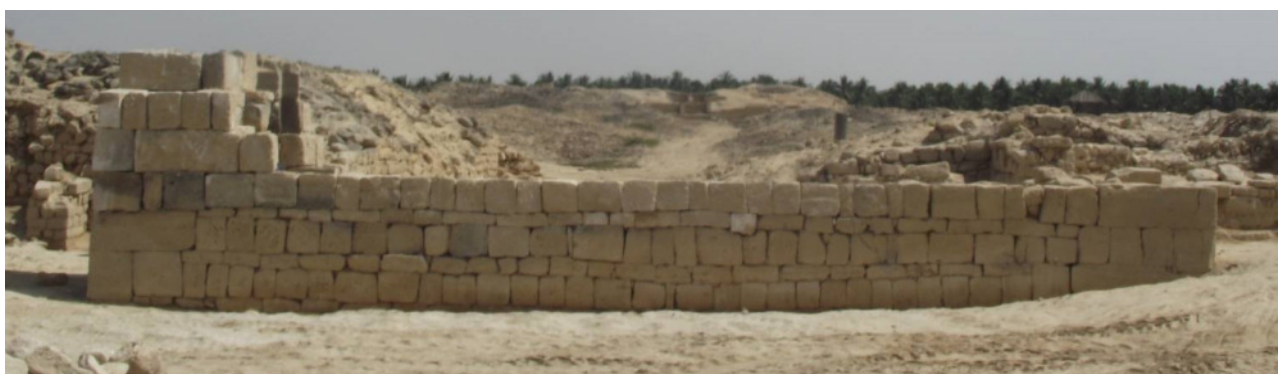
257 Figure 8 -The Main Gate with stones incorrectly placed before (upper) and after restoration (lower).

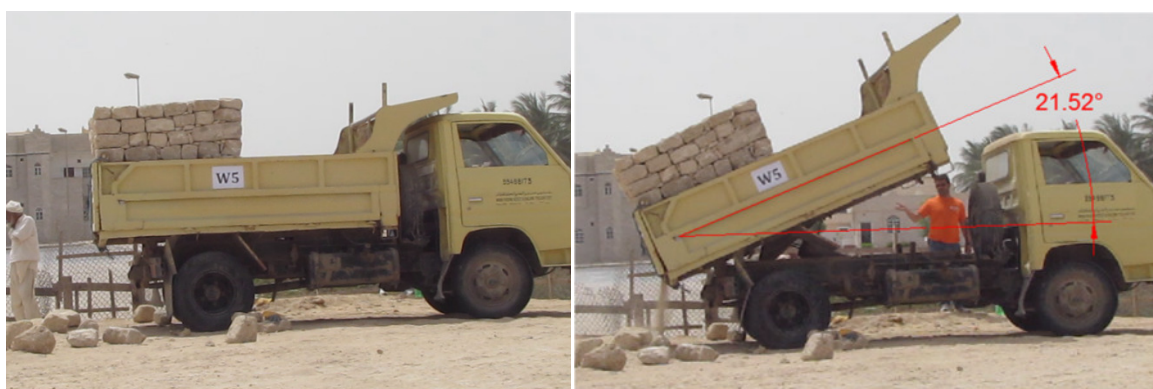
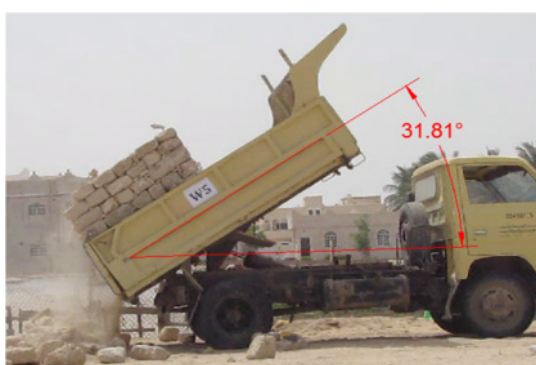
Start of test (a)

Tilt failure (b)

Sliding failure (c)

Figure 9 -On site mechanical tests.

281 Five dry masonry specimens were prepared on the hydraulic lift bed of a small truck to
282 measure the angle of failure due to the sliding self-weight. The specimens replied the transverse
283 section of the reconstructed walls; their dimensions were: 1.30m (the typical width of the southern
284 city wall) x 2.00m (the width of the utilized hydraulic bed of the truck) x 0.40-0,90 (from the top of
285 the truck bed edge) as illustrated in Fig.9.

286 Out-of-plane rocking and sliding mechanisms were then observed and the maximum angles,
287 corresponding to each step of the failure, were recorded. Two different collapse mechanisms were
288 observed: the first is the rocking of irregular stones, mainly in the center of the testing procedure
289 blocks, corresponding to the internal filling of the city walls. This mechanism was activated at an
290 angle of about 12° with a truck load composed of irregular stones (spec.W1) and 22°-23° in case of
291 medium regular stones (spec.W2-W3-W4-W5).

292 The second mechanism is the sliding movement of regular stones, mainly on the external layers
293 of walls. It is related to the friction coefficient of the surface of walls, with collapse angles of about
294 28°-38°, depending on the presence of transverse connections (spec.W3-W4) and the height of the
295 wall (W2). This section may be divided by subheadings. Authors should discuss the results and how
296 they can be interpreted in perspective of previous studies and of the working hypotheses. The
297 findings and their implications should be discussed in the broadest context possible. Future research
298 directions may also be highlighted.

299 Using a design value of 22° for the friction angle, a Mohr Coulomb friction coefficient of $\varphi = \text{tg}$
300 $22^\circ = 0,40$ can be deduced, corresponding to the standard value adopted for masonry structures.
301 Considering the diagrams reported in fig.21 (Sassuet *al*, 2012), a maximum free height for dry stone
302 walls of about 2,8-3,1 meters is the maximum range for a safe one-side excavation. This limit value
303 has been adopted by archaeologists to determine the maximum differential height of the
304 slope/embankment during excavations near the walls. It permitted a convenient safety level for
305 workers and researchers involved in the nearby archaeological excavations.

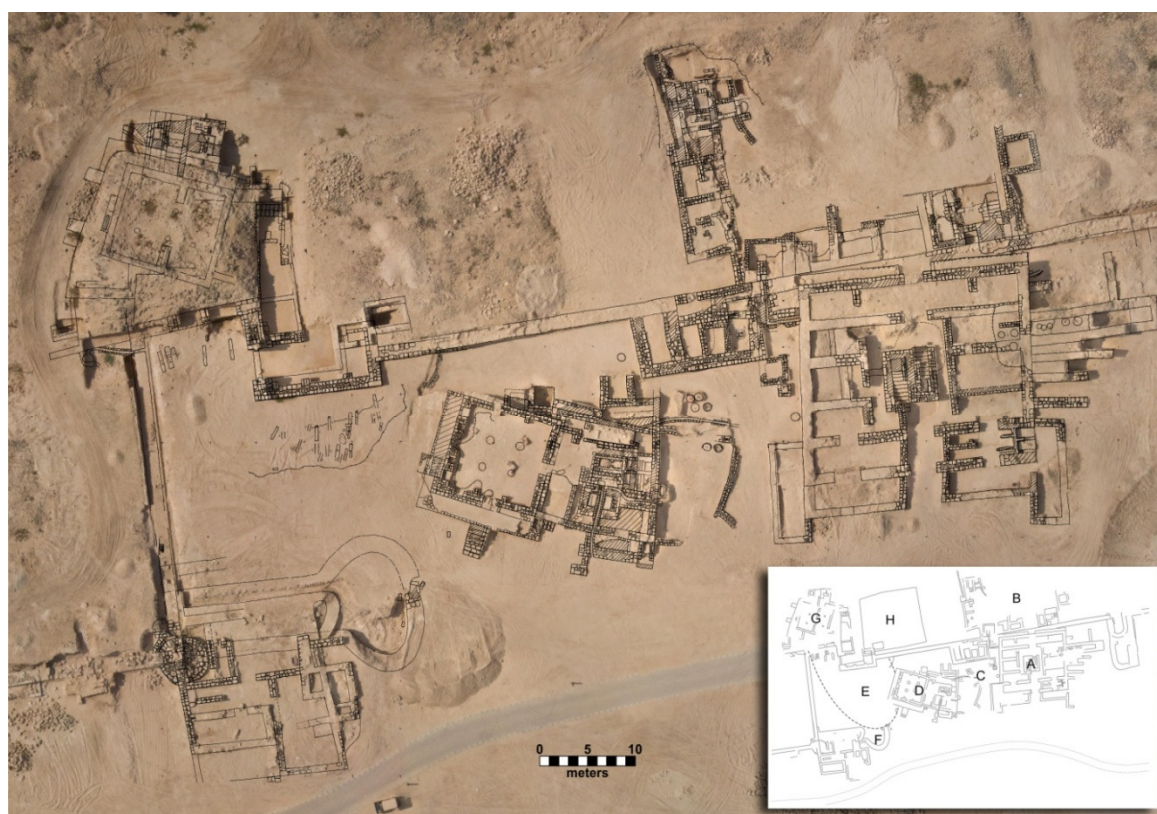
350 Figure 10. The Southwest Corner Complex of al-Baleed (insert) and the Specific Areas. (W.
 351 Isenberger, Digital Mapping and Graphics).
 352

336 To the north of the trapezoidal building, approached by a formal northern gate over the old city
 337 wall, a large rectangular basin well bonded in lime plaster represents a large water feature (Fig. 10B).
 338 With basins, walls, and drains, it may also be similar to Hindu temple water features found in
 339 temple complexes in India (Newton & Zarins, 2014:263; and Fig.2). To the west of the trapezoidal
 340 building a series of large amphorae were found perhaps associated with a nearby drain system
 341 attached to a local mosque (Fig. 10C). These large amphorae were probably part of maritime
 342 shipping and found principally on ocean-going ships. Many are hole mouth vessels with or without
 343 handles. Primarily red in color, they are paddle stamped, some with graffiti and markings on the
 344 shoulder(Newton & Zarins, 2014:263; and Fig.6). Similar amphorae have been found throughout
 345 the Northern Indian Ocean in an early 2nd millennium CE context. Inside one of the amphorae was

353 To the west of the amphora area a unique cemetery was located and defined by the interment of
 354 single bodies in slab lined graves (Fig. 10E) (Newton & Zarins, 2014:265-266; and Figs.8-9). They had
 355 been placed in the area after the abandonment of the southwest gate, sometime in the 12-13th
 356 century CE(see above).

357 Finally, a new stone jetty was uncovered in 2012 (Fig. 10F). It projected east from the earlier city
 358 wall contrary to all other jetties and piers described above. It appears to have been associated with
 359 an earlier city phase in which the jetty and city wall served as a small offloading pool in which goods
 360 were taken to the storehouses(Fig. 10G) and the Sultan's residence (*husn*) via the formal south main
 361 gate (Newton & Zarins, 2014:257-258; and Fig.2). This jetty was cut into by the later cist grave
 362 cemetery which in total numbered perhaps over 50 burials (Newton & Zarins, 2014:265-266; and Figs.
 363 8-9). Ongoing analysis through diet studies with Strontium isotopes etc. suggests the interments are
