TYOLOGICAL CHARACTERIZATION OF ANCIENT TOWN WALLS FOR DISASTER PREVENTION AND MITIGATION: THE MO.M.U. PROJECT

ANNA DE FALCO¹, FRANCESCA GIULIANI^{1*}, DANIELA LADIANA², LEDIANA
RJOLLI¹, DAVIDE BORDO¹, FRANCESCA GAGLIO¹ AND MICHELE DI SIVO¹

Keywords: Town Walls, Masonry Structures, Risk Prioritisation, Heritage Conservation.

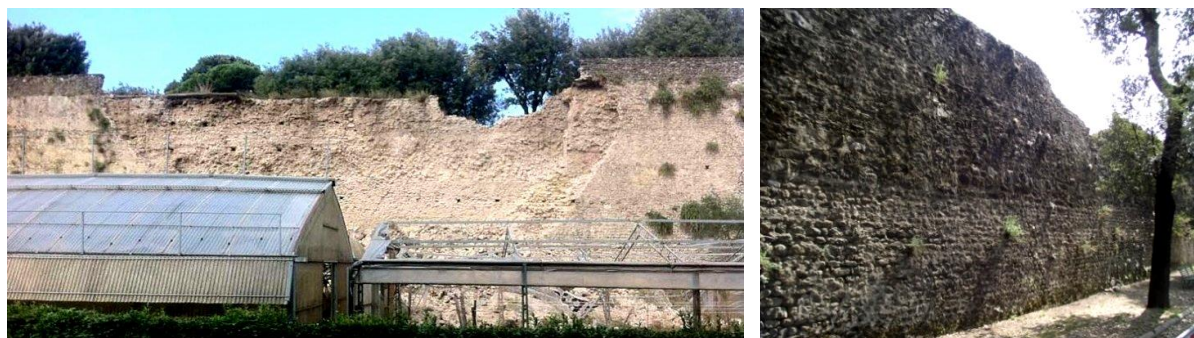
Figure 1: Collapse of the city walls of Pistoia (September 19, 2011). On the left: the failure seen from the outer side; on the right: the failure seen from the city centre.

Pistoia is an important city that still shows traces of its Gallic, Ligurian, Etruscan and Roman past. On September 19, 2011, a portion of about 25 meters of medieval town walls outwardly collapsed. The curtain wall facing the city centre remained standing and the outer layer crumbled (Fig. 1). The consequence did not result in deaths or injuries, but debris fell on some greenhouses, causing economic losses to agricultural activities. The collapse was triggered by heavy rain in an already critical situation. The main factors influencing the

collapse were the wall slenderness, its height, the difference between the floor levels on the two sides of the wall and the poor quality of the masonry. Walls are made of river pebbles and are weakened by texture irregularity, traces of poorly chosen interventions and lack of maintenance [7]. In September 2020, the same curtain completely collapsed for a length of 30 m. In this case, no extreme climatic events preceded the disaster.

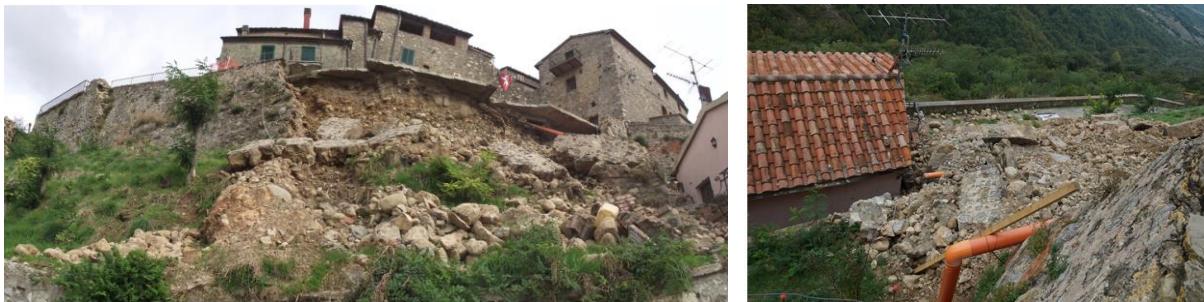
Figure 3: Collapse of the city walls in Cana di Roccalbegna (October 5, 2013). On the left: the collapse seen from below; on the right: the debris near the building below the wall.

On October 5, 2013 about 13 meters of town walls collapsed during a heavy rainfall in an ancient small town, Cana di Roccalbegna (Fig. 3). The system was made of a stone masonry retaining wall dating back to the XV century, surmounted by a reinforced concrete slab which formed the base of a panoramic viewpoint square. The masonry was inhomogeneous in terms

of material and construction techniques. The failure was caused by the erosion due to incorrect water drainage and increase of hydrostatic pressure behind the wall during the heavy rainfall event. The rubble reached a building, which fortunately was only hit by minute debris, and the street below, where a parked car was buried. On 21 August 2020 the reinforced concrete slab suddenly broke during the execution of the consolidation works. Four houses have been evacuated and a part of the village has become inaccessible due to debris.

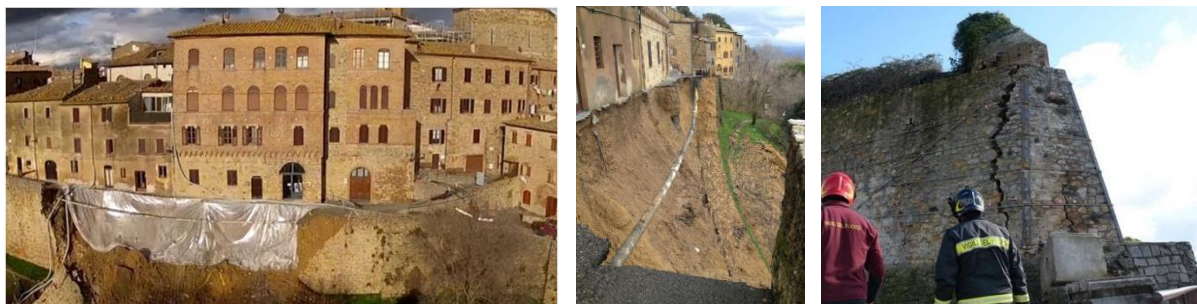
Figure 4: The collapse of the city walls of Volterra (January 31, 2014).

On January 31, 2014 about 35 meters of the town walls in the south-western side of Volterra suddenly collapsed, after a series of heavy rainfall events. Volterra is a walled hilltop town in Tuscany, one of the most important Etruscan settlements, successively developed as a medieval centre. The failure involved a 9.5 m high segment of a stone masonry retaining wall that embraces the city centre, laying bare the foundations of the historical masonry buildings above (Fig. 4). Luckily, there were no casualties, but the buildings located at a distance of a few meters from the wall were slightly damaged. The main causes of the collapse are the incoherent sandy terrain behind the curtain wall weakened by previous repeated water infiltrations due to the old sewer system of the historic centre, and the water from the heavy rains of January, which increased the hydrostatic pressure on the curtain [8]. Added to this is the intrinsic weakness of the masonry of the collapsed portion, due to the significant and repeated restorations during time, from the middle age up to now. On March 3, 2014 another
