# Macroseismic risk classification of historical constructions: the LEXSIS approach

The present paper deals with the elaboration of a methodology to assess the macro-seismic risk of monumental historical buildings, representing a fundamental part of the European cultural assets. Monumental buildings typically arise from a very complex constructive and morphological evolution process characterised by modifications occurred over the centuries. Therefore, they are usually heterogeneous buildings similar to 'structural aggregates' rather than single constructions and characterised by a structural behaviour depending on the mutual interaction of different structural units. An accurate knowledge process can allow the determination of structural units within the complex: such units can be therefore analysed using a specific evaluation form conceived to provide a 'risk ranking' of the different portions constituting the aggregate and accounting for vulnerability, exposure and seismic hazard parameters. The proposed methodology exploits what is already used to quickly determine structural features and eventual damages in the post-earthquake phase for ordinary buildings, introducing specifi

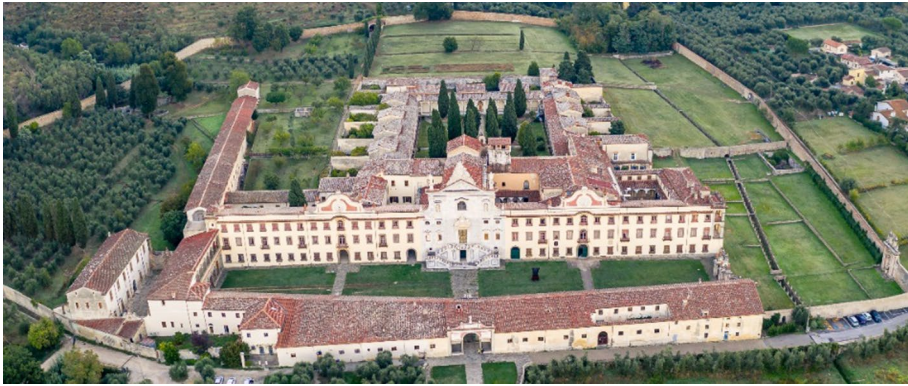
**Fig. 3** View of the monumental complex. Photo by courtesy of Guglielmo Giambartolomei

The last relevant transformation phase started in 1769 with the prior Alfonso Maggi, brought the building to its current appearance (Fig. 3). The main court was doubled by adding new blocks, the church became the central fulcrum, and the symmetry of the complex was finally achieved, introducing the portion missing on the southern corner. The renovation of the refectory, the construction of a new tower bell, the realisation of a new monumental staircase, the decoration of several spaces of the complex and new structures on the northern side were even performed (Piombanti 1884; Manghi 1911).

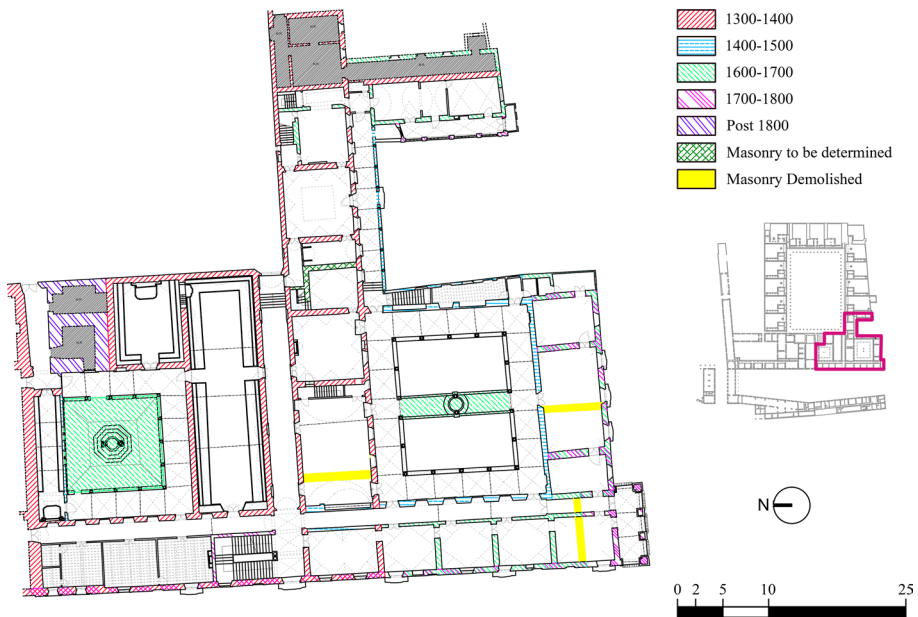
**Fig. 5** First plan of a portion of the Certosa with the indication of the macro-constructive phases according to the legend

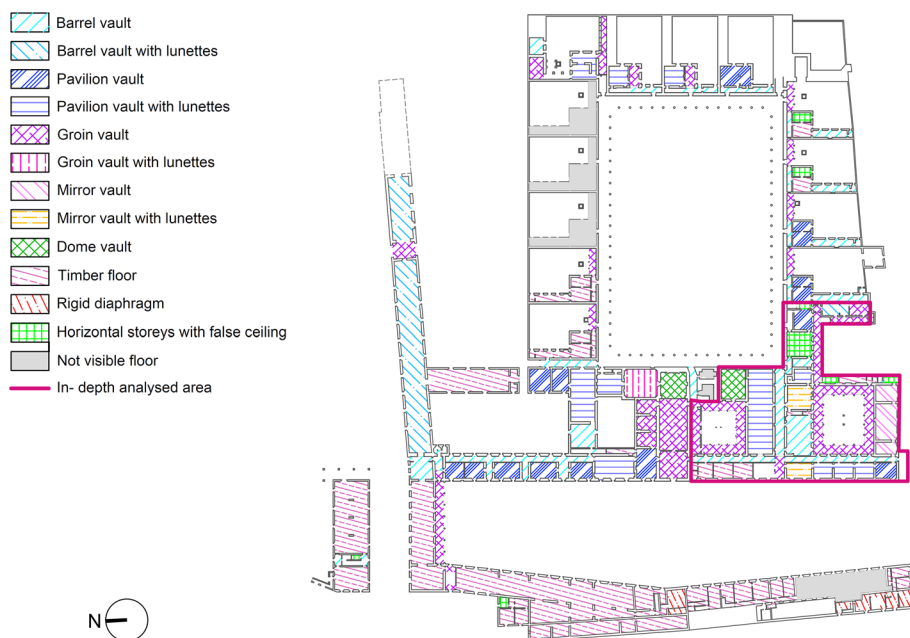
**Fig. 6** First plan of the Certosa Monumental complex with the identification of the surveyed floor typology

In-depth in-situ investigations were mainly concentrated in the area marked in Fig. 6, affected by several maintenance issues causing relevant degradation phenomena and evident vulnerabilities.

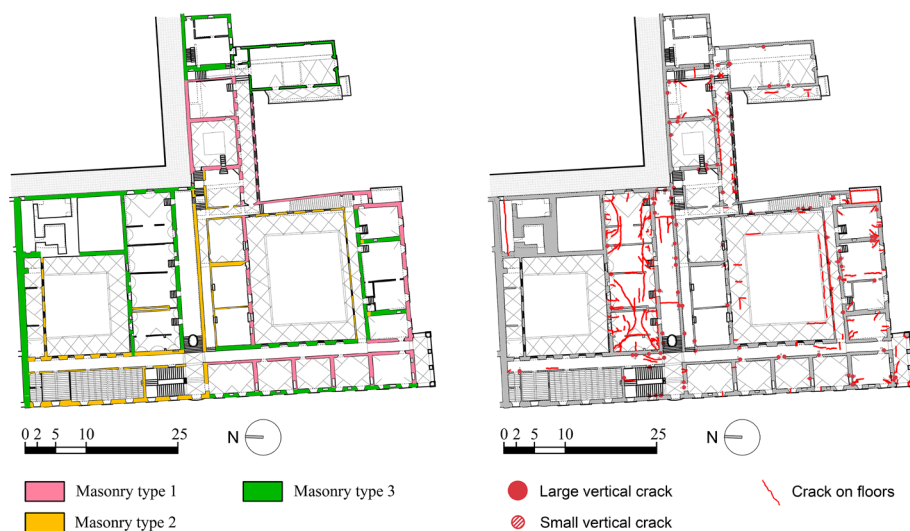
**Fig. 7** Second plan of the portion of the monumental complex more in-depth analysed representing: **a** the survey of the masonry typologies, **b** the crack pattern survey

Almost all the investigated walls exhibited a continuous thickness, without cavities or internal nuclei. Seven typologies of masonry patterns were recognised, including also the areas naturally devoid of plaster within the entire complex (Fig. 7a). No clear correspondence between the masonry typology and the constructive phases detected from the historical analysis (Fig. 5) was recognised, as well as the lack of suitable connections among

The performed investigations also included the cracking scenario survey by recording position and (estimated) entity of the existing cracks to identify structural deficiencies and

local mechanisms (Fig. 7b). Finally, the distribution and the state of tension of the steel tie rods were surveyed.
