New Frontiers of Composites Applications in Heritage Buildings: Repair of Exposed Masonry of St. Nicola Church in Pisa

Pietro Croce

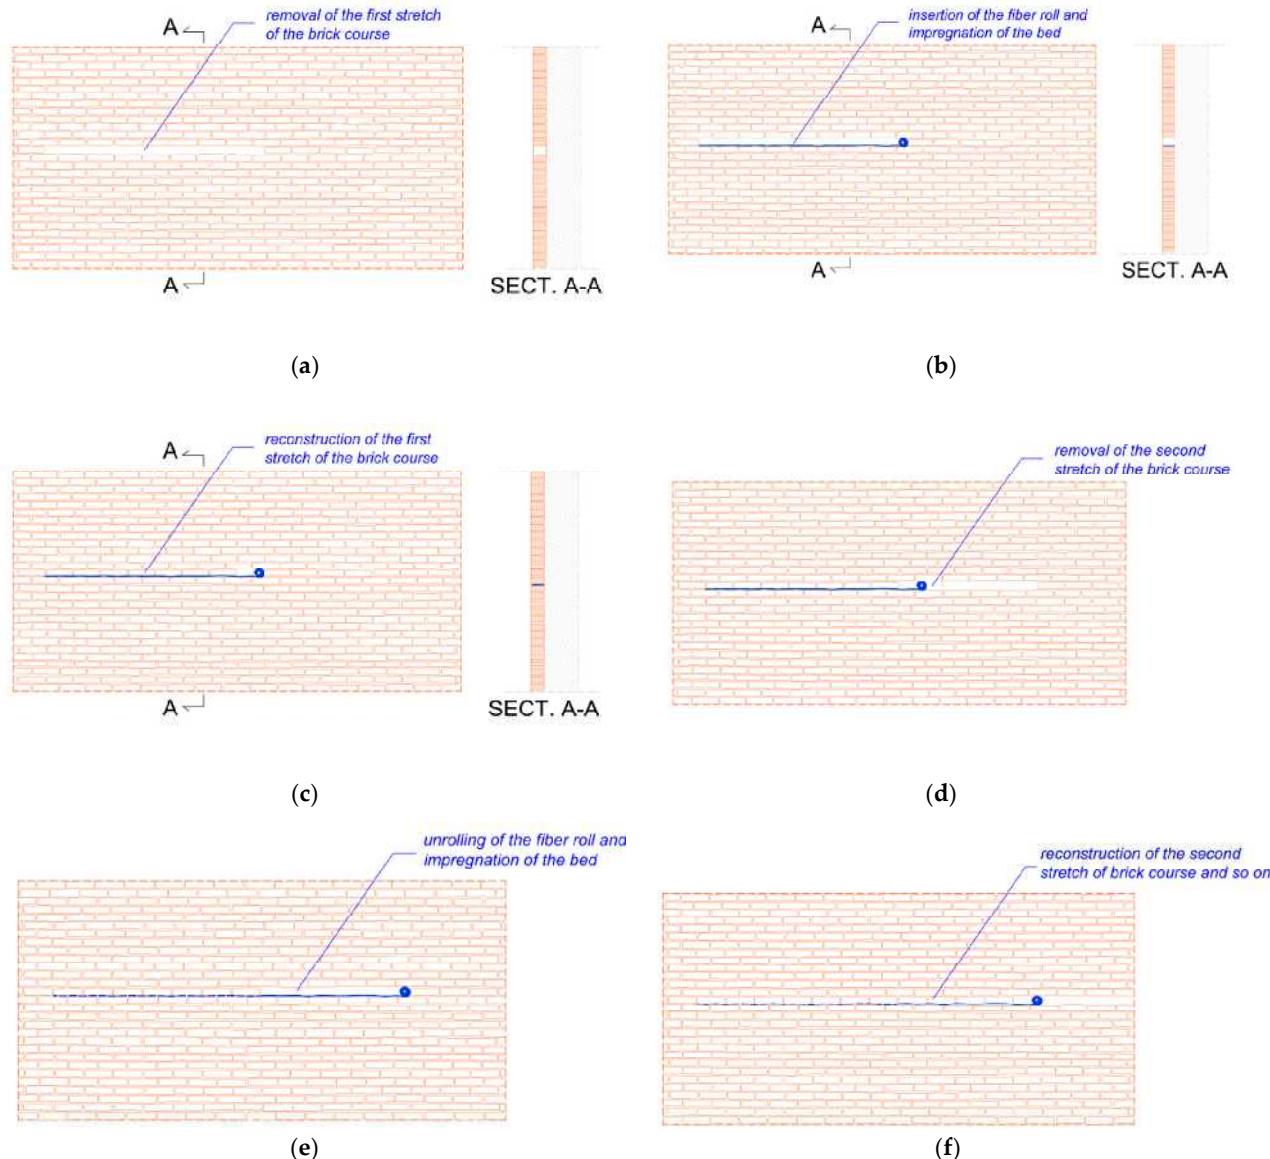
Figure 9. Phases of the proposed intervention: (a) removal of the first stretch of brick course; (b) unrolling and impregnation of the fiber roll; (c) reconstruction of the first stretch of the brick course; (d) removal of the second stretch of brick course; (e) unrolling and impregnation of the fiber roll; (f) reconstruction of the second stretch of the brick course.

3. rolling up of the fiber strip,
4. starting of the indent: careful removal of the first stretch of the brick course (Figure 9a), and cleaning of the so obtained recess,

5. application, using a spatula or a paintbrush, of low viscosity polymeric resin, for example, epoxy resin, insertion and partial unrolling of the fiber roll and its impregnation with the resin (Figure 9b),

6. waiting until the resin is suitably cured, typically 24 h;
7. reconstruction of the stretch of the brick course: reinsertion of the bricks and renovation of mortar joints (Figure 9c), using a mortar having a composition similar to the historical one, for example, a lime mortar,

8. removal of the second stretch of the bridge course (Figure 9d),
9. unrolling and impregnation of the fiber roll, as in step 5 (Figure 9e),
10. reconstruction of the stretch and renovation of mortar joints, as in step 6, and so on until the total extension of the course is completed (Figure 9f).

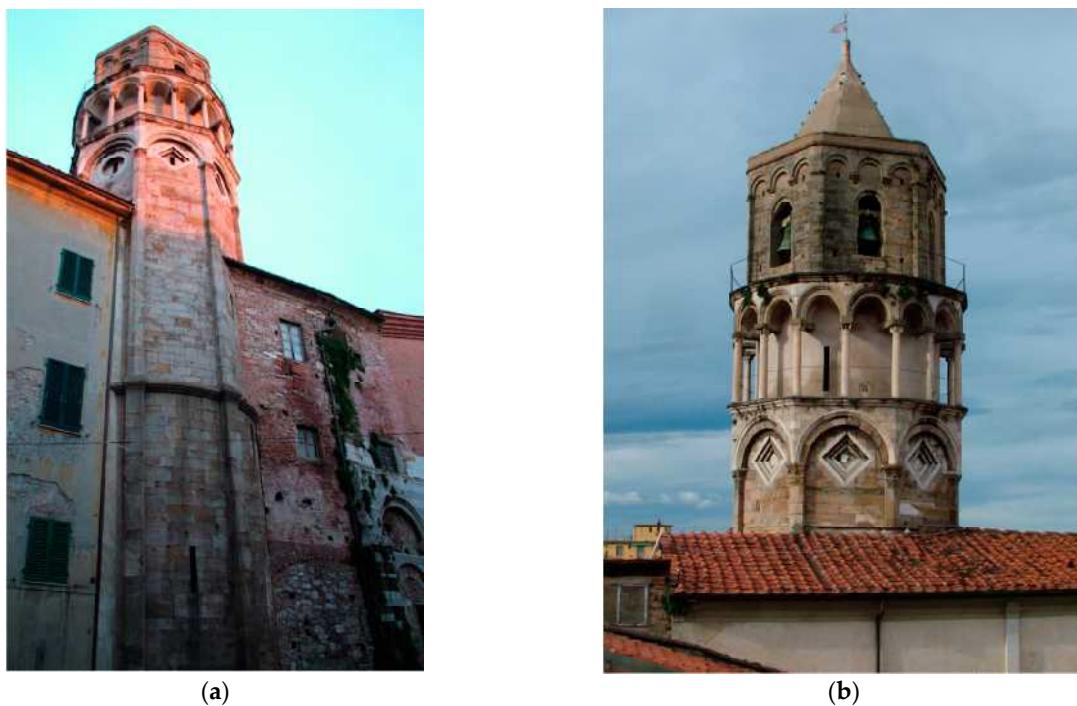
The leaning bell-tower (Figure 12), 35.5 m high, and inclined around $1^{\circ}13'$, and considered a masterpiece of the Pisan Romanesque style, is characterized by a complex architectural organization, with the cross section varying along the height: actually, the cross section starts as ribbed circular, with eight external ribs, at the base, to become octagonal at higher orders, and finally hexagonal at the level of the belfry, and of the roof.

Figure 12. The bell tower of the St. Nicola Church in Pisa: (a) the bell tower from St. Maria Street; (b) the belfry.

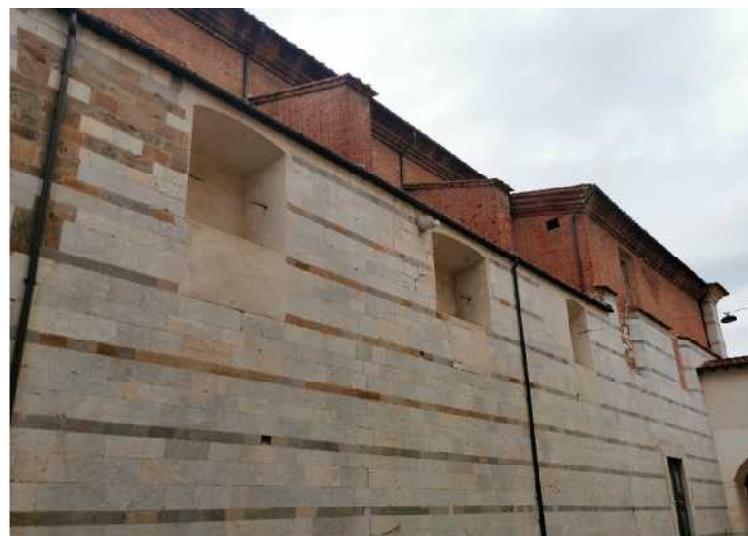
The thrust of the barrel vault is sustained by buttresses supported by the transverse walls of the south chapels, coming up from the mono-pitched roof of the south side, as illustrated in Figure 13.

Figure 13. The south wall of St. Nicola Church.
