## An update on the Tower of Pisa

**ABSTRACT:** The Leaning Tower of Pisa has been stabilised in the years 1999–2000 by an International Committee appointed by the Italian Government. An analysis of the whole history of the monument, starting from its construction in the XII century and including the results of the modern monitoring of XIX and XX century led the Committee to the conclusion that the Tower is affected by a phenomenon of instability of the equilibrium, depending on the deformability and not on the strength of the foundation soils. The stabilisation intervention, totally respectful of the integrity of the monument, consisted in slightly decreasing the inclination of the Tower by underexcavating a small volume of soil beneath the north side of the foundation. The paper briefly reports the analysis and the intervention; the observation of the behaviour in the twenty years elapsed since then allows some preliminary evaluation of the future behaviour.

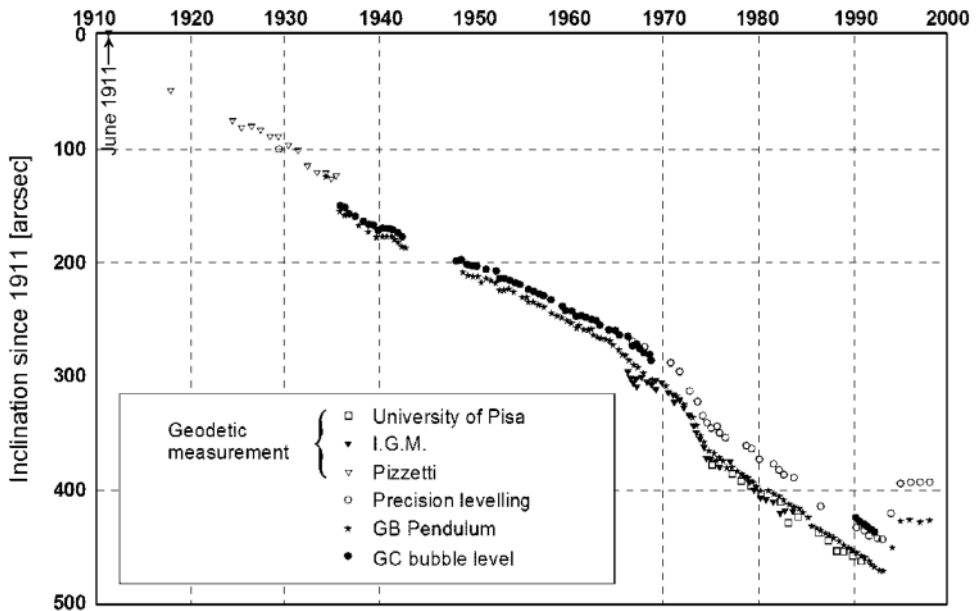
Figure 4. Inclination of the Tower from 1911 (start of modern monitoring) to 1999 (start of the underexcavation). GB inclinometer and geodetic measurements include the deformations of the Tower body, and hence their results are slightly larger than those of GC level and optical levelling, representative of the rotation of the foundation.

The inclination of the Tower from 1911 to 1999, as obtained by different procedures, is reported in Figure 4. This shows a continuous increase of the inclination, affected by some perturbations.

From the early 1970s, an increase of the rate of tilt of the Tower is evident in Figure 4. This has been related to the increasing pumping of water from the deep sands (Figure 5) inducing subsidence all over the Pisa plain (Croce et al. 1981) and was eventually brought to an end by closing a number

From a structural point of view, a hoop of pre-tensioned steel wires was installed around the first cornice of the Tower. From a geotechnical point of view, a counterweight of 5.9 MN consisting of 64 lead ingots was installed on the North edge of the base of the Tower, producing a counter rotation of 53". This may be seen in Figure 4 and in more detail in Figure 7.

rotation by the application of further lead weights on the North, the intervention was abandoned. The negative effect of this attempt may be seen in Figure 4.

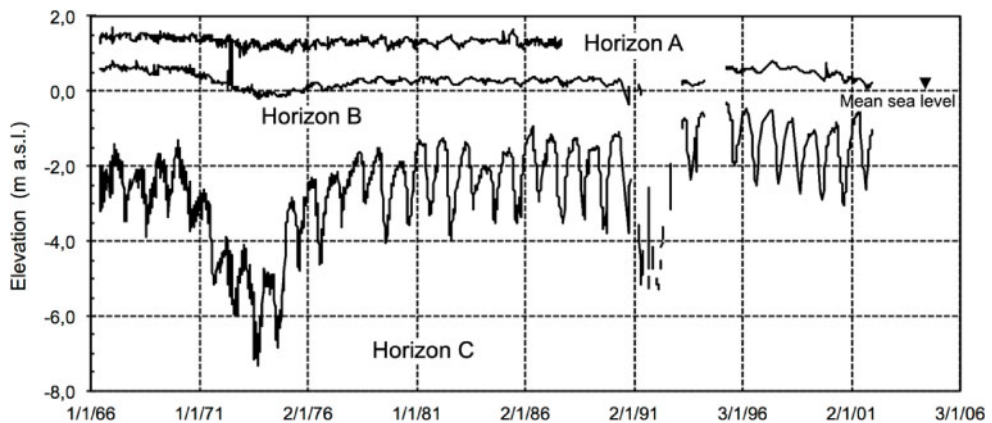
Figure 5. Groundwater regime in the subsoil of the Tower. The piezometric elevation in the lower sand is affected by pumping in the whole Pisa plain; in the 70's pumping increased because of a sequence of dry years.

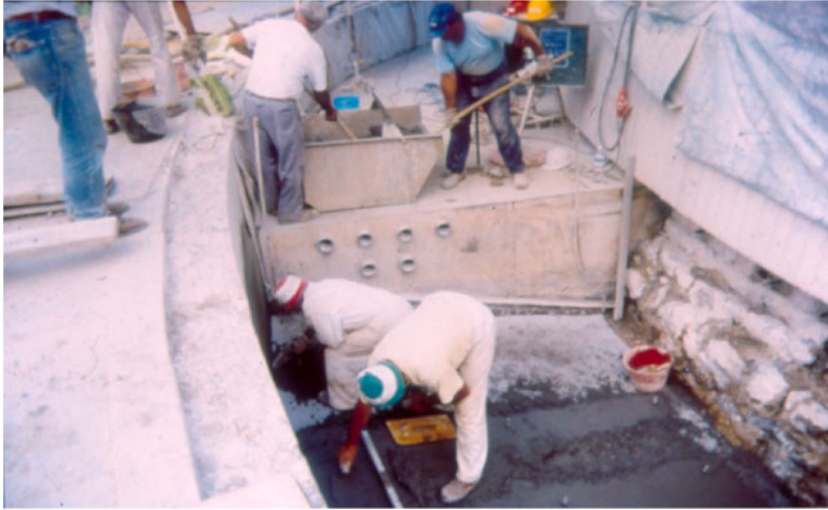
Figure 9. Construction of the northern sections of the ring beam for the ten anchors.

Without going into the details, it can be reported that the northern sections of the ring beams were successfully installed (Figure 9). However, when freezing was commenced on the South-West and the South-East sides, the Tower began to rotate southwards; after some attempts of controlling the

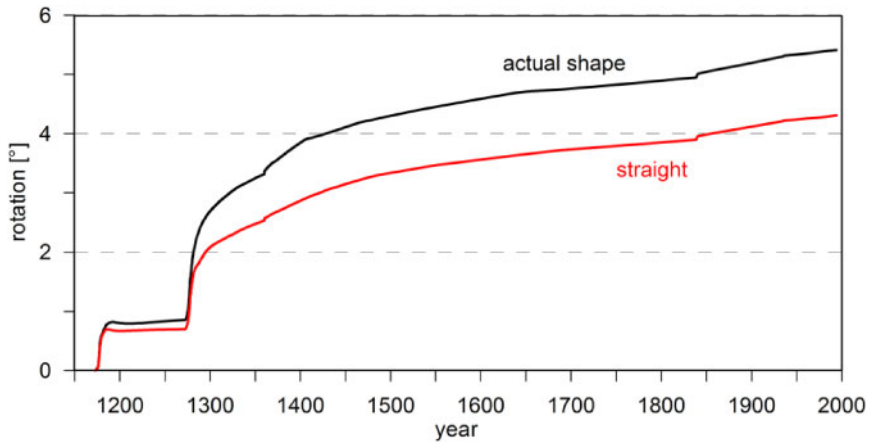
Figure 13. Rotation of the Tower with and without correction of its shape.

In the framework of this analysis, the model has been used to predict the rotation of the Tower in the assumption of no correction of its shape during construction, and hence with a straight axis. Surprisingly, the comparison of these results with those obtained with the actual curved axis (Figure 13), reveals that without corrections – the rotation of the Tower in 1993 would have been 4.3°, i.e., significantly smaller than the actual 5.5°.
